FIELDWORK ON THE SITE OF DUKESFIELD SMELTMILLS HEXHAMSHIRE

REPORT ON ARCHAEOLOGICAL EVALUATION CARRIED OUT IN OCTOBER 2012

by
THE ARCHAEOLOGICAL PRACTICE LTD.

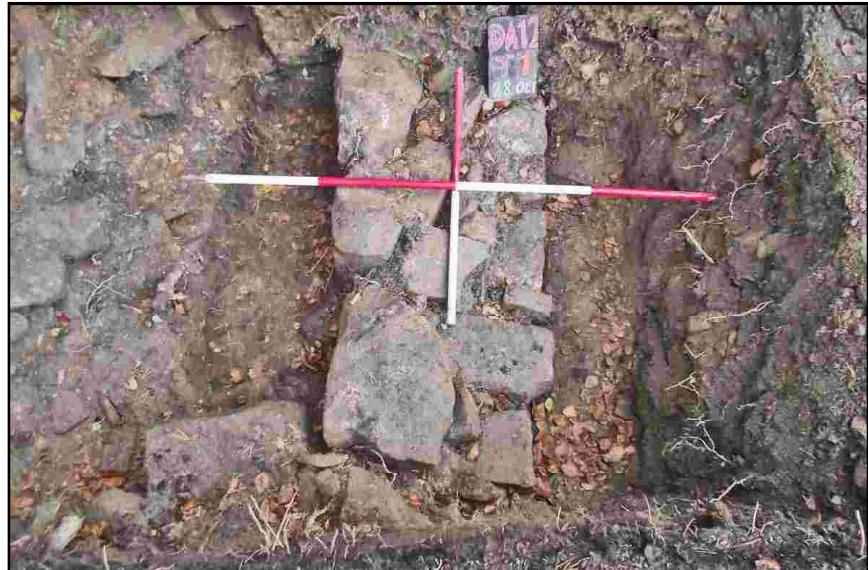
Illus. 29: View from the north of wall remains exposed in Trench 1.

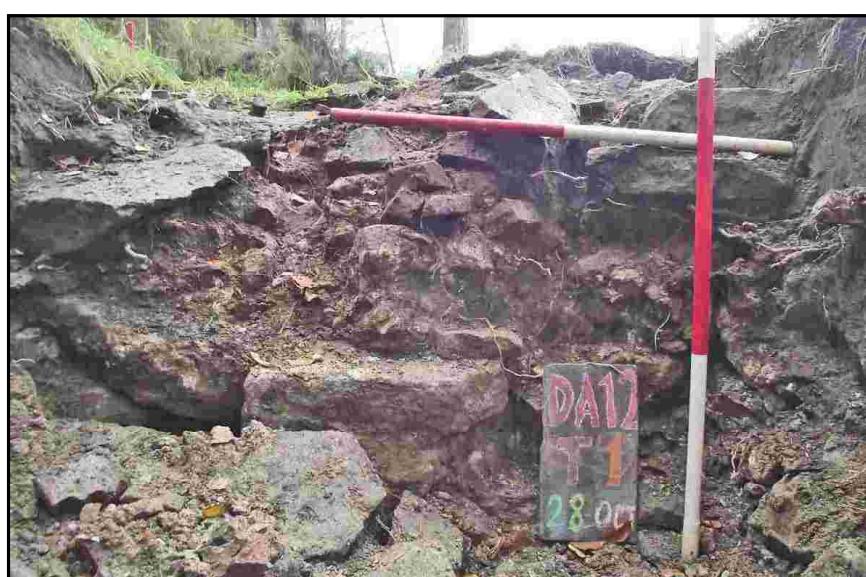
Illus. 31: Close-up view of rubble at the west end of Trench 1.

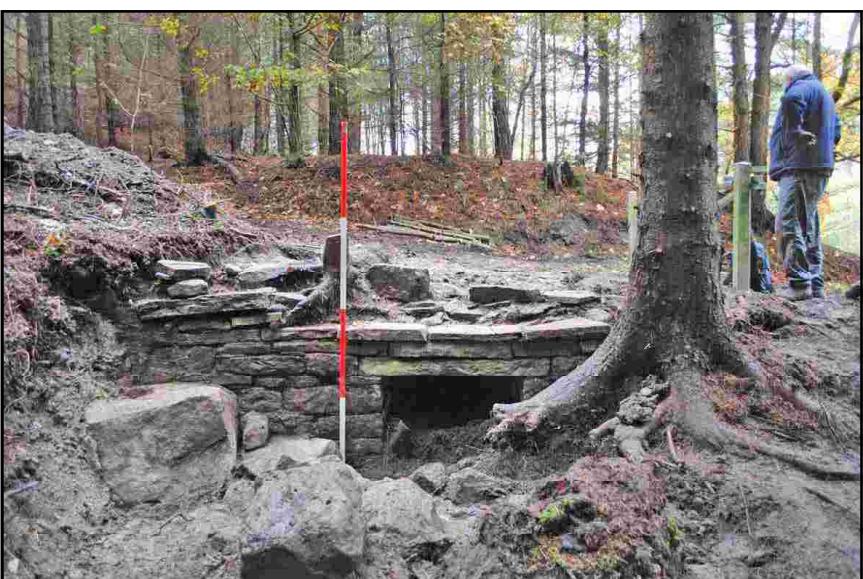
Illus. 36: View of the east-facing culvert entrance exposed in Trench 2.

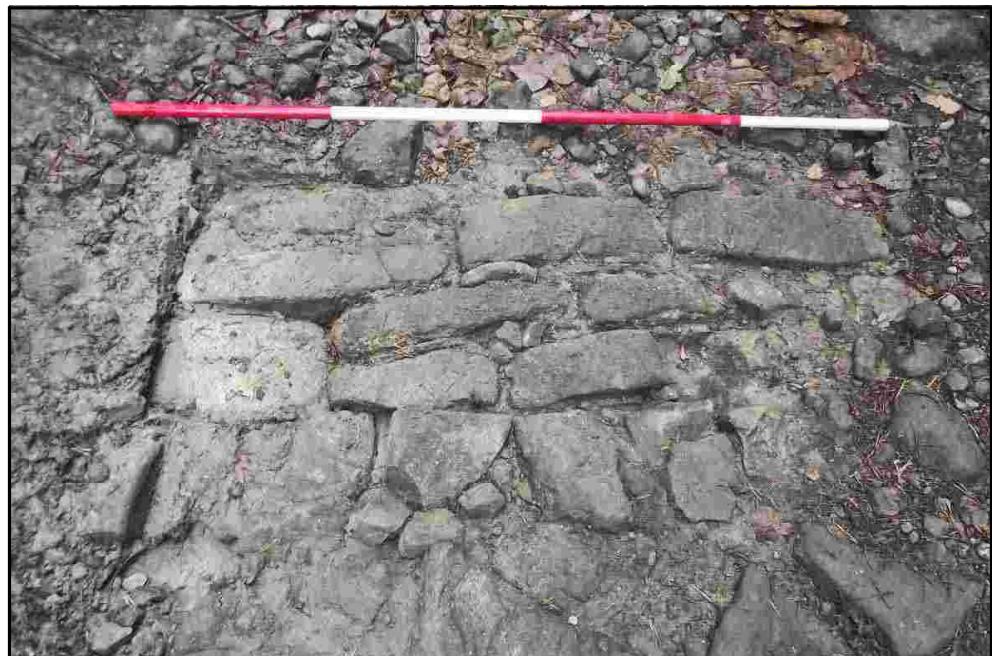
Illus. 39: View northwards of an exposed section of culvert roof exposed in Trench 2 (see above).

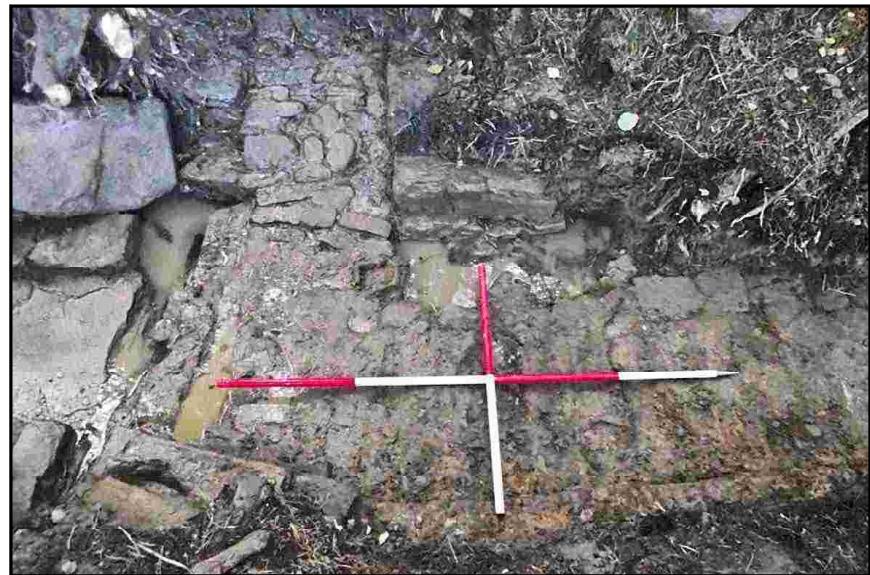
Illus. 52: East end of the hearthstone-lined leat revealed in Trench 3, with 'ramp' to the south and flagging to the east.

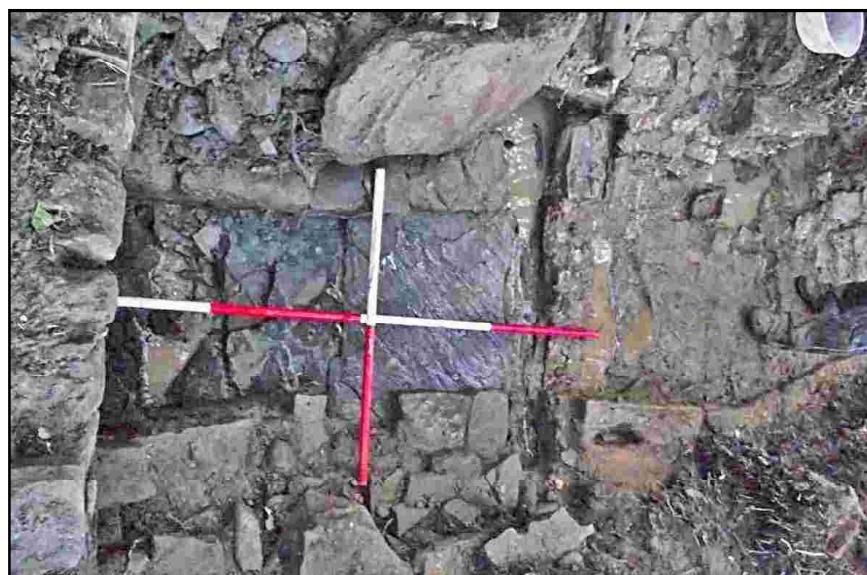
Illus. 53: Vertical view of flag-floored culvert entrance at the east end of Trench 3, with wood-lined slot between flagged- and hearthstone-lined sections of floor.

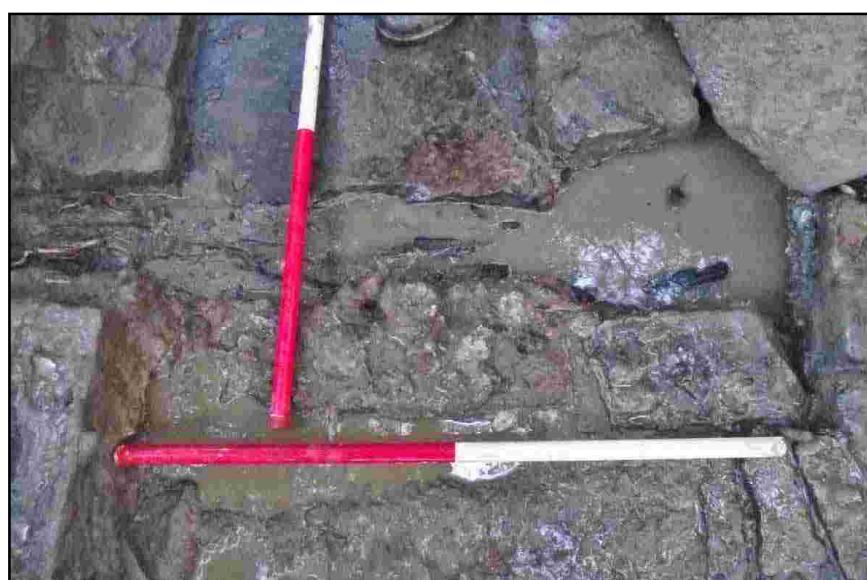
Illus. 54: Detail of preserved timber and iron fittings in socket marking the position of a former sluice gate at the east end of Trench 3.

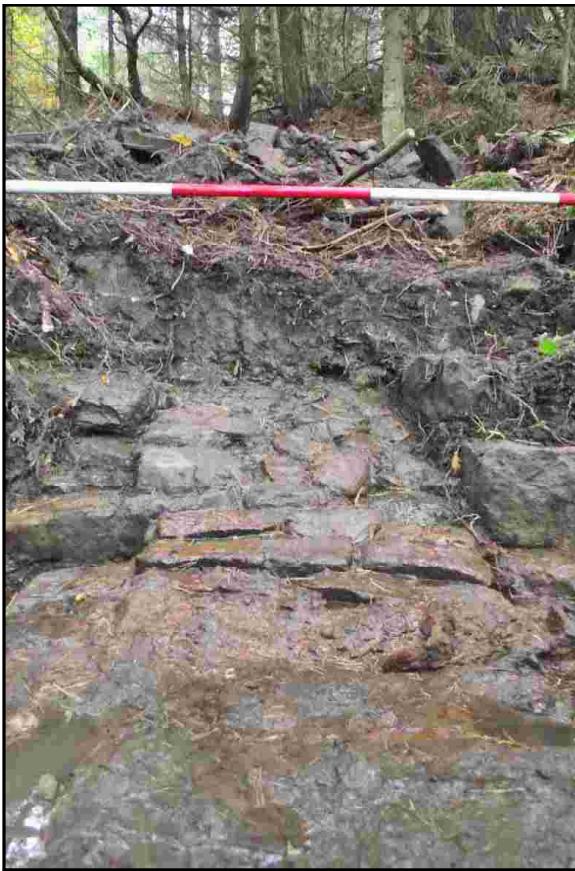
Illus. 55: View from the north of a cobbled feature - presumably a former water-course or access ramp - running into the south side of the leat exposed in Trench 3.

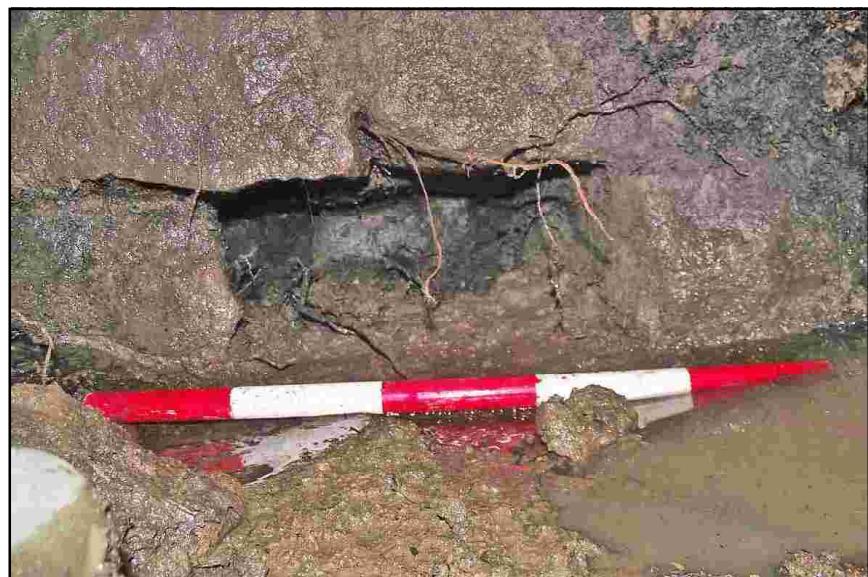
Illus. 59: View of a deep socket in the south-facing interior wall of the culvert, just above floor level, close to its west end, as revealed in Trench 3.

The section of leat with flagged floor east of the 'ramp' feature was bounded on either side by a lining of stonework, backed on the north side by a bank or dry-stone wall of similar construction to that noted at the west end of the trench. The stone lining tied in with the west-facing stonework of the arched entrance to the culvert, a straight-sided channel of coursed sandstone masonry, with corbelled roof set on a springer-course. On the north side of the culvert entrance, within the west-facing supporting wall of the springer-course, was a slot some 0.12 metres long and 0.08 metres high, with a depth of c0.10 metres. A second, larger and deeper slot, measuring some 0.30m long by 0.16 metres deep and at least 0.40 metres deep was observed in the south-facing wall of the culvert close to its entrance, just above floor level.

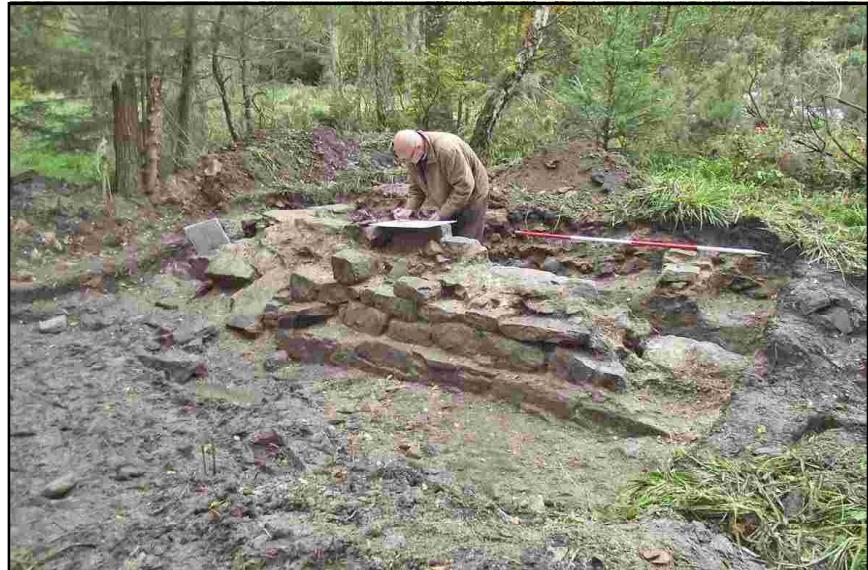
Illus. 64: View during the excavation of Trench 4, looking south at structural remains of a wall with cobbled floor in front.

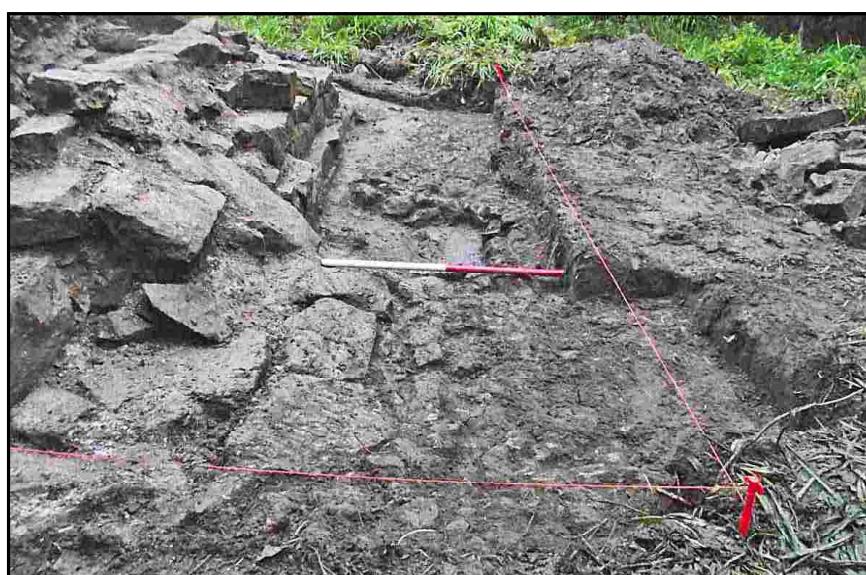
Illus. 66: View looking west along a wall face (above) fronted by cobbling in Trench 4.

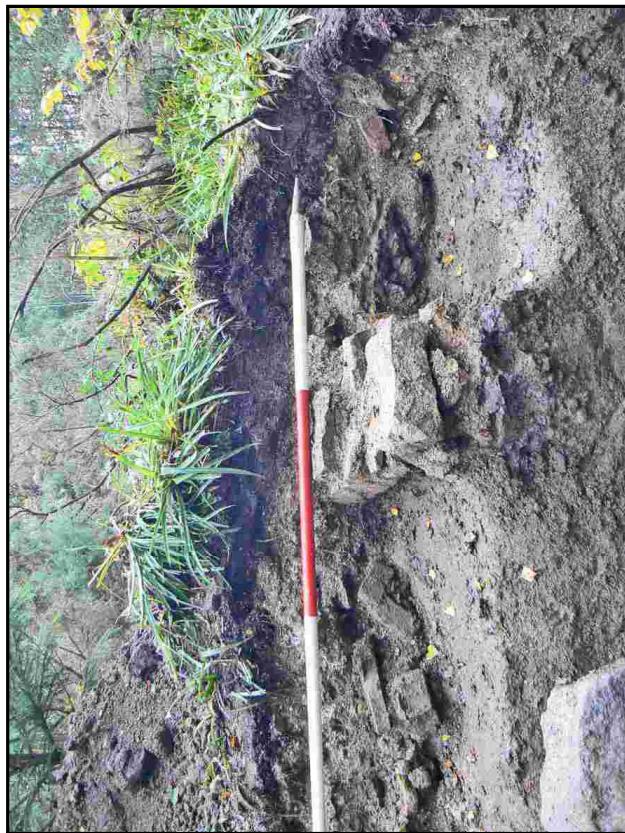
Illus. 71: View looking south of shallow-footed wall remains at the west end of Trench 4.
