A SECOND SEASON OF FIELDWORK ON THE SITE OF  
DUKESFIELD SMELTMILLS, HEXHAMSHIRE

REPORT ON ARCHAEOLOGICAL EXCAVATION, RECORDING  
AND MONITORING CARRIED OUT BETWEEN  
JULY AND OCTOBER 2013

by  
THE ARCHAEOLOGICAL PRACTICE LTD.  
for  
THE FRIENDS OF NORTH PENNINES

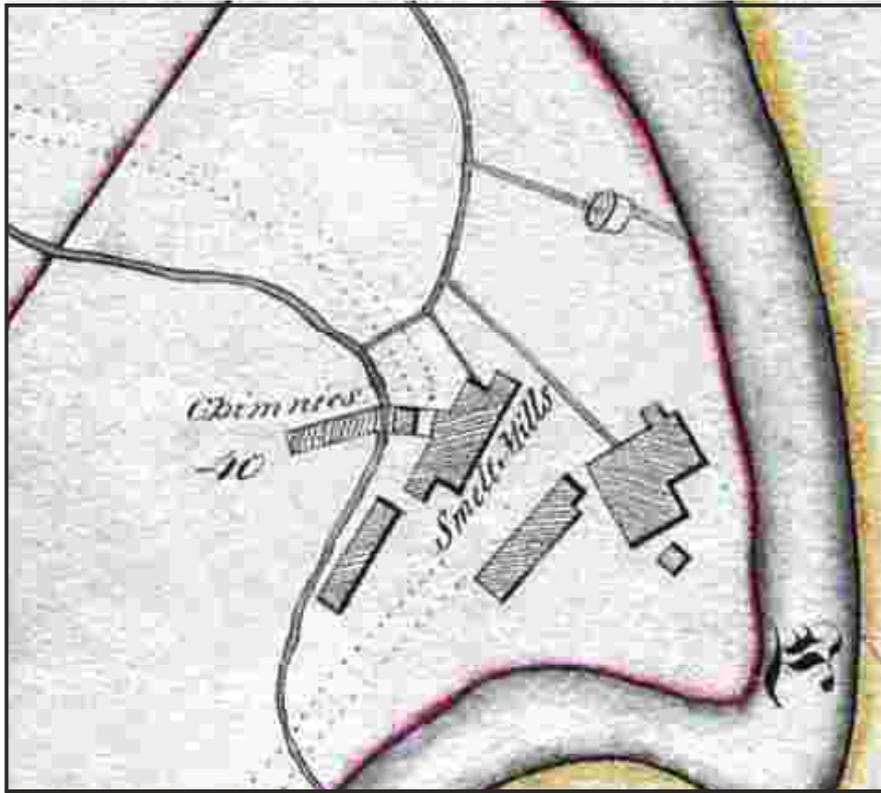
**Illus. 05:**  
A plan of the smelt mill works taken from an estate plan of 1802.

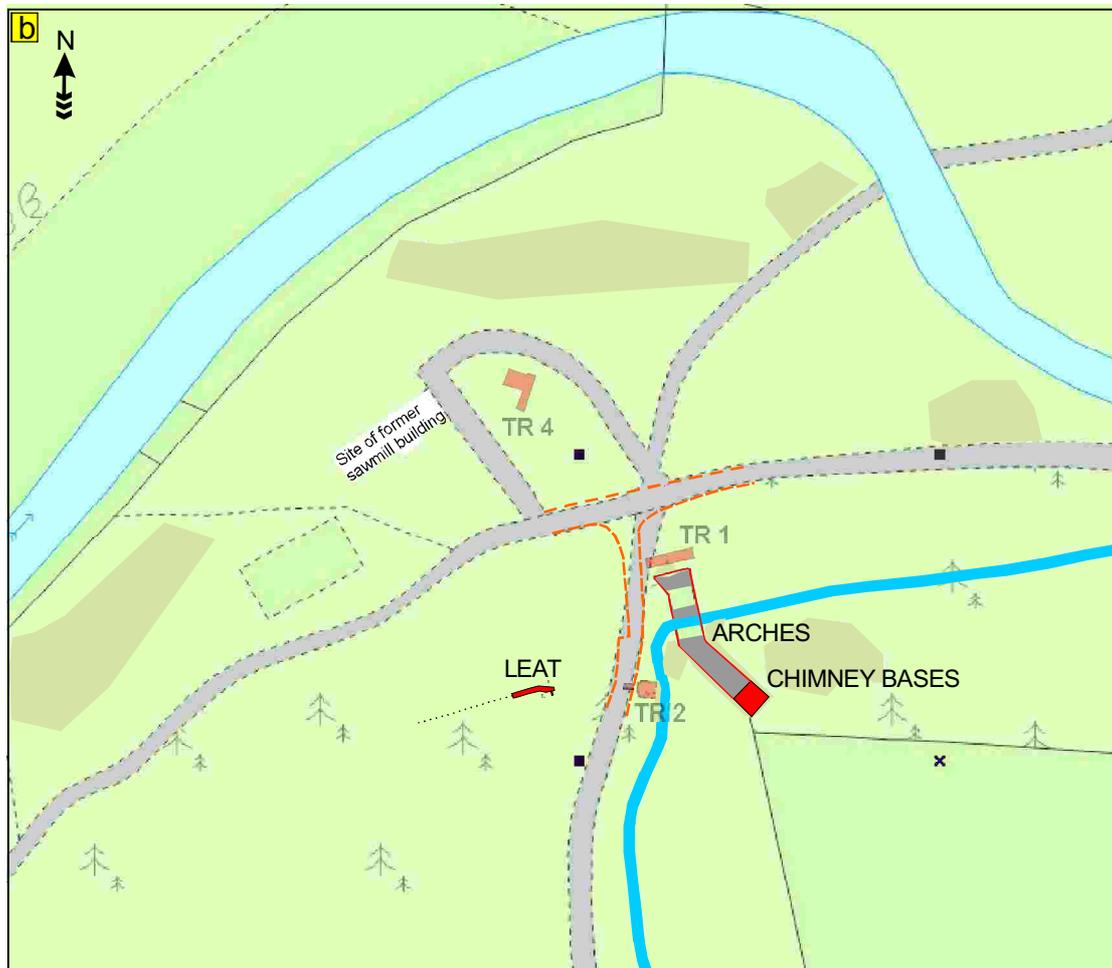
*Illus. 07: Location of archaeological Investigations carried out on the chimney bases, arches and leat between July & October, 2013 (based on a site survey carried out in October 2012), with trenches excavated in 2012 shown as transparencies.*

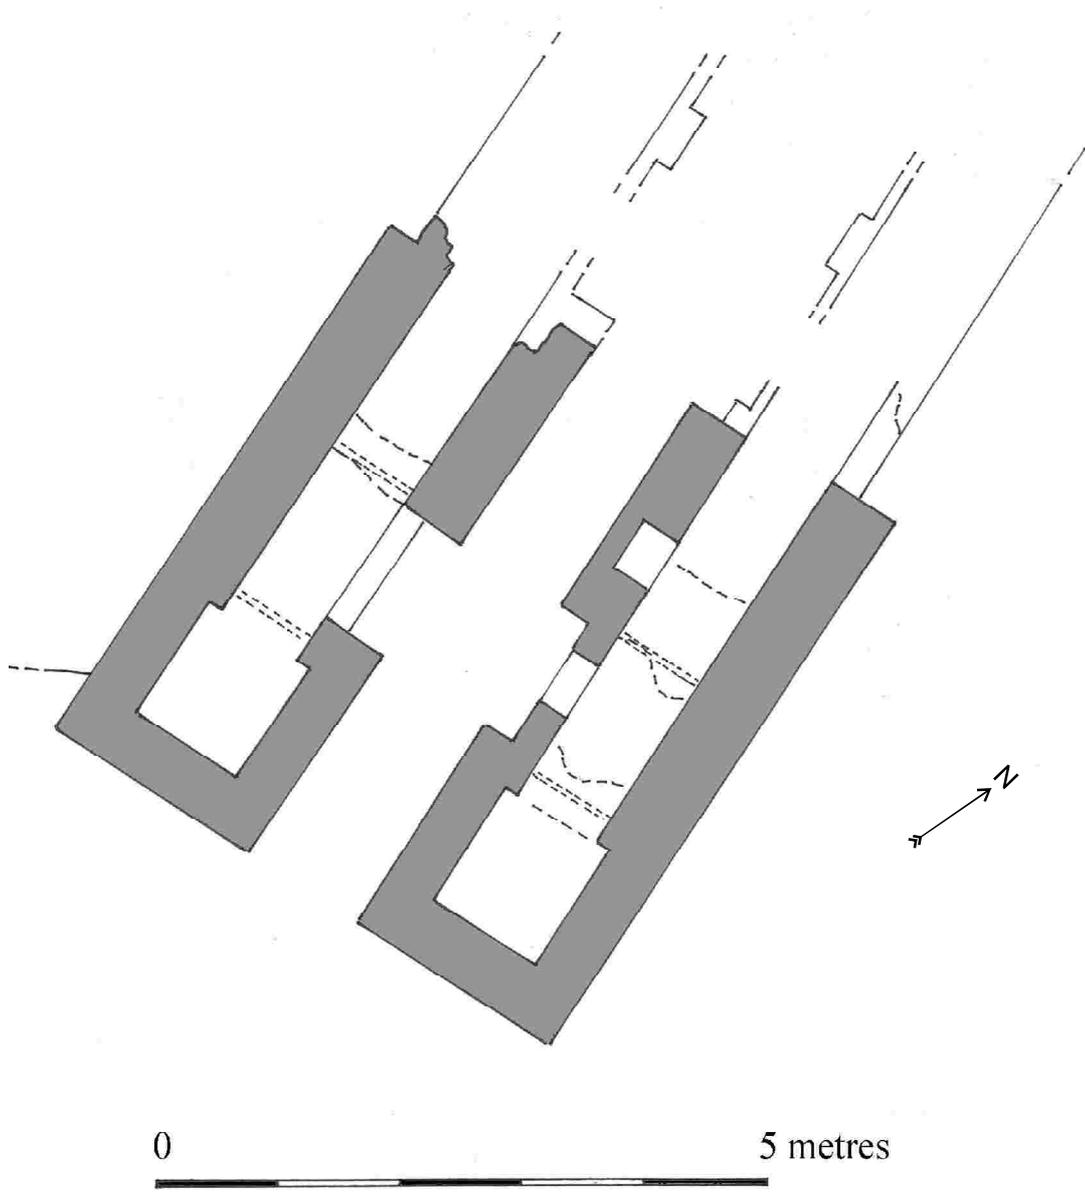
#### **Description** (Illus. 08 and see *Photos 62-69*)

The chimney bases comprise two pairs of interconnected, stone-built and brick-lined chambers divided by a central passageway. Each pair of chambers comprises, at the front of

*Illus. 08: Plan of the Chimney Stacks*

the complex adjoining the stone-built arch structure, a covered (or formerly covered) chamber attached by means of a short, roofed conduit or flue to an open-topped chamber or chimney. The front chamber, interpreted as a condensing chamber, is connected to the arches structure by the remains of brick flues running from the position of the former smelting hearths at the north end of the arches. Each condensing chamber, which is stone-built but lined with hand-made earthenware bricks, has in its inner wall (i.e. facing the central passageway) a blocked opening, constructed with a sandstone lintel but otherwise featureless. The roofs of the condensing chambers were of sandstone flags, as were the flagged floors, upon which, as in the chimneys, were deposits of grey powder, probably ash-based but very likely containing other, mineral-based components resulting from the smelting process. The conduits or flues linking condensing chambers and chimneys were brick-built and roofed with flags; the eastern flue has had an opening in it from the central passage (i.e. through its west-facing wall) which does not appear to have been replicated in the corresponding wall of the western flue, unless the evidence for it has been lost. The brick-lined chimneys appear to have been of identical form and construction, brick-lined but slightly wider than their associated condensing chambers and connecting flues. One additional feature of note is the presence, in the external and internal passageway walls of the stone-built structure, of small holes, each about the dimensions of a brick end, forming no apparent pattern but spaced between 0.15 and 0.70 m apart. It was noticed that some of these holes were blocked, particularly on the west-facing external face of the structure, suggesting that they may have played a role in ventilation, or influencing in some way the draft between source and chimneys. A similar suggestion is made with respect to the (blocked) openings in the sides of the condensing chambers, while that in the connecting conduit/flue may have performed a similar role or, perhaps, have been used to gain access into the flue and chimney for purposes of waste deposit retrieval and general maintenance.

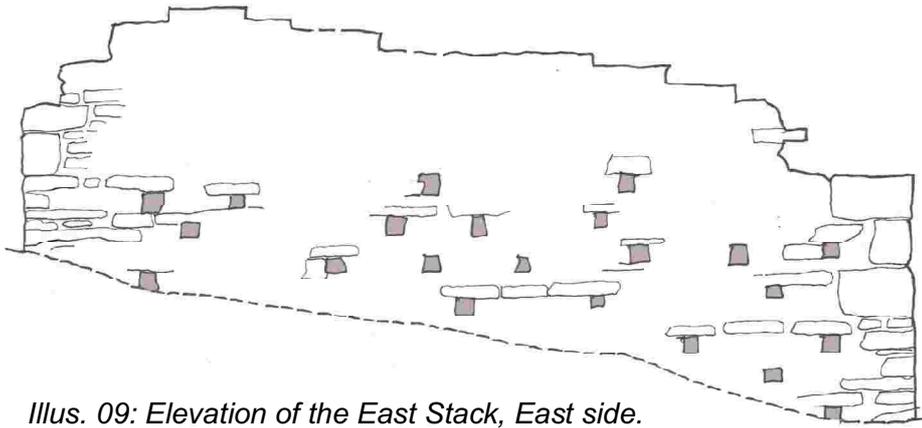
*Illus. 09: Elevation of the East Stack, East side.*

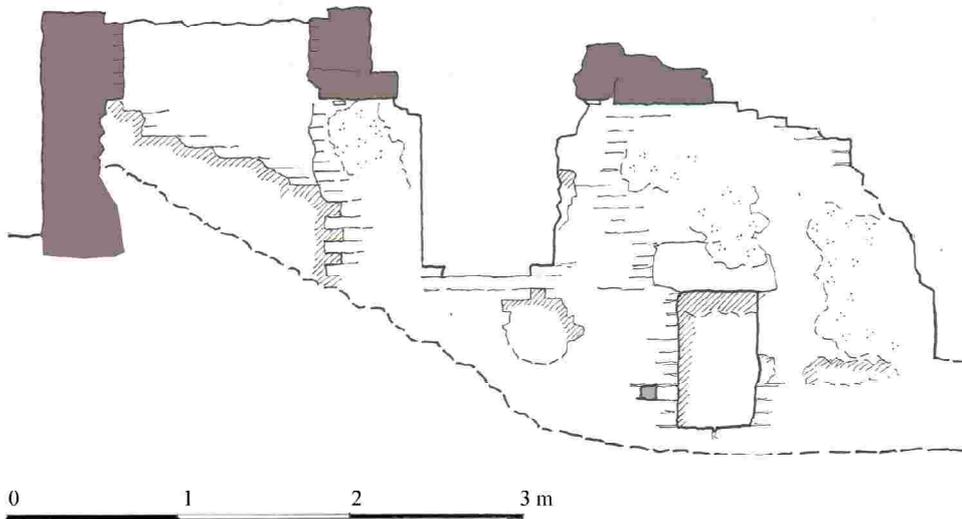
*Illus. 10: Section through the East Stack, looking west.*

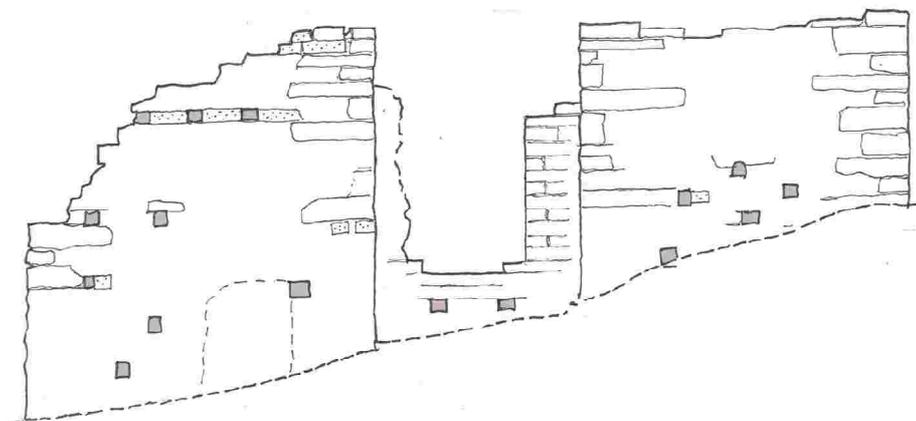
*Illus. 11: Elevation of the East Stack, west side.*

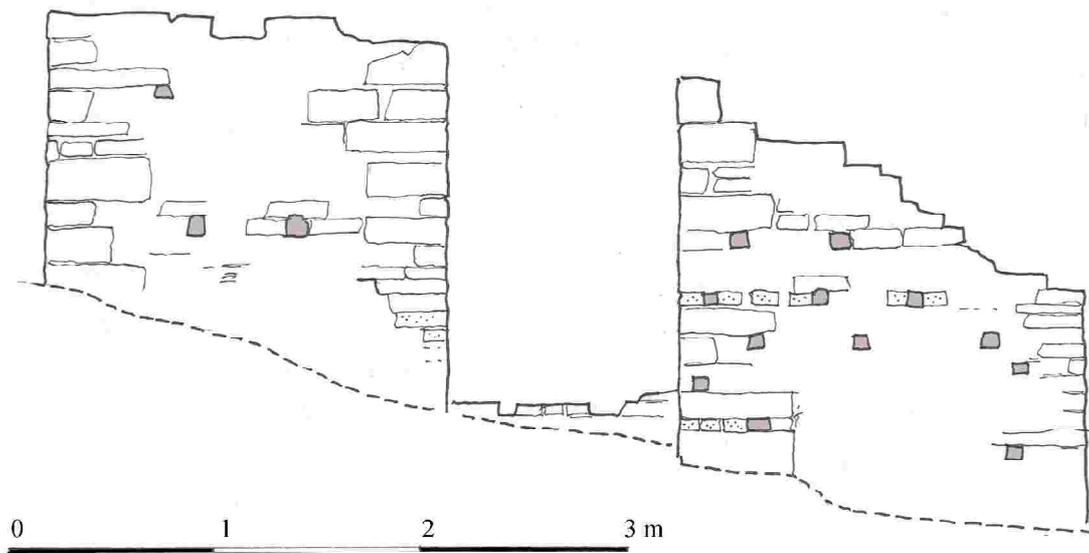
*Illus. 12: Elevation of the West Stack, East side.*

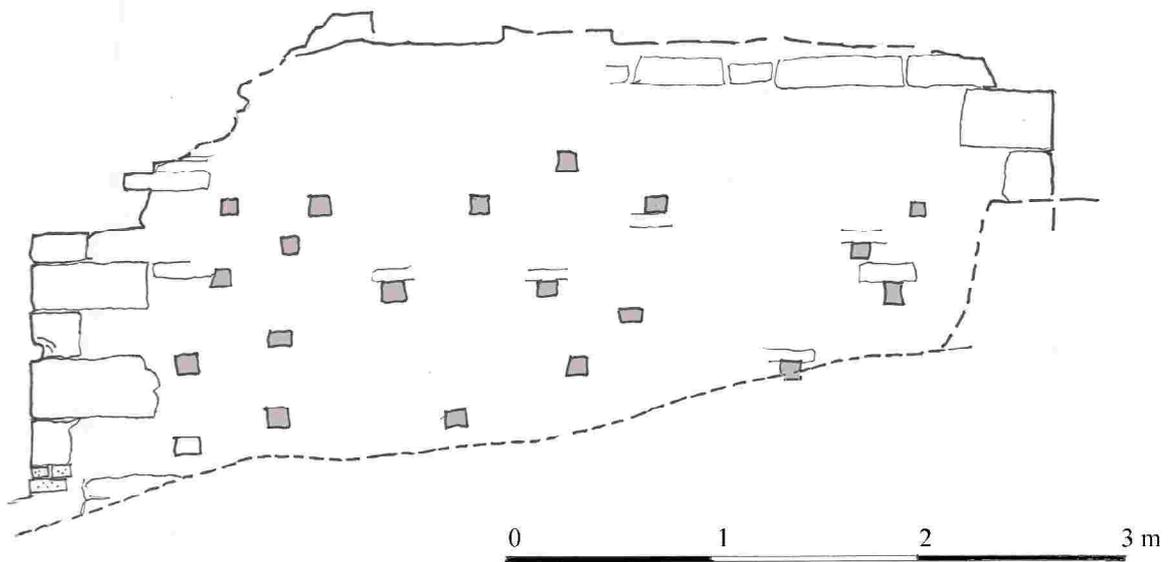
*Illus. 13: Elevation of the West Stack, West side.*

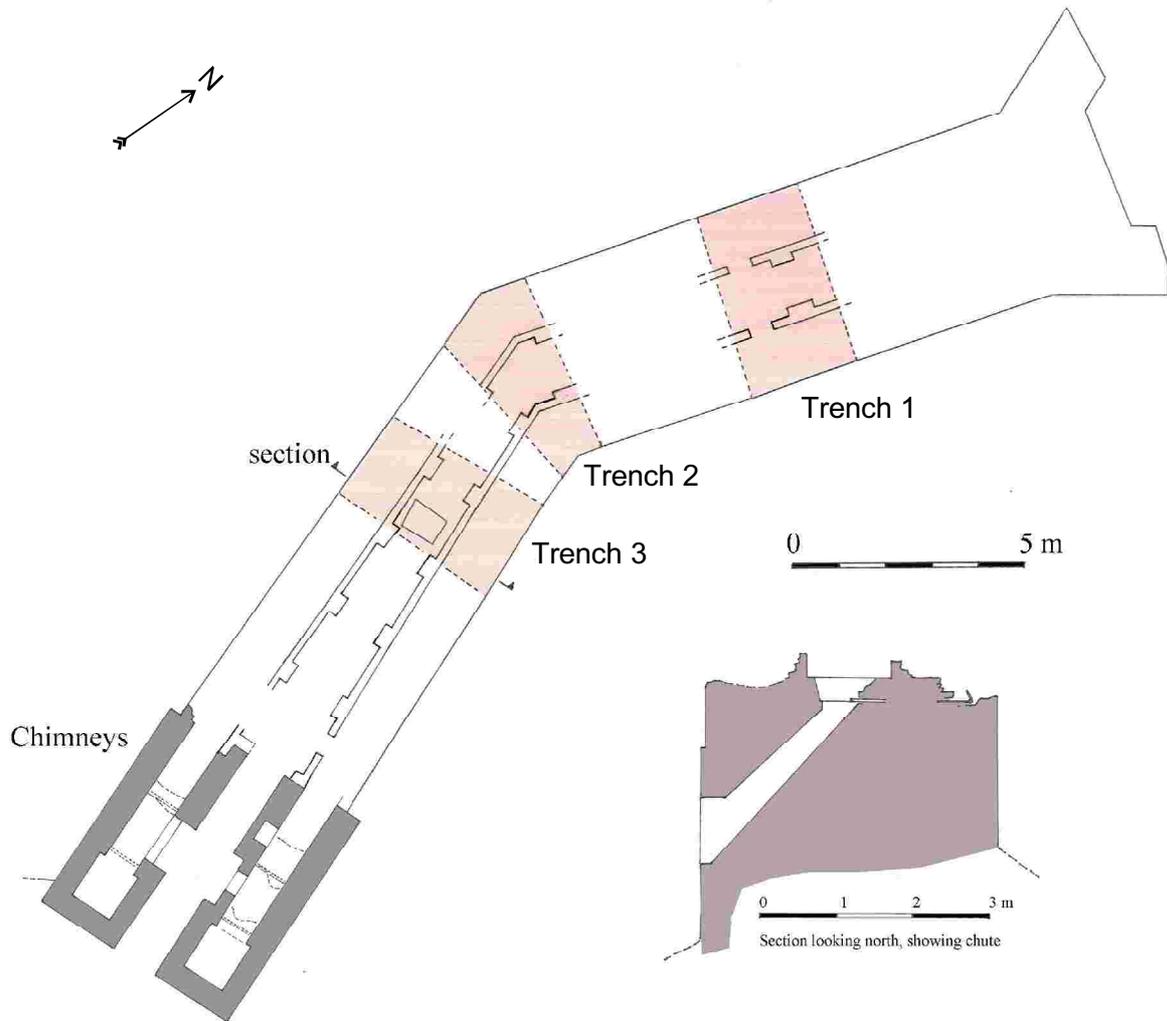
*Illus. 14: Plan of Evaluation trenches excavated on the arches roof; also showing course of other flue remains exposed in relation to the chimney stacks, with a section through the arches at the site of Trench 3 showing the course of the chute between roof and south-west facing wall.*

that noted in the three evaluation trenches was recorded, with double-skinned brick wall strengthened at intervals by internal buttresses. At the south end, where the flue ran into the condensing chambers of the chimneys structure, an opening, presumably for a door, of similar dimensions to that recorded in evaluation trench 1, was observed in the inside wall of the east flue, and, a similar opening may be postulated for the corresponding position in the west flue, although the poor survival of the masonry in that position does not permit verification. At the north end of the arches roof, the flue remains tapered away into a mass of recently-consolidated masonry rubble, but it seems likely that the two flues diverged to join chimneys via the north-east and north-west projections of the arches roof.

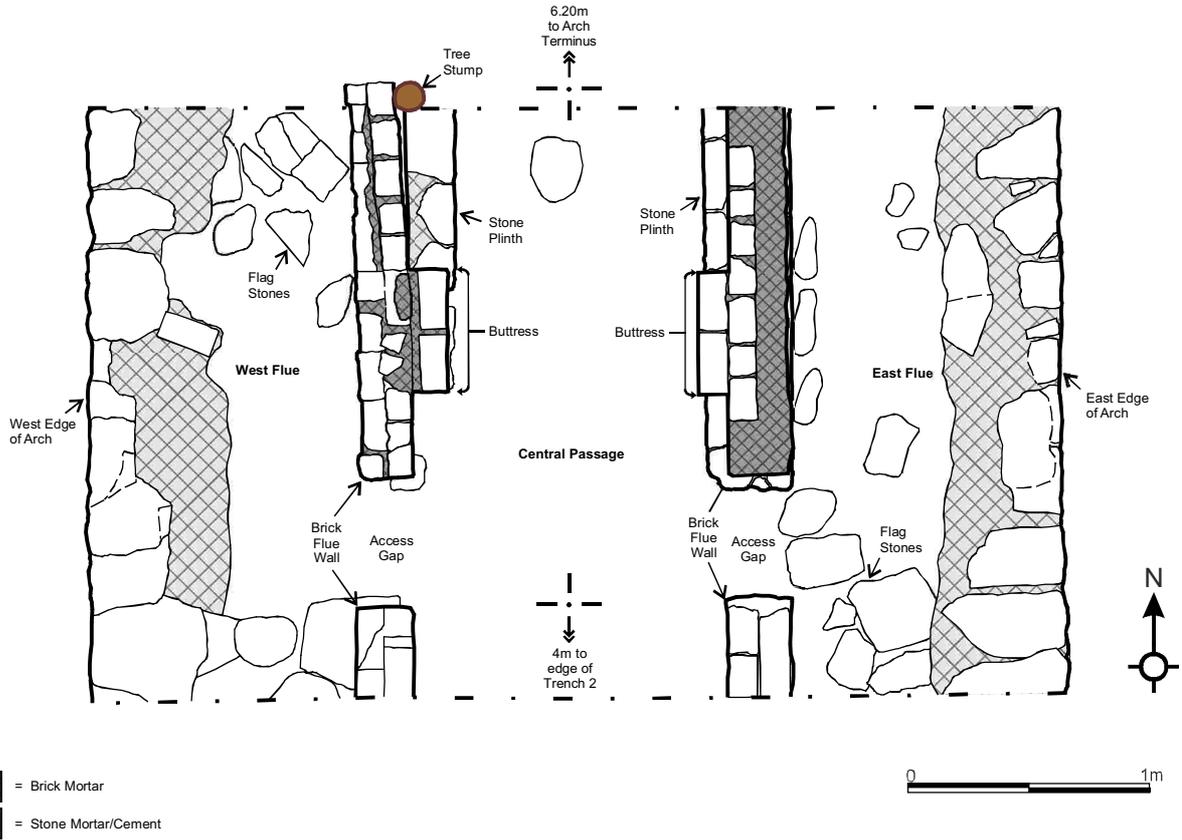
The excavation revealed parallel, double-skin brick walls up to four courses high - interpreted as forming the inner walls of parallel flues - each buttressed internally and sitting upon flagstone foundations themselves mortared to the flagged surface of the arches structure. A gap in each wall was probably constructed to be used as a doorway from the central passage running for the full length of the arches.

**Illus. 15:** Plan of Trench 1, Dukesfield Arches 2013.

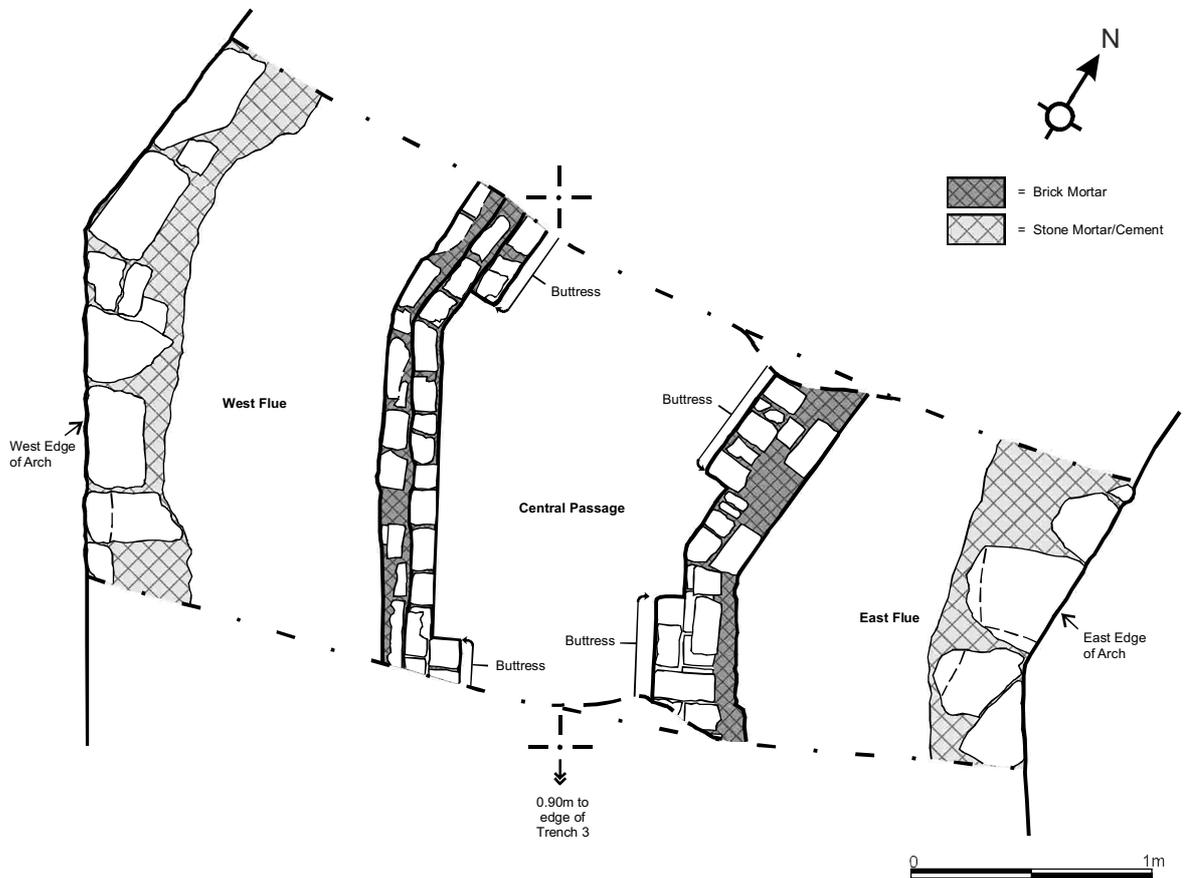
### ***Description*** (*Illus. 14 & 16 and see Photographs 77 - 81*)

The excavation revealed a similar arrangement of double-skinned brick walls as in Trench 1, with single skin brick buttresses added either side of the angle marking the change in course of the walls, though not positioned adjacently as in Trench 1. Also revealed in this trench

**Illus. 16:** Plan of Trench 2, Dukesfield Arches 2013.

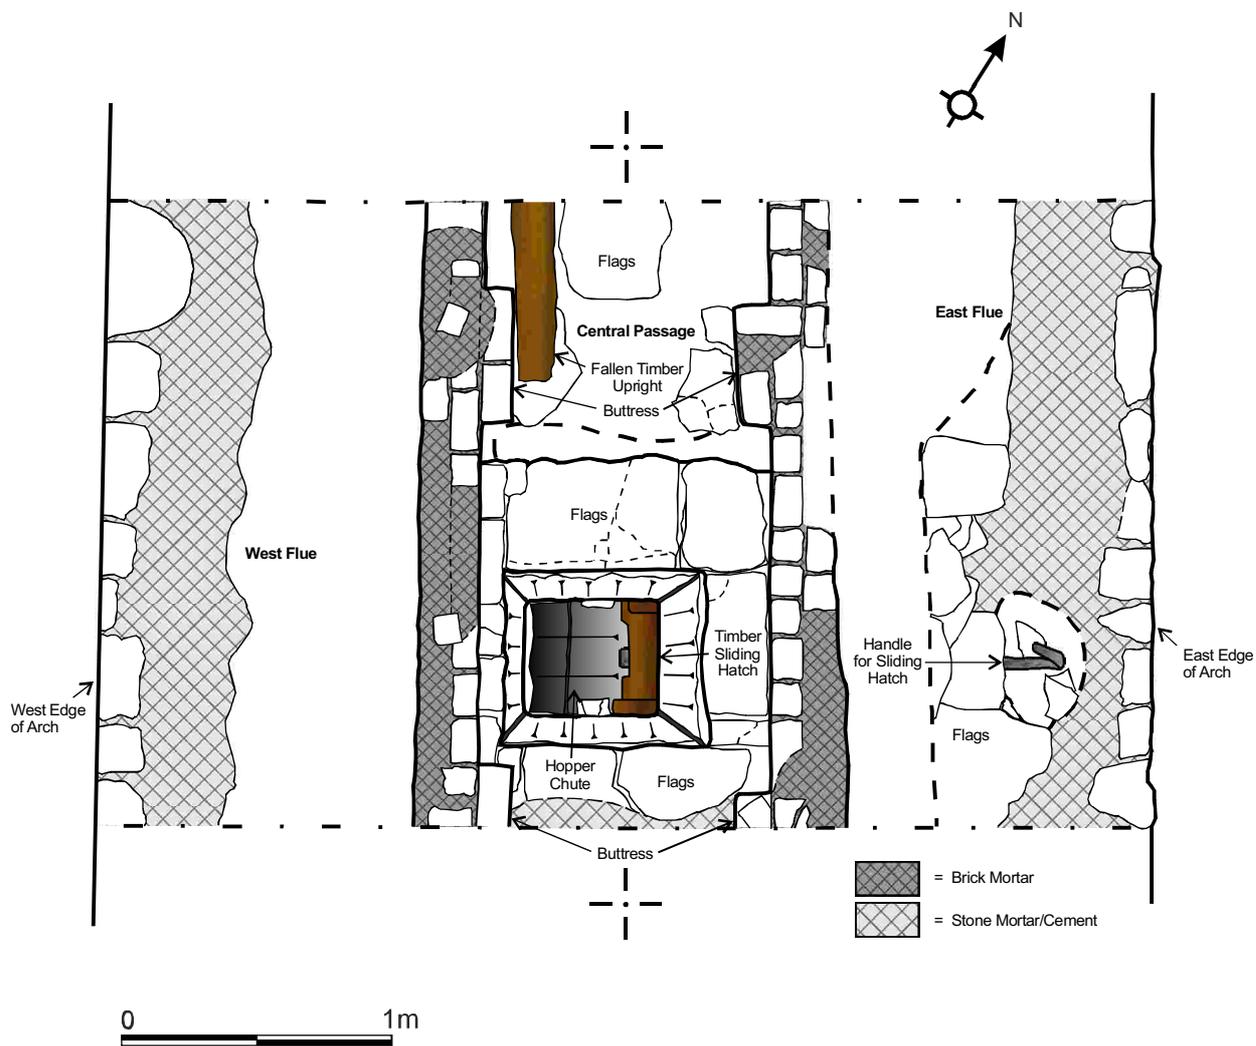
*Illus. 17: Plan of Trench 3, Dukesfield Arches.*

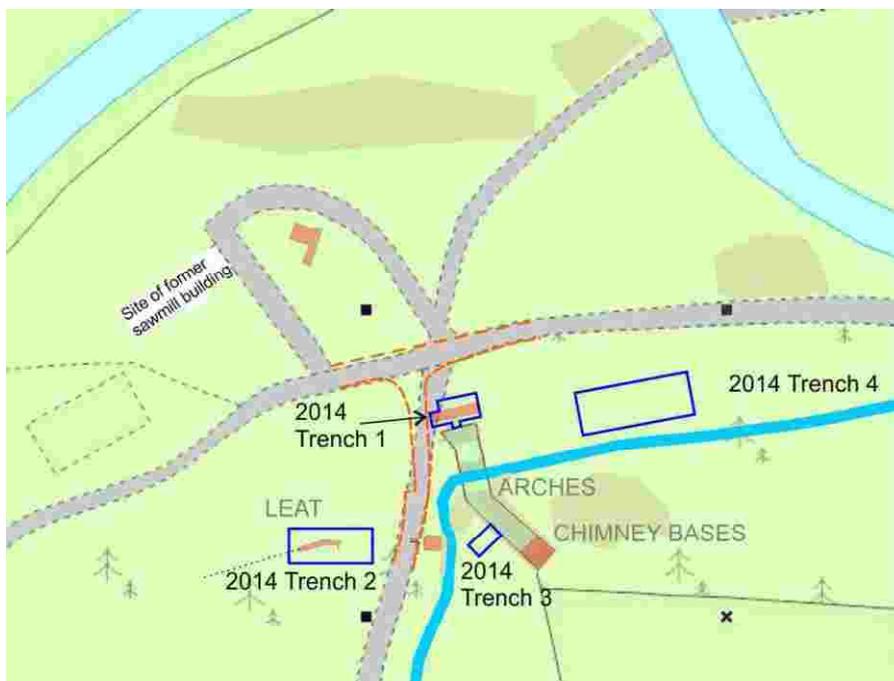
*Illus. 16: Suggested Trench Locations for excavation in 2014.*

The area to the west and north of the Arches end wall should be investigated by widening and deepening the trench opened in October 2012, with the aim of establishing the extent, depth, character and chronological phasing of remains known or suspected to be present there. Specifically, the character and function of a wall, first excavated in 2013, should be investigated to determine whether it is associated with the documented smelting hearths structure, or part of an earlier phase of construction. Its structural relationship with the current arches structure should be established by excavating a narrow sondage from a main trench running east-west in front of the arches end wall, up to the footings of the arches.

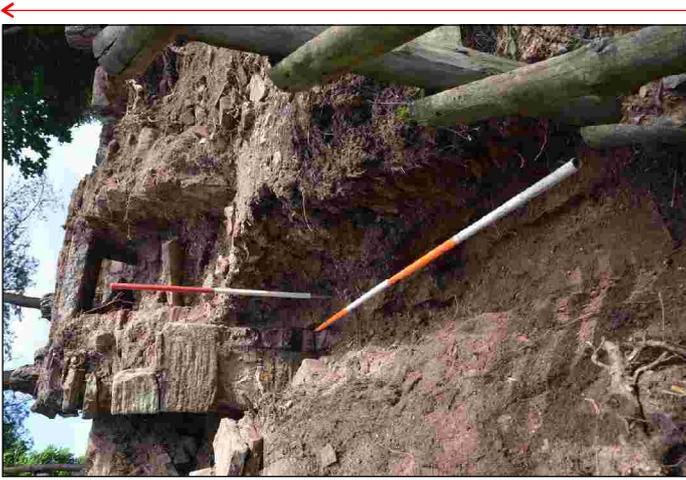
Photo 7

- 7 East part of chimney bases viewed from the north-west following re-excavation, also showing emergence of remains of flues structure running north-westwards.

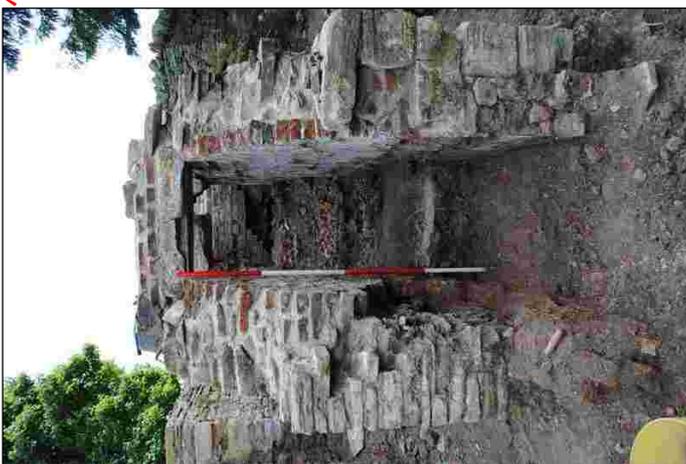
Photo 64

- 64 *View from the north-west into east condensing chamber.*
- 65 *Cut through deposits forming infill of the east condensing chamber.*
- 66 *View from the north-west into east condensing chamber following further removal of floor deposits (note damaged brickwork skin on south-west facing interior wall to left of view - see also Photos 67 & 68).*

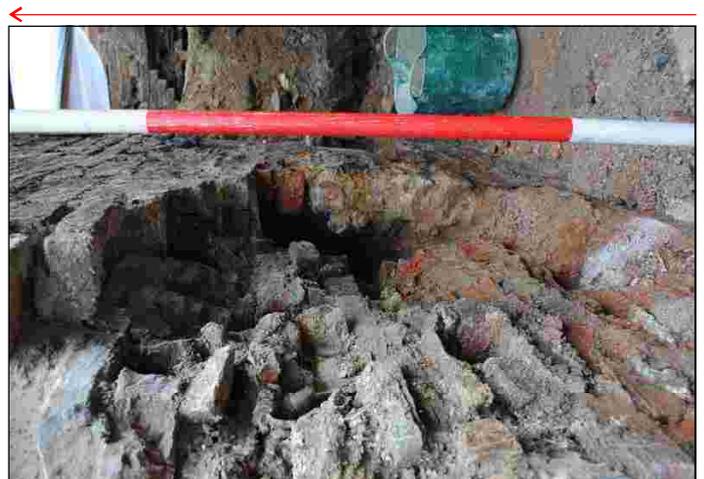
Photo 67

- 67 *Damaged brickwork skin on south-west facing interior wall of the east condensing chamber (see also Photo 68).*
- 68 *View through damaged brickwork skin on south-west facing interior wall of the east condensing chamber, showing rendered wall of chamber/opening within.*

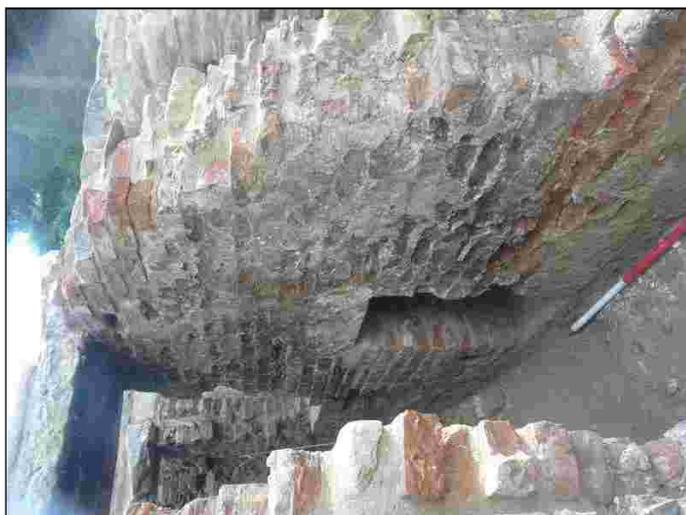
Photo 69

- 69 *View from the north of an opening, with stone lintel in the brick wall, in the north-east facing internal wall of the east condensing chamber.*

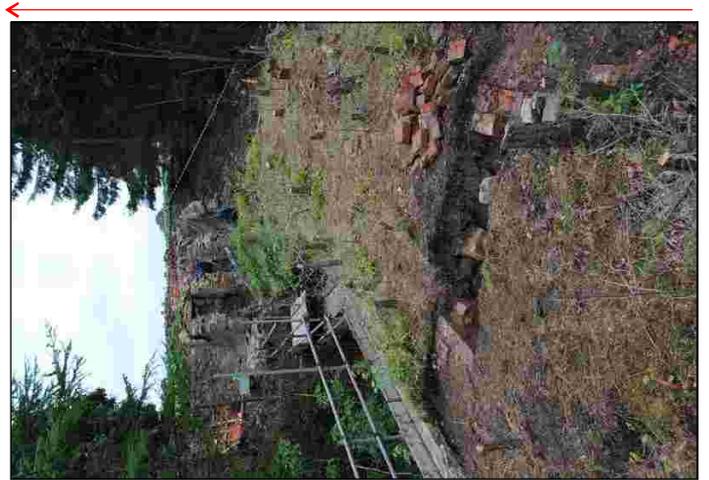
Photo 71

This trench was excavated close to the north end of the Dukesfield arches structure and expanded on a small test excavation carried out by a local volunteer (see *Photograph 71*).

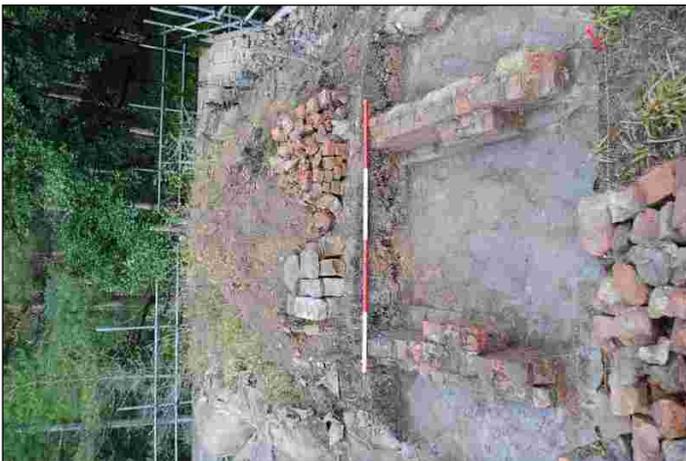
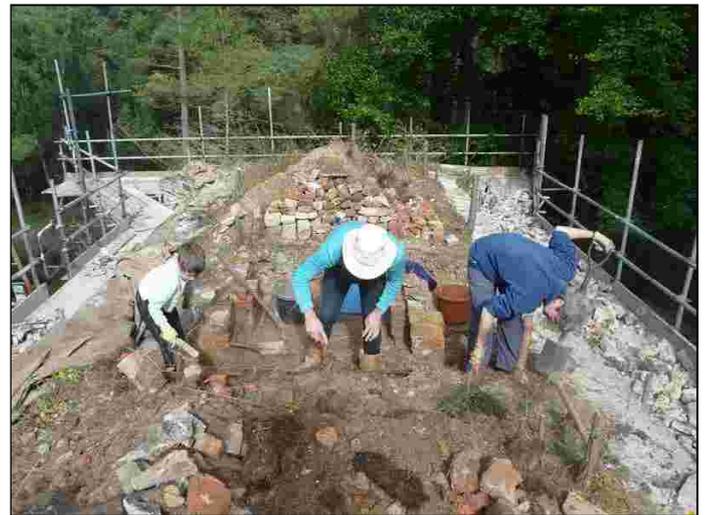
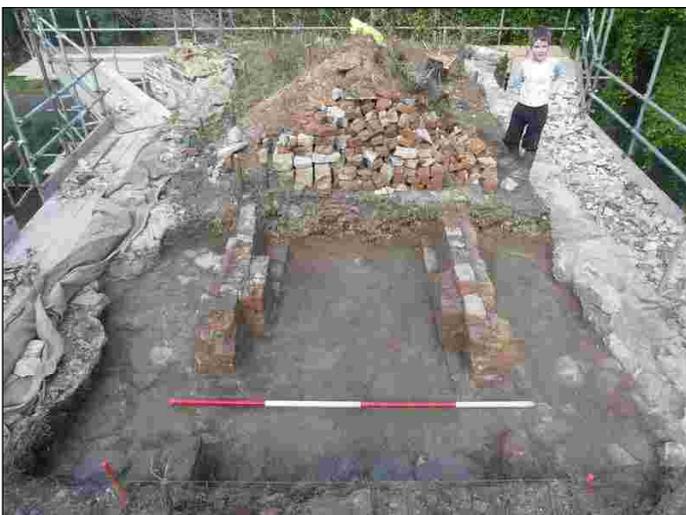
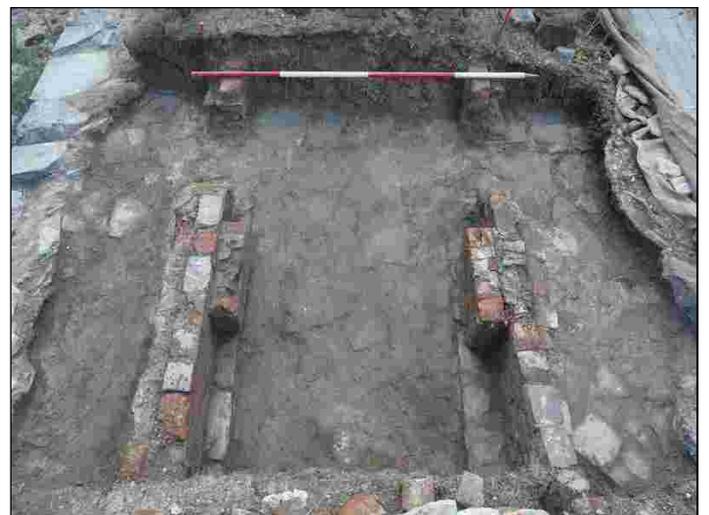
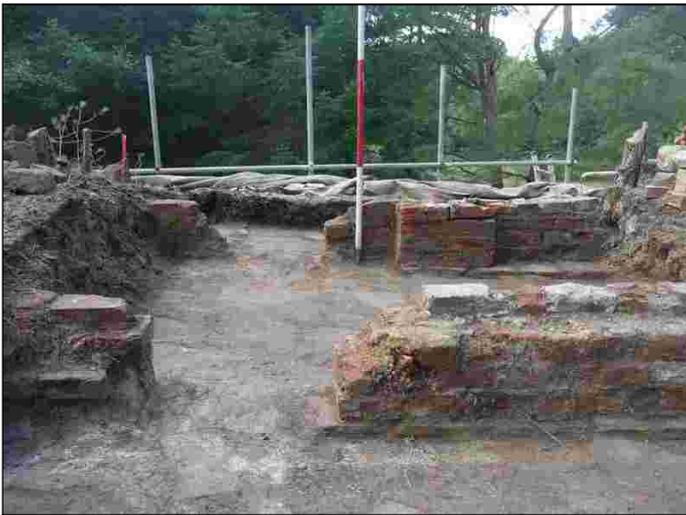
### ***Description*** (*Illus. 14 - 15 and see Photographs 72 - 76*)

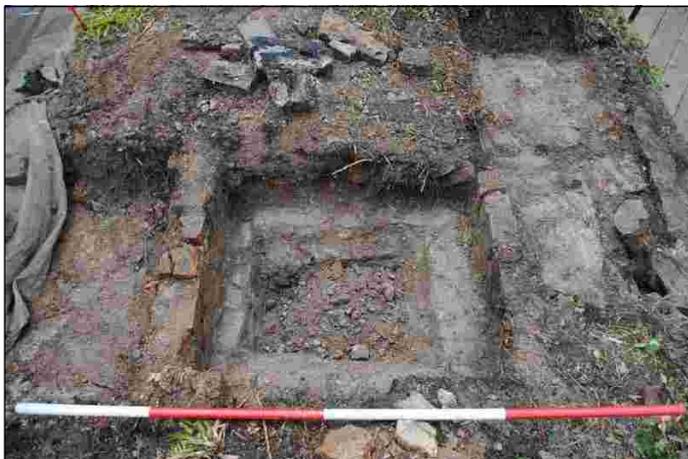
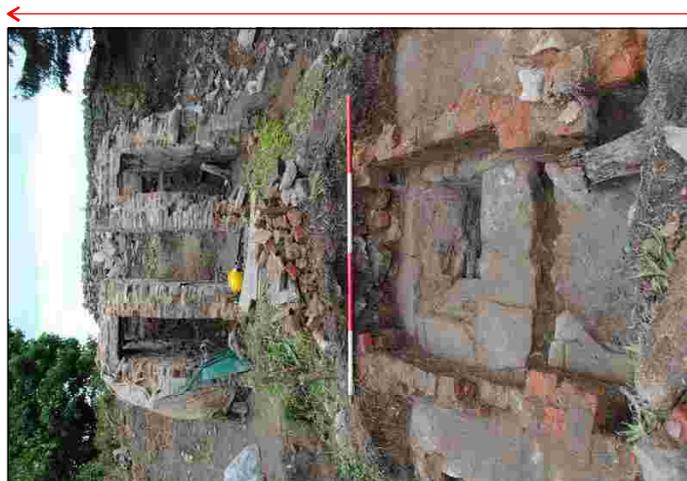
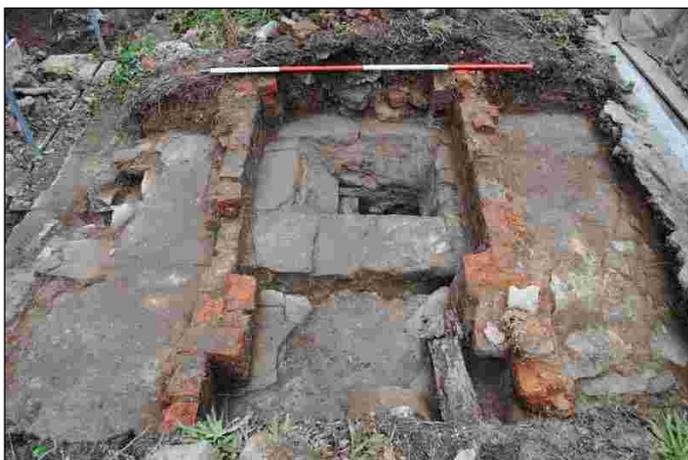
**Description** (*Illus. 14 & 17 and see Photographs 82 - 94 & 96*)

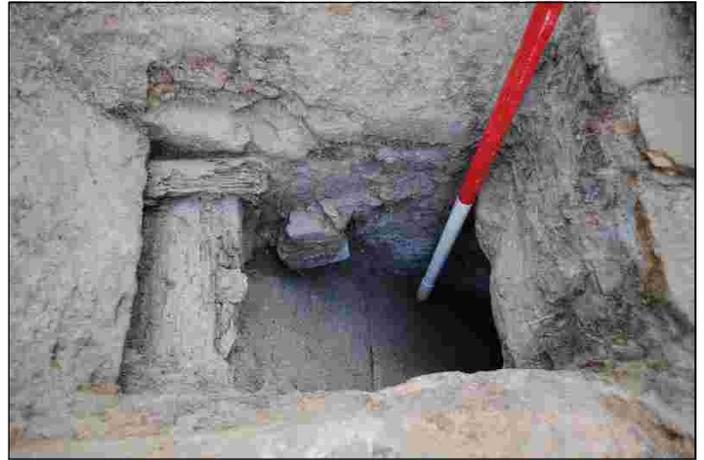
Photo 89

- 89 Vertical oblique close-up view of chute structure from the north-west.
- 90 Vertical oblique close-up view down the chute structure from the north-east to its exit on the south-west elevation of the arches structure (see Photo 91).

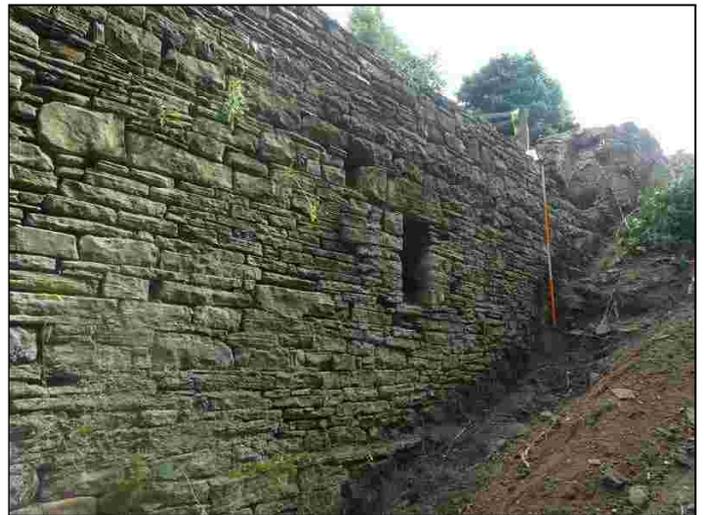
Photo 91

- 91 View from the north-west of the exit to the chute feature on the south-west elevation of the arches structure.
- 92 Trench 3 viewed from the north-east. showing chute structure between brick flue remains and a metal strip built into the sub-floor deposits of the eastern flue (adjacent, but not thought to be related to, the chute feature).

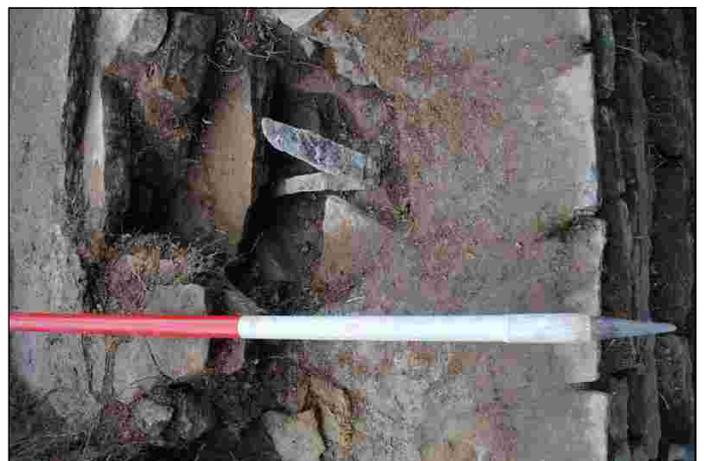
Photo 93

- 93 View from the east of a metal strip built into the sub-floor deposits of the eastern flue (see Photo 92, above).
- 94 View of Trench 3 from the south-west, showing previously-consolidated arches wall tops and the internal wall of the western flue.

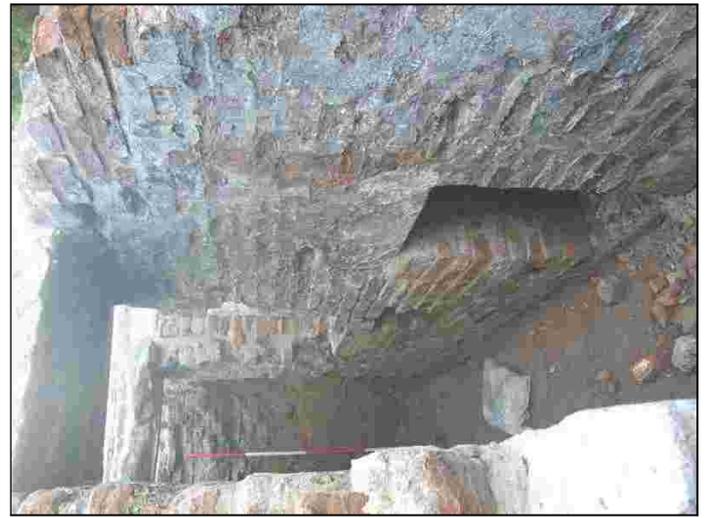
Photo 115

115 *Oblique view from the north showing opening in the north-east facing interior wall (blocked by a skin of brickwork on the other side, facing the through passage).*

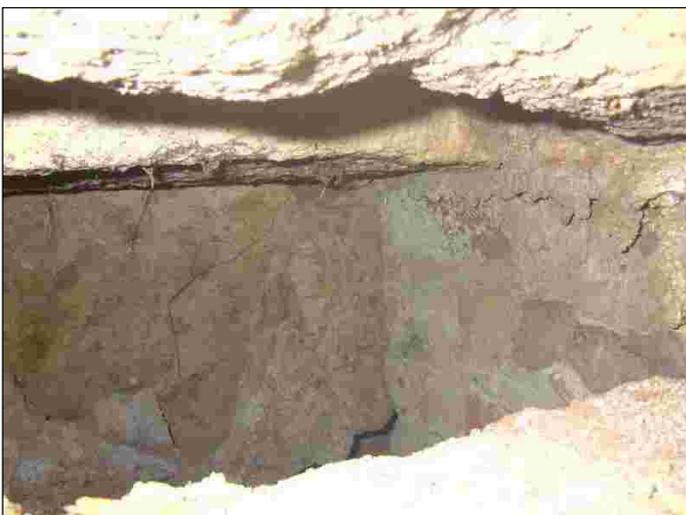
Photo 118

118 *View into blocked opening at the south end of the internal west wall of the east chimney, showing rendered cavity within.*

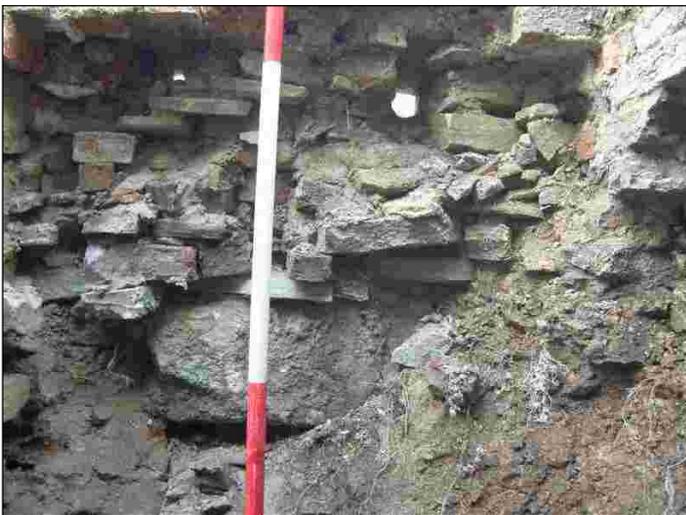
Photo 124

124 *Small openings in the east wall of the west chimney with possible large blocked opening below.*

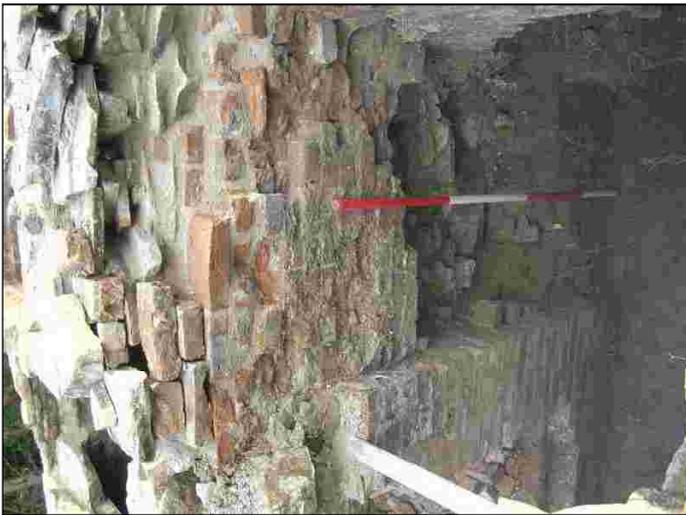
Photo 126

126 *Vertical oblique view of the east wall of the west chimney, showing eroded lower brickwork (and possible blocked opening?)*

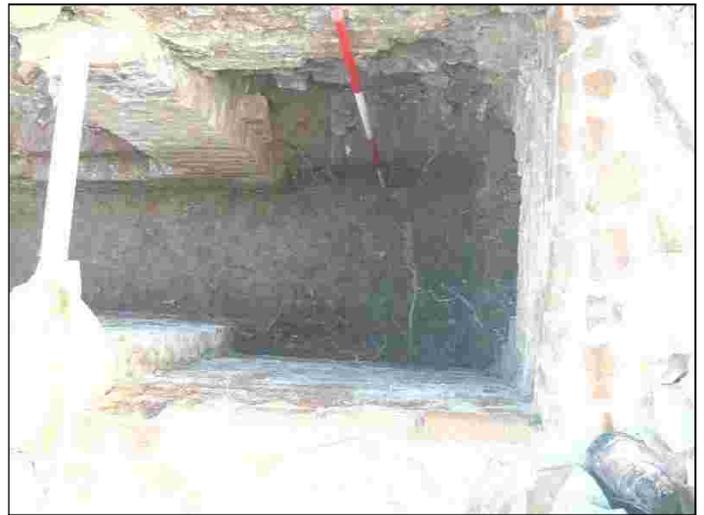
Photo 127

127 *Vertical oblique view from the south-west of the west chimney interior, focusing on the east wall (see Photo 126, above).*

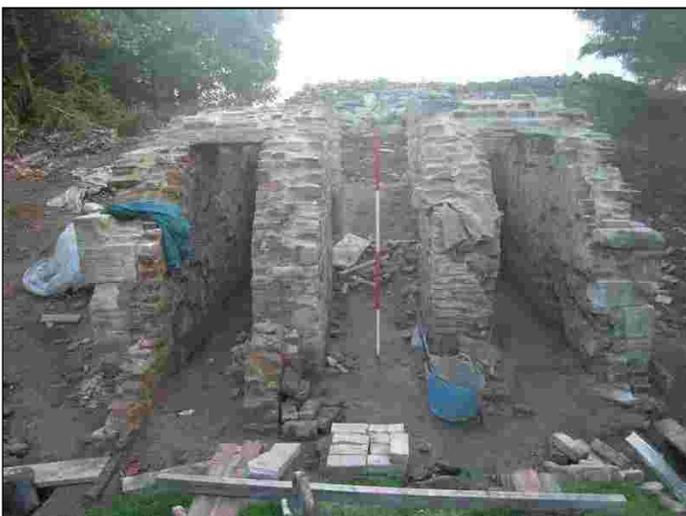
Photo 128

128 *View from the north-west of chimney bases following full extent of rubble removal and consolidation.*

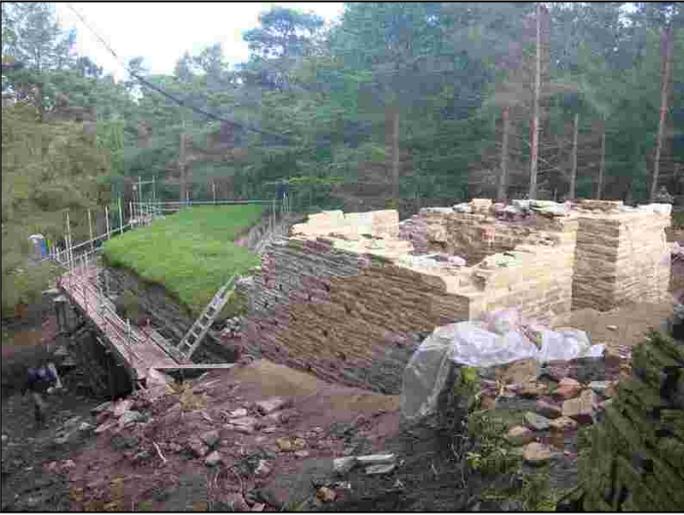
Photo 135

Phase 5ii - Arch Top Watching Brief  
*Photo 135*
