# A THIRD SEASON OF FIELDWORK ON THE SITE OF DUKESFIELD SMELTMILLS, HEXHAMSHIRE

REPORT ON ARCHAEOLOGICAL EXCAVATIONS AND  
MONITORING CARRIED OUT BETWEEN  
MAY AND DECEMBER 2014

by  
THE ARCHAEOLOGICAL PRACTICE LTD.  
for  
THE FRIENDS OF NORTH PENNINES

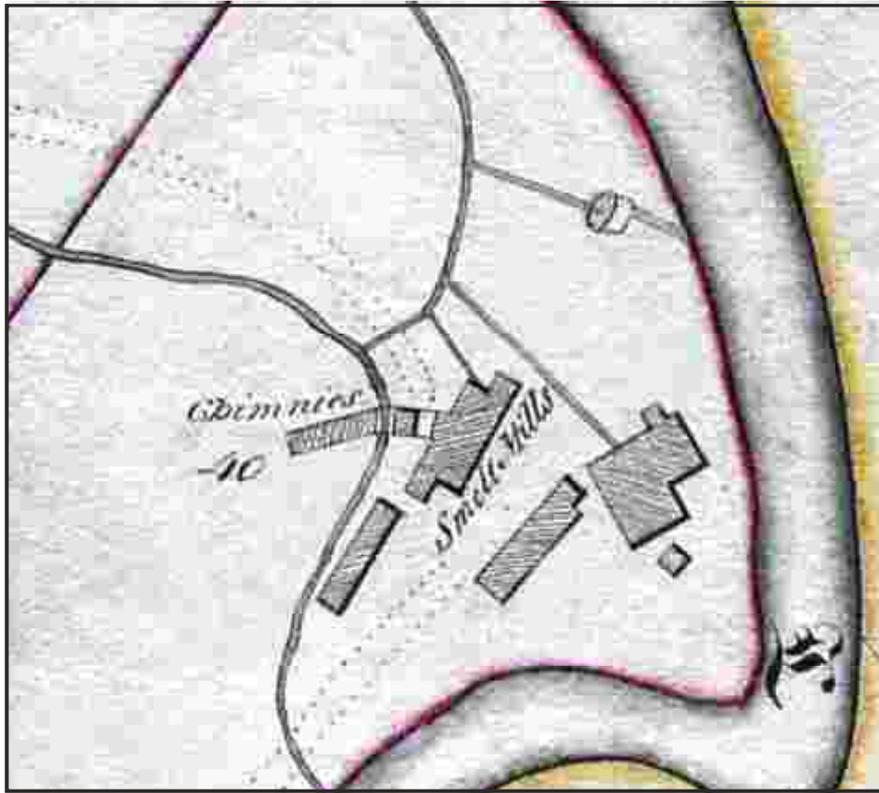
**Illus. 05:**  
A plan of the smelt mill works taken from an estate plan of 1802.

An estate map, surveyed in May 1802 (*Illus. 05*), shows the extent of the mill at its peak of production, when it was processing some 3,000 tons of lead ore annually. The arches structure is labelled on the plan as “chimnies”, with its southern arch spanning the Hall Burn, and the trackway from Dukesfield – which gave access to the lead road towards Blaydon – curving through the northern arch. The course of the mill race can be followed westwards away from the site, and a culverted spillway drops beneath the track to Dukesfield Hall, emptying into the Hall Burn, the course of which had been redirected, presumably when the arches were built in the second half of the 18<sup>th</sup> century, to flow through the arches structure.

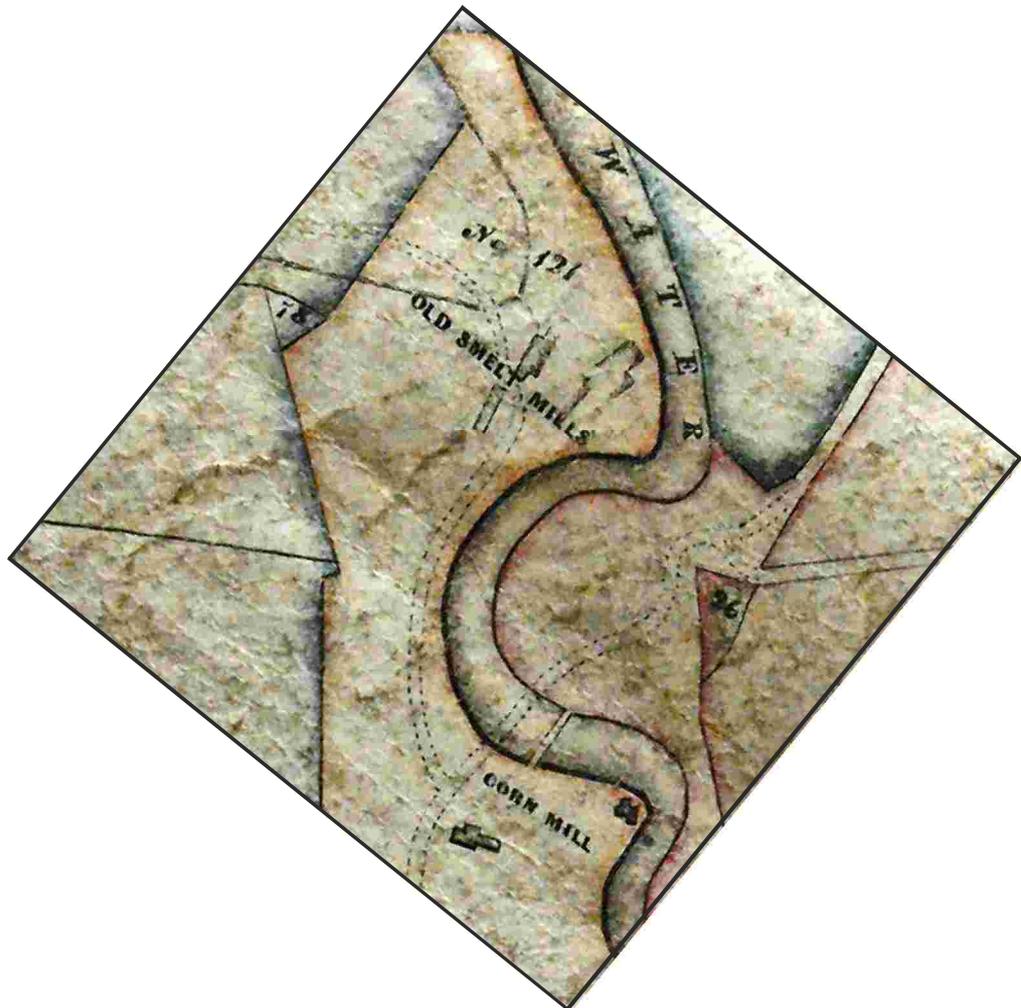
**Illus. 06:** The partly dissembled works shown on an estate plan of 1848 (orientated to allow comparison with the 1802 plan, above).

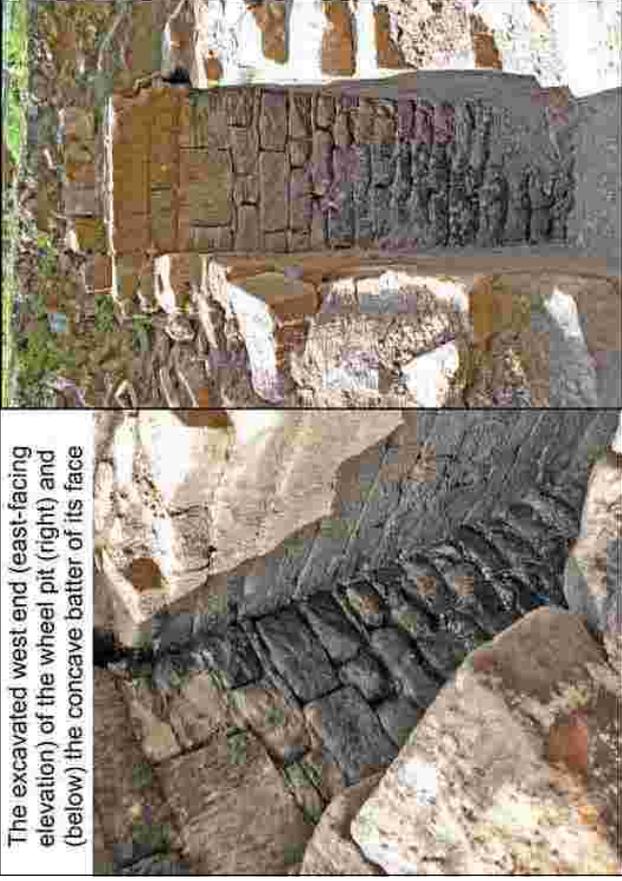
**Photo 10:**

The excavated west end (east-facing elevation) of the wheel pit (right) and (below) the concave batter of its face

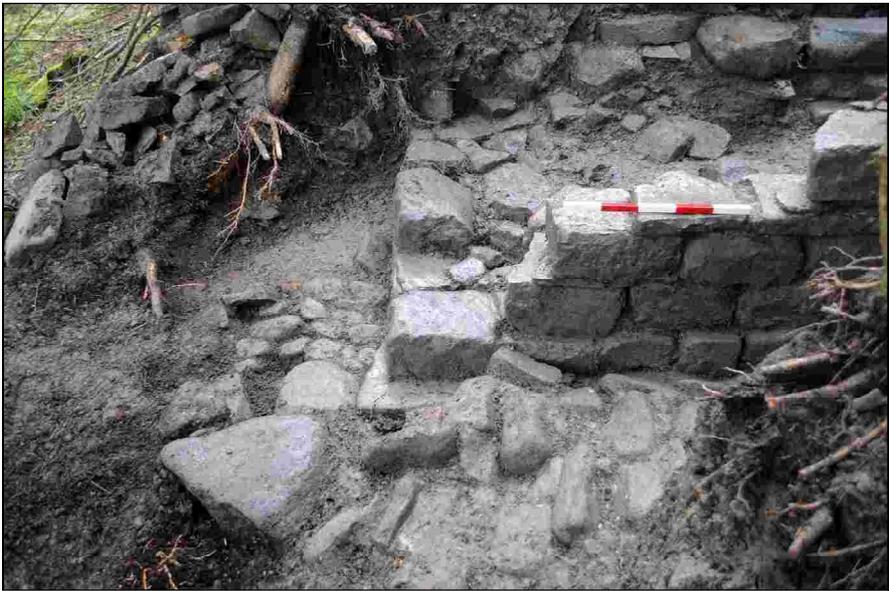
**Photo 30:**

30	<i>View from the north-east of stone-built remains revealed in the north-east part of Site B (as above, Photo. 29), following the exposure of steps along the west side of the platform feature and removal of flat stones (structural remains or later blocking; sitting below the cobbles seen in Photos. 15 &amp; 16, above) from the south-west part of this complex, adjacent to the shuttered-enclosure.</i>
31	<i>View from the north-west of the lower (north-east) part of a complex of stone-built features, largely comprising an extensive platform-like structure, built on the north side of the leat at its east end and aligned SW-NE.</i>
32	<i>View from the north-east of a revetment or chute-like feature within the upper (south-west) part of the complex of stone-built features north-east of the leat/timber-shuttered enclosure exit.</i>
33	<i>Vertical view of the leat/timber-shuttered enclosure exit, showing a diagonal timber, supported by posts, forming the NE corner of the shuttered enclosure with clay packing around it and, at a higher level to the north-east, a timber-lined stone feature on a different alignment (though roughly aligned with the reused hearthstones forming the end of the leat wall to the south-west – to left of view).</i>

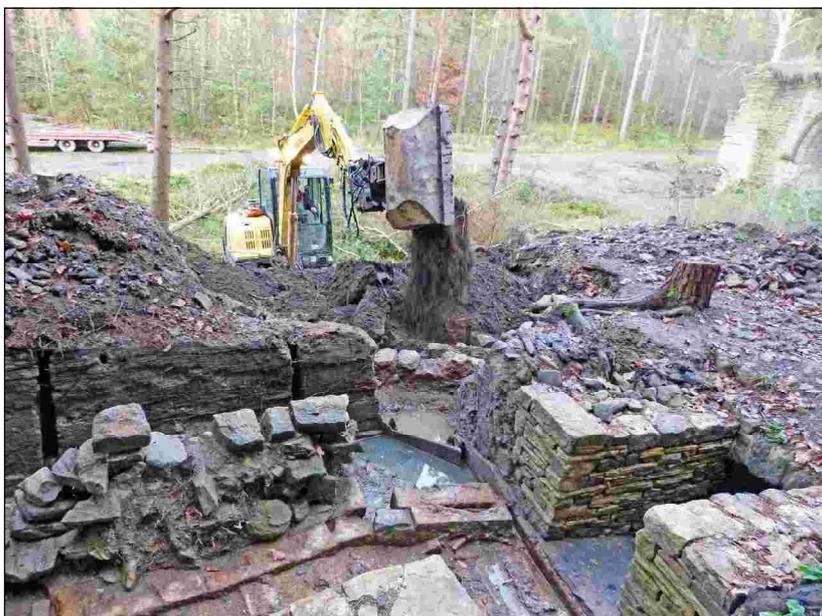
**Photo 34:**

34	<i>View from the south of the leat/timber-shuttered enclosure exit, showing features as described above (Photo 32).</i>
35	<i>Infilling of the excavated features north and north-east of the hearthstone-lined leat in November 2014.</i>
36	<i>Overlying east-west walls in Site C, east of the arches, uncovered in May 2014.</i>
37	<i>A test-pit on the north side of the burnside wall exposed in Site C, showing the surviving depth of the wall close to the west end of the excavated area.</i>
38	<i>The remains of a (possibly truncated) N-S wall north of the burnside wall shown above (Photo 35).</i>
39	<i>Investigating the character and extent of a narrow, eastward extension to the north (E-W) face of the arches structure in December 2014.</i>
40	<i>View from the east of the eastward extension to the north face of the arches structure (see above, Photo. 38)</i>
41	<i>View from the north-east of a substantial wall running along the lower, northern edge of the bank containing the hearthstone-lined leat and earlier timber-shuttered channel or enclosure.</i>

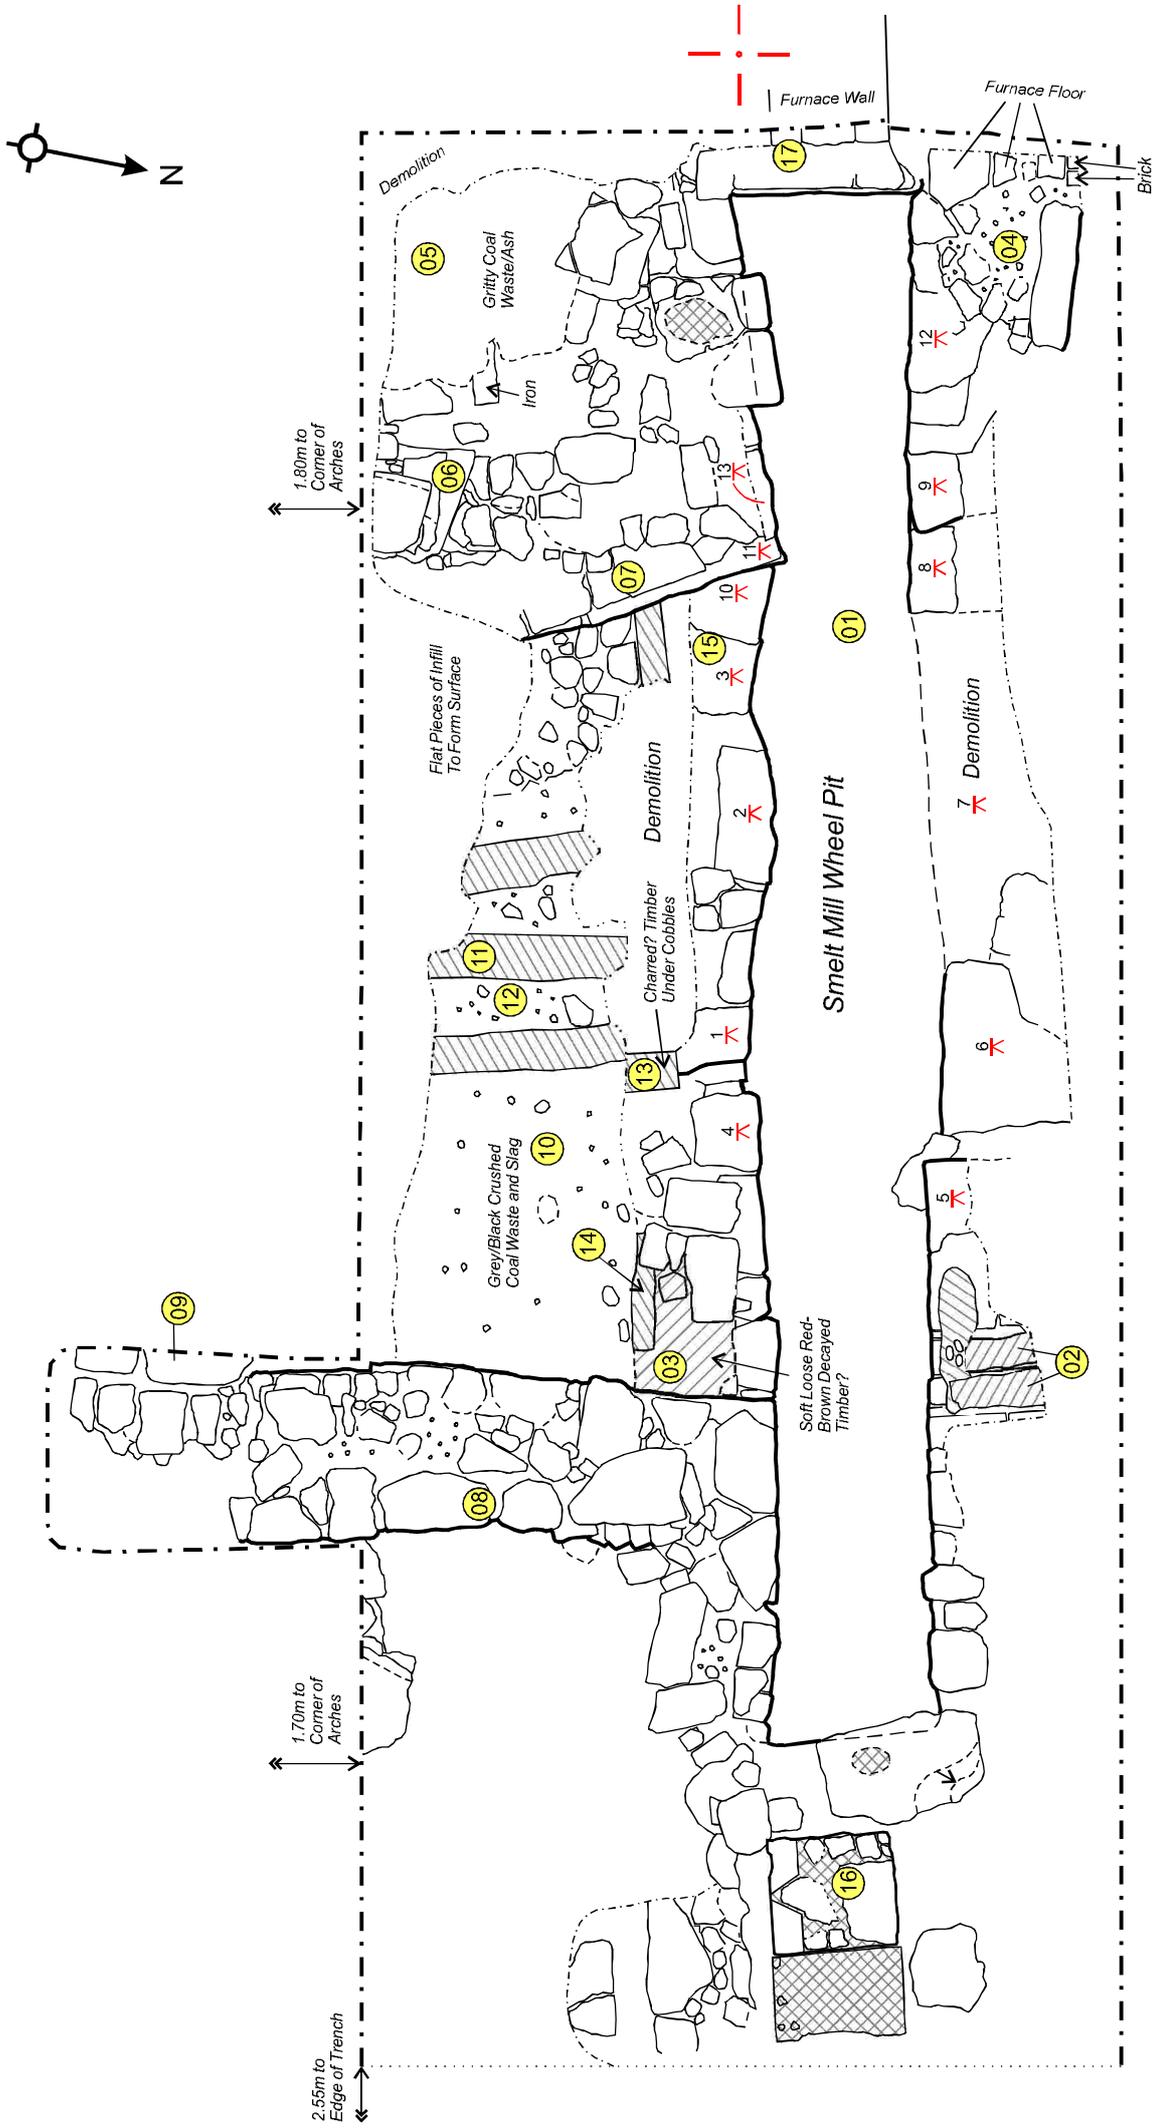
Illus. 10: Plan of Trench 1 (Smelt Mills), Dukeshire Arches.

Running east-west along the north side of the trench was a deep, rubble-filled pit (see [01] on *Illus. 10*), formed of sandstone walls which had collapsed in places, notably in the centre of both the north and south side, leading initially to erroneous interpretations of its overall form. Subsequent excavation revealed it to be some 8.10 m long, 0.80 – 0.90 m wide and at least 3 m deep from the top of the highest surviving remains at the west end to the deepest excavated point of its corbelled west face. The west end, including north and west sides, were of coursed, tooled sandstone blocks of consistent size in the side walls but thinner with depth in the end wall. The east end, while of similar masonry and also corbelled inwards (westwards) with depth, was of poorer construction, with interrupted coursing and signs of a possible rebuild near the east end of the north wall. At this point a wooden feature [02] appeared to have been inserted, apparently comprising two beams set orthogonal to the north wall of the pit, the western one sitting in a recessed socket within the wall and jointed or bolted to another timber running parallel with the wall and sitting level with the eastern N-S beam. Much of this feature had rotted away, making it difficult to understand its original form, with the E-W timber surviving only as an organic impression on stonework. Three iron bolts also survived, apparently connecting (or at least perforating) the remains of the E-W timber and western N-S timber in its crude stone socket. Decayed timberwork [03], probably also comprising the remains of N-S beams, also occurred in the corresponding position on the south side of the pit but was too decayed to determine any discrete structural components. The only other features of note in the walls of this structure were bolts and metal strips – most prominently at c. 2 m depth in the corbelled west wall – and, at similar depth in the west end of the north wall, the stub of a wooden insert. In the absence of alternative explanations, these features could be tentatively and provisionally interpreted as the remains of some kind of internal wooden casing for the pit. No other structural features were revealed within the fill or in the wall structures of the pit – interpreted as the wheel pit for a waterwheel powering bellows associated with the lead smelting process - but the collapsed sides of the central section may be significant since this is where the bearing for a large wheel would have been located. The depth of wall collapse in the central 3 m long section remains

The burnt material interpreted as possible hearth floor (or hearth waste) deposit sat upon an apparent platform bounded on the east side by a rough stone wall [06] and, immediately east of it at lower level, an apparently integral (though slightly oblique) south-eastward return [07] to the east end of the surviving section of south side wheel pit wall. [06] & [07] seem to be related, probably as different phases of the same feature, or with [06] representing an elevated extension of [07]. Some 4.4 m east of rough wall [06] is another wall [08], that first uncovered in 2012, which proved to be 0.75-0.80 m wide, of poor, loosely-bonded construction and up to three courses in height. An southward extension to the trench showed that it extended to the north wall of the arches, but had largely been robbed away in the last metre or so on its approach to the arches – it was unclear whether it had been robbed in order to build the arches, which seems unlikely, or removed at some later stage, perhaps to allow access along the north face of the arches, which seems more likely, especially as there seemed to be associated flagged flooring [09] on its west side.

Between the two structures [06]/[07] & [08] was an area of loose, mixed grey waste material [10], probably comprising spent fuel as well as other mineral waste and mortar, upon and within which were preserved timber beams. Most prominent were a group of three such timbers [11], their north ends truncated, arranged orthogonal to the north wall of the arches and some 2 metres from it, each 0.19 – 0.22 m wide and spaced c. 0.25 m apart. The timbers sat upon an apparent *ad hoc* blackened floor deposit of compacted burnt deposits and cobbles [12], below which, almost underlying the eastern of the group of three timbers, were the remains of another timber [13], its preserved north end extending as far as the rear (hidden) face of the south wall of the wheel pit. The remains of other timbers were recorded on an east-west orientation, one [14] associated with the area of decayed timber [03] on the west side of wall [08], the other [15] apparently abutting or running under platform edge [07] close to the west end of the trench.

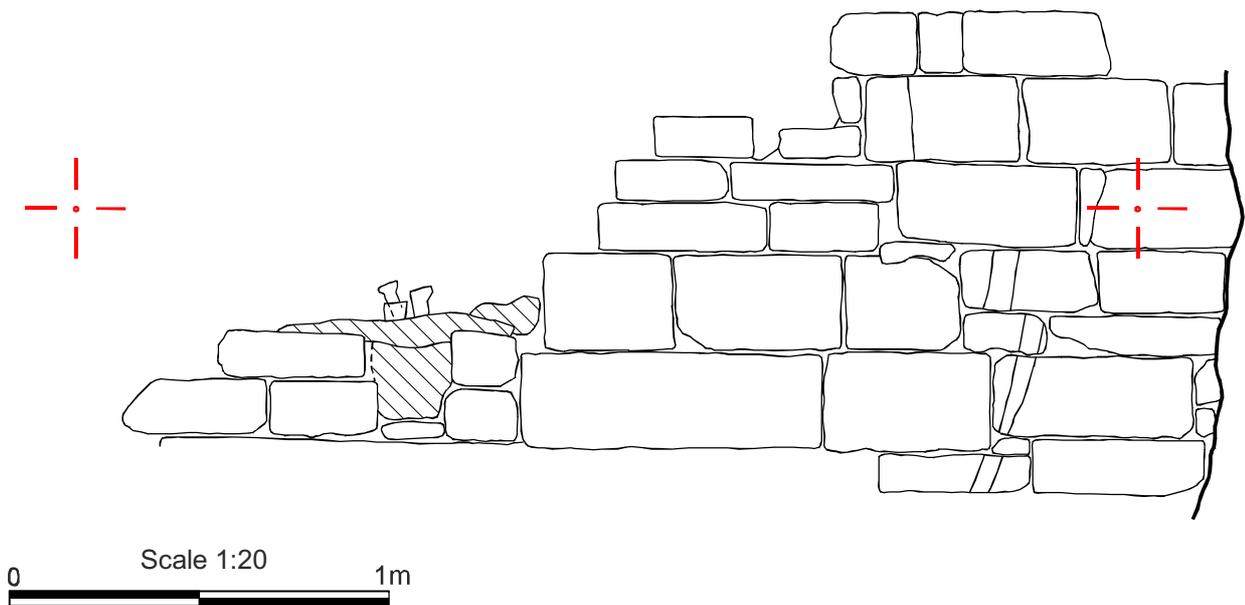
**Illus. 11:** East Facing Elevation #1 of Wall #1, Area A Wheel Pit.

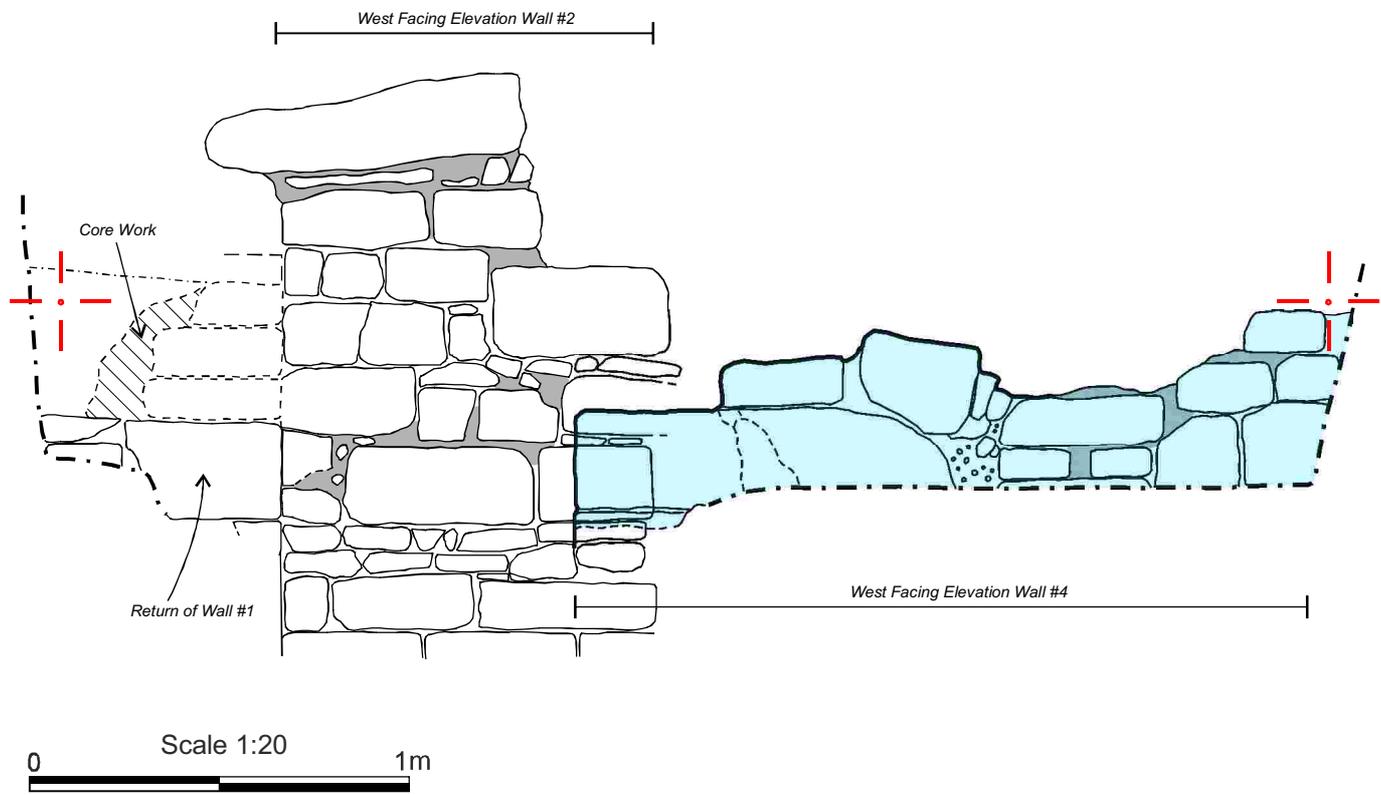
**Illus. 12:** West Facing Elevation #2 of Wall #2 and #4, Area A Wheel Pit.

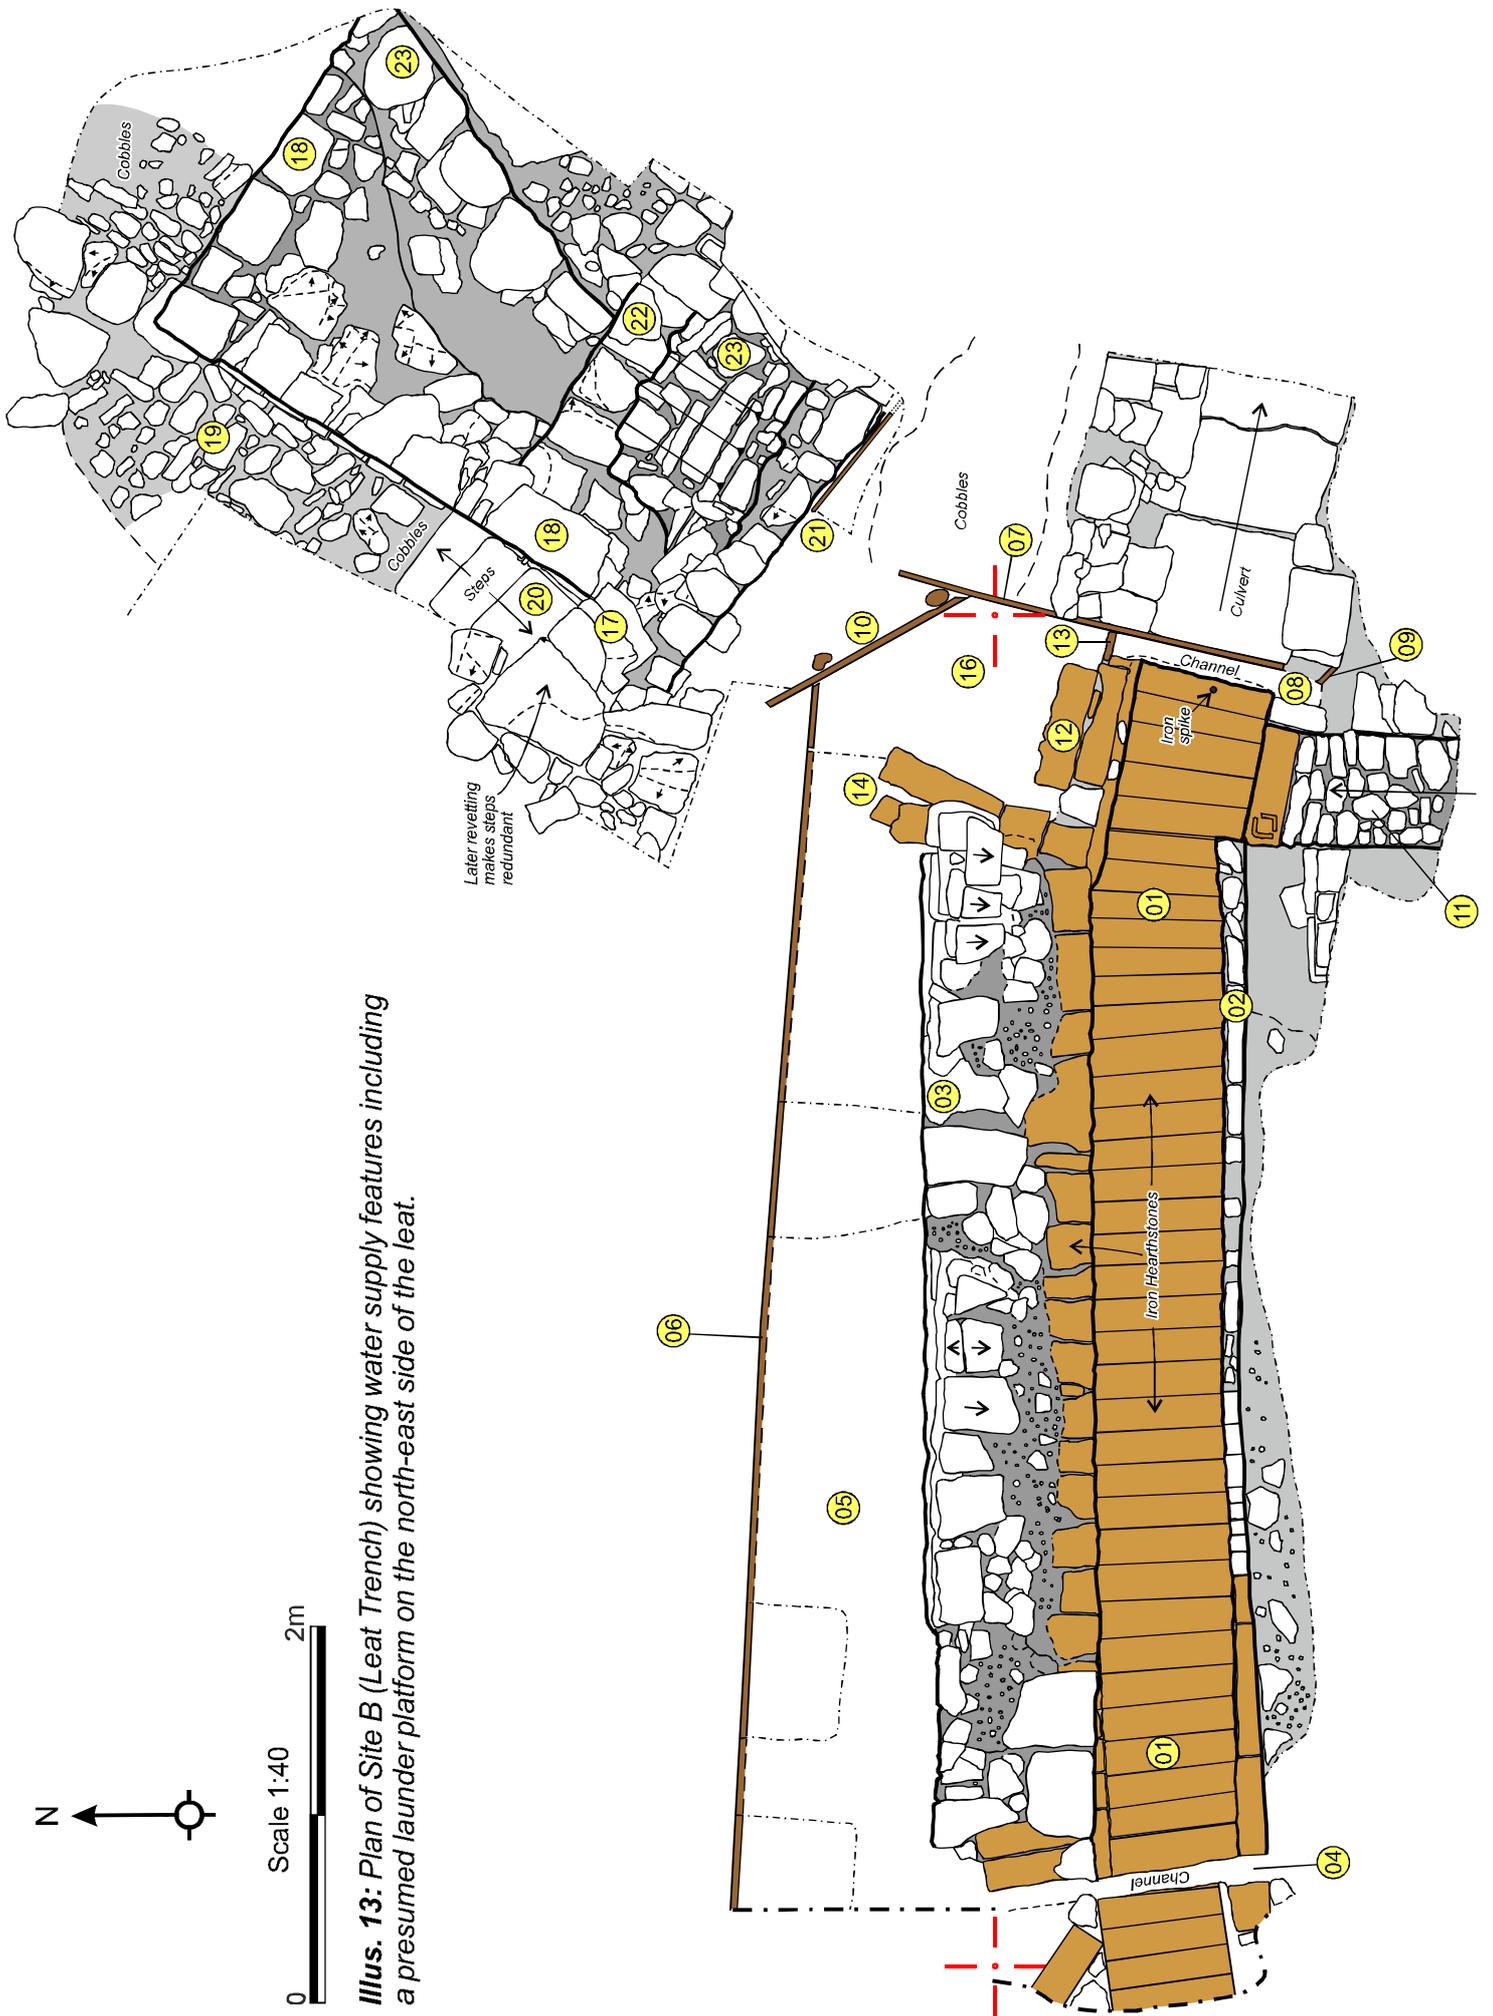
**Illus. 13:** Plan of Site B (Leat Trench) showing water supply features including a presumed launder platform on the north-east side of the leat.

Excavation of the leat revealed a floor of reused hearthstones [01] previously exposed in 2012, enclosed by roughly constructed rubble walls [02] (on the south side) & [03] (on the north), that on the south side being largely robbed-out. The total length of leat floor exposed was 8.8 m, the western 7.2 m of which comprised a total of 41 hearth stones c. 0.69 m long, averaging c. 0.17 m wide, laid side to side and fused by rusting into a single, continuous unit. At the west end hearth-stones, or parts of hearth-stones, were also used to form the foundations of the north and south boundary walls, which survived on the north side up to 0.60 m high, but had been robbed away above foundation level on the south side to expose coarse, core material. Significant additional features at the west end of the leat, where it was extended in May 2014 beyond the limit reached in 2012, included a slot [04] 0.11 m wide which extended into the wall foundation layers on either side of the leat floor. On its west side was a hearth stone apparently deliberately-angled obliquely NW-SE to the course of the leat, on approximately the same orientation as that of a poorly-constructed brick wall [05] uncovered in 2013 – could this be the remains of an exit from the leat to the middle of the three launders shown on the 1802 site plan, or perhaps *an ad hoc* run-off for water backing up to the east? Also found in this area in 2012 was a socketed stone which may also have been part of a launder or run-off exit from the leat, with water flowing along the dressed face and the socket holding a sluice gate preventing water from flowing west (this would make most sense if the lower end of the leat served as a kind of mill pond, supplied from the east). Three alignments of the leat can be identified over the 8.8 m exposed. Beginning in the west it changes course by c. 10 degrees from ENE towards due east – an extension of the pattern taken further west to bring it from its out-take on the Devil's Water - then, halfway along its course, changes again, more subtly, in the same direction by another degree or two and, finally, from the point at which it meets a chute-like watercourse from the south, by another 10 degrees towards ESE from where it continues on a straight course towards its outflow on the Hall burn.

Additional features of note in the leat include those previously described in 2012, such as the aforementioned cobbled chute [11] entering from the south and, opposite it, a double thickness of hearthstones [12] perhaps creating the base of a sluice in this location, which would have been necessary in order to control flow to launder(s) and culverted run-off from the later stone-and-hearthstone leat. Credence is added to this view by an additional short piece of timber [13], found at floor level extending between the west side of the culvert north wall and joint between the two hearth stones, apparently forming the north end of the slot next to the culvert entrance. More hearth stones [14] underlie and extend north-east beyond the north-east corner of the battered north wall of the stone-&-hearthstone leat, with which they are likely to be contemporary.

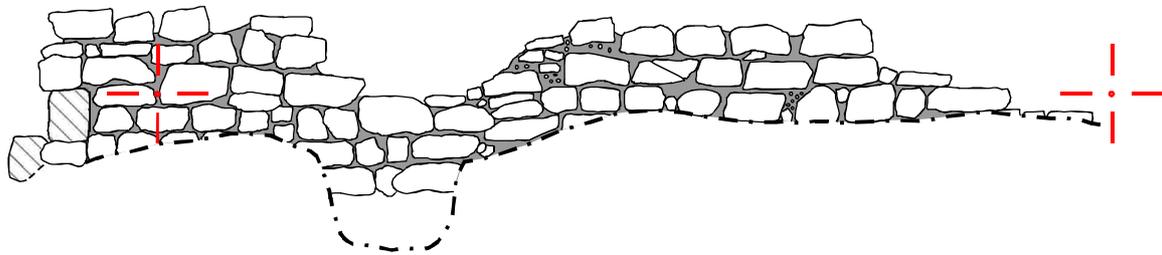
**Illus. 14:** North Face of a wall which formed the outer north-facing elevation of the north side of the hearthstone-lined leat and/or the south side of an earlier wooden-shuttered channel or enclosure.

Extension of the leat excavations northwards and north-eastwards revealed numerous features of note. First, the north-face of the north-side leat wall [03] was revealed as a well-made, clay- or earth-bonded structure of coursed masonry with a gently battered face which, unlike the south face, was well-preserved. Further excavation of the coarse, sandy gravel fill [05] north of the north wall of the leat revealed a vertical face of wooden rails, or shuttering, which continued beyond the east end of the battered stone-built leat wall and extended westwards at least as far as the western sluice-gate floor slot. This wooden structure, up to 1.5 m high (where explored by means of test pits) and comprised of rails c. 0.25 m deep and 0.07 m thick, was interrupted at irregular intervals by four vertical, or near vertical gaps, 0.10 m wide, interpreted as post slots for rails subsequently removed, presumably by decay; alternatively, for some kind of water management system. This timber face has clearly been constructed to line a vertical cut in an existing (though not necessarily natural) earthen bank, meaning that the vertical timbers could have been temporary arrangements. A further section of wooden facing [07], though without obvious rail slots, was uncovered east of the leat wall, running N-S against the west end of the north side culvert wall. The latter section of N-S timberwork continued at floor level across the culvert opening, on the east side of a floor slot [08] of similar width to that at the west end of the leat (see above) – both being interpreted as sluice gate slots - with a further branch [09] extending at that level south-east underneath, but at an oblique angle to, the south wall of the culvert structure. In the north-east corner of the enclosure created by the two plank-lined or shuttered faces was another planked face [10], arranged obliquely to stagger the otherwise acute angle between the main E-W and N-S faces whilst maintaining the integrity of the enclosure. This short, oblique section of timber face was secured by posts placed at either end on the external north-east side. All features of this timber, including the position of the pegs in relation to its overlapping north-west end and abutting south-east end, indicate that this timber was designed to resist force (of water) applied from the south and west sides.

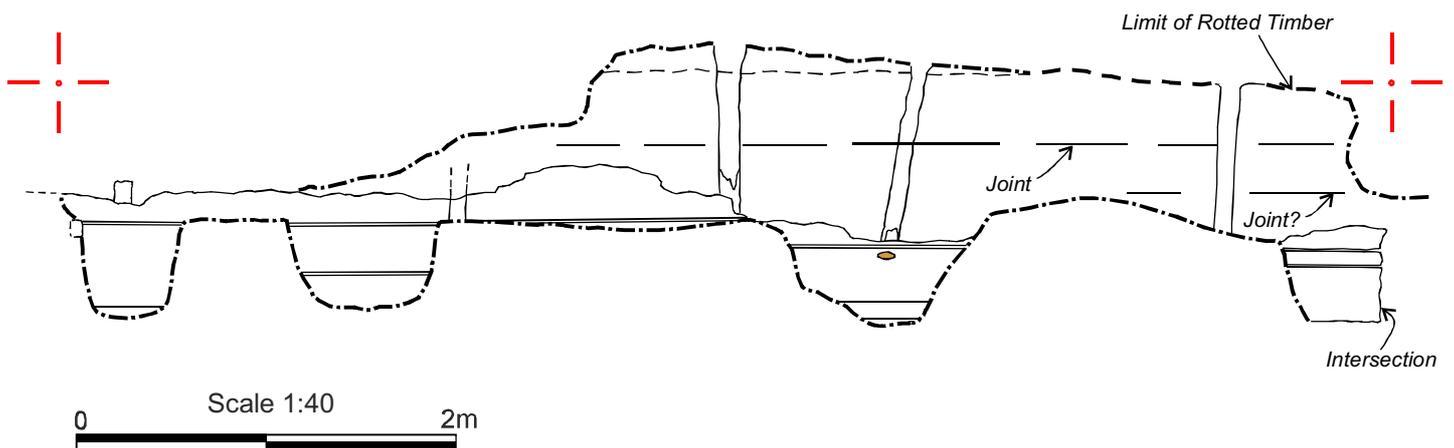
**Illus. 15:** South Facing Section of timber-shuttered holding pond or channel.

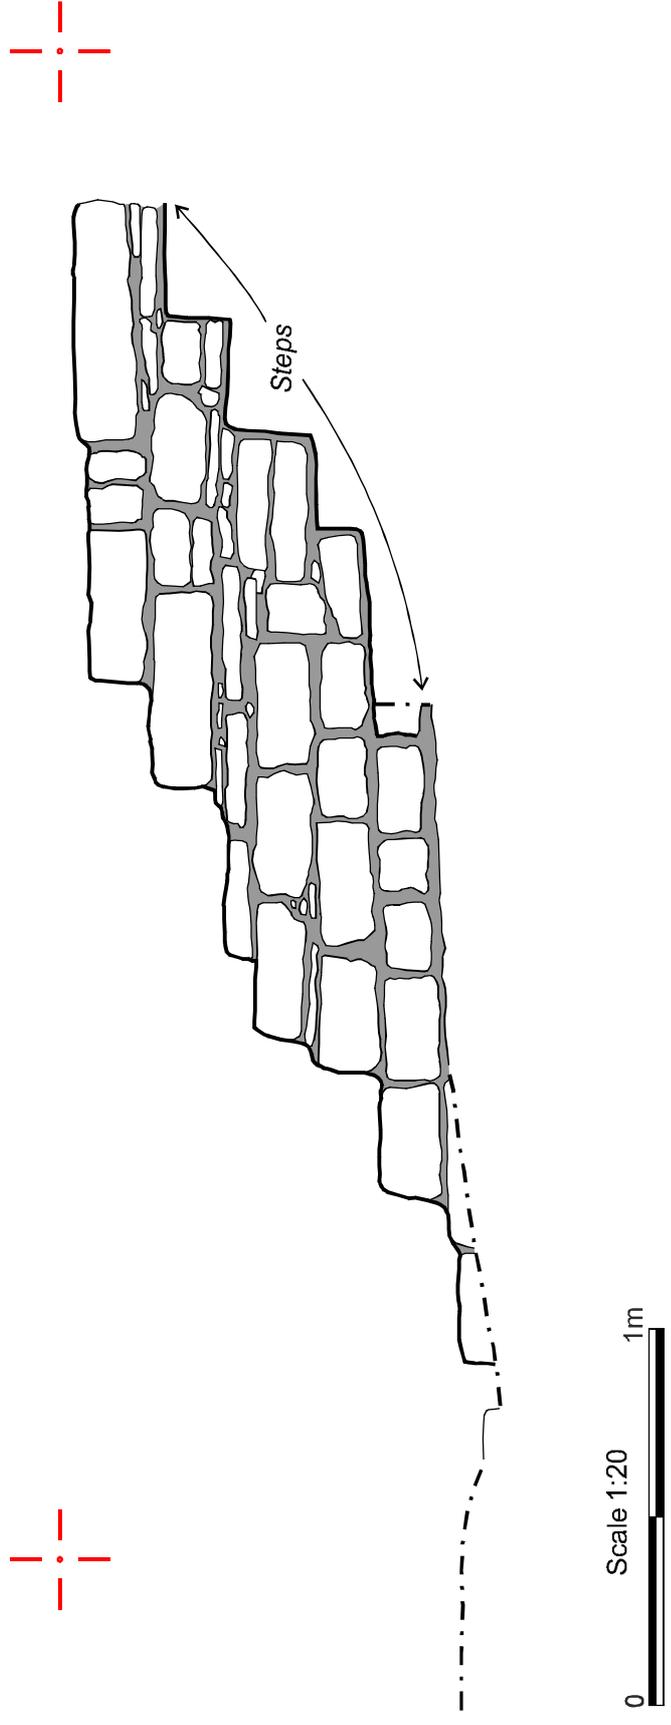
*Illus. 16: West facing section of the launder platform structure on the north side of the leat.*

The stone-built features north and north-east of the leat(s) are likely to have functioned as supports for the launder structure and spill-ways for leaking or excess water, but whether during the putative first of second phases described above, is unclear. The steps on the west side would probably have provided secure access to the bank-top above the wooden pond/channel enclosure for maintenance or operational purposes. It appears, however, that this system was abandoned at some point, presumably when the shuttered enclosure was abandoned, the steps and stonework to the east being covered by relatively unstructured stonework which appears, in part, to have served as a base for the cobbled surface first uncovered, in part, in 2012 at or immediately below current (bank top) ground level. The cobbling and, to an extent, stonework infill below it presents a problem because it seals any outward channel between leat and presumed launder. This can only be explained by the presence of a conduit, for which the structural evidence did not appear completely convincing (although see *Appendix 1* for suggestions to the contrary), or by assuming that the sealing and cobbling of the former channel site took place following abandonment and dissembling of the launder system. Why this should have taken place, however, when it would have been far simpler simply to prevent inflow of water from the Devil's Water, is

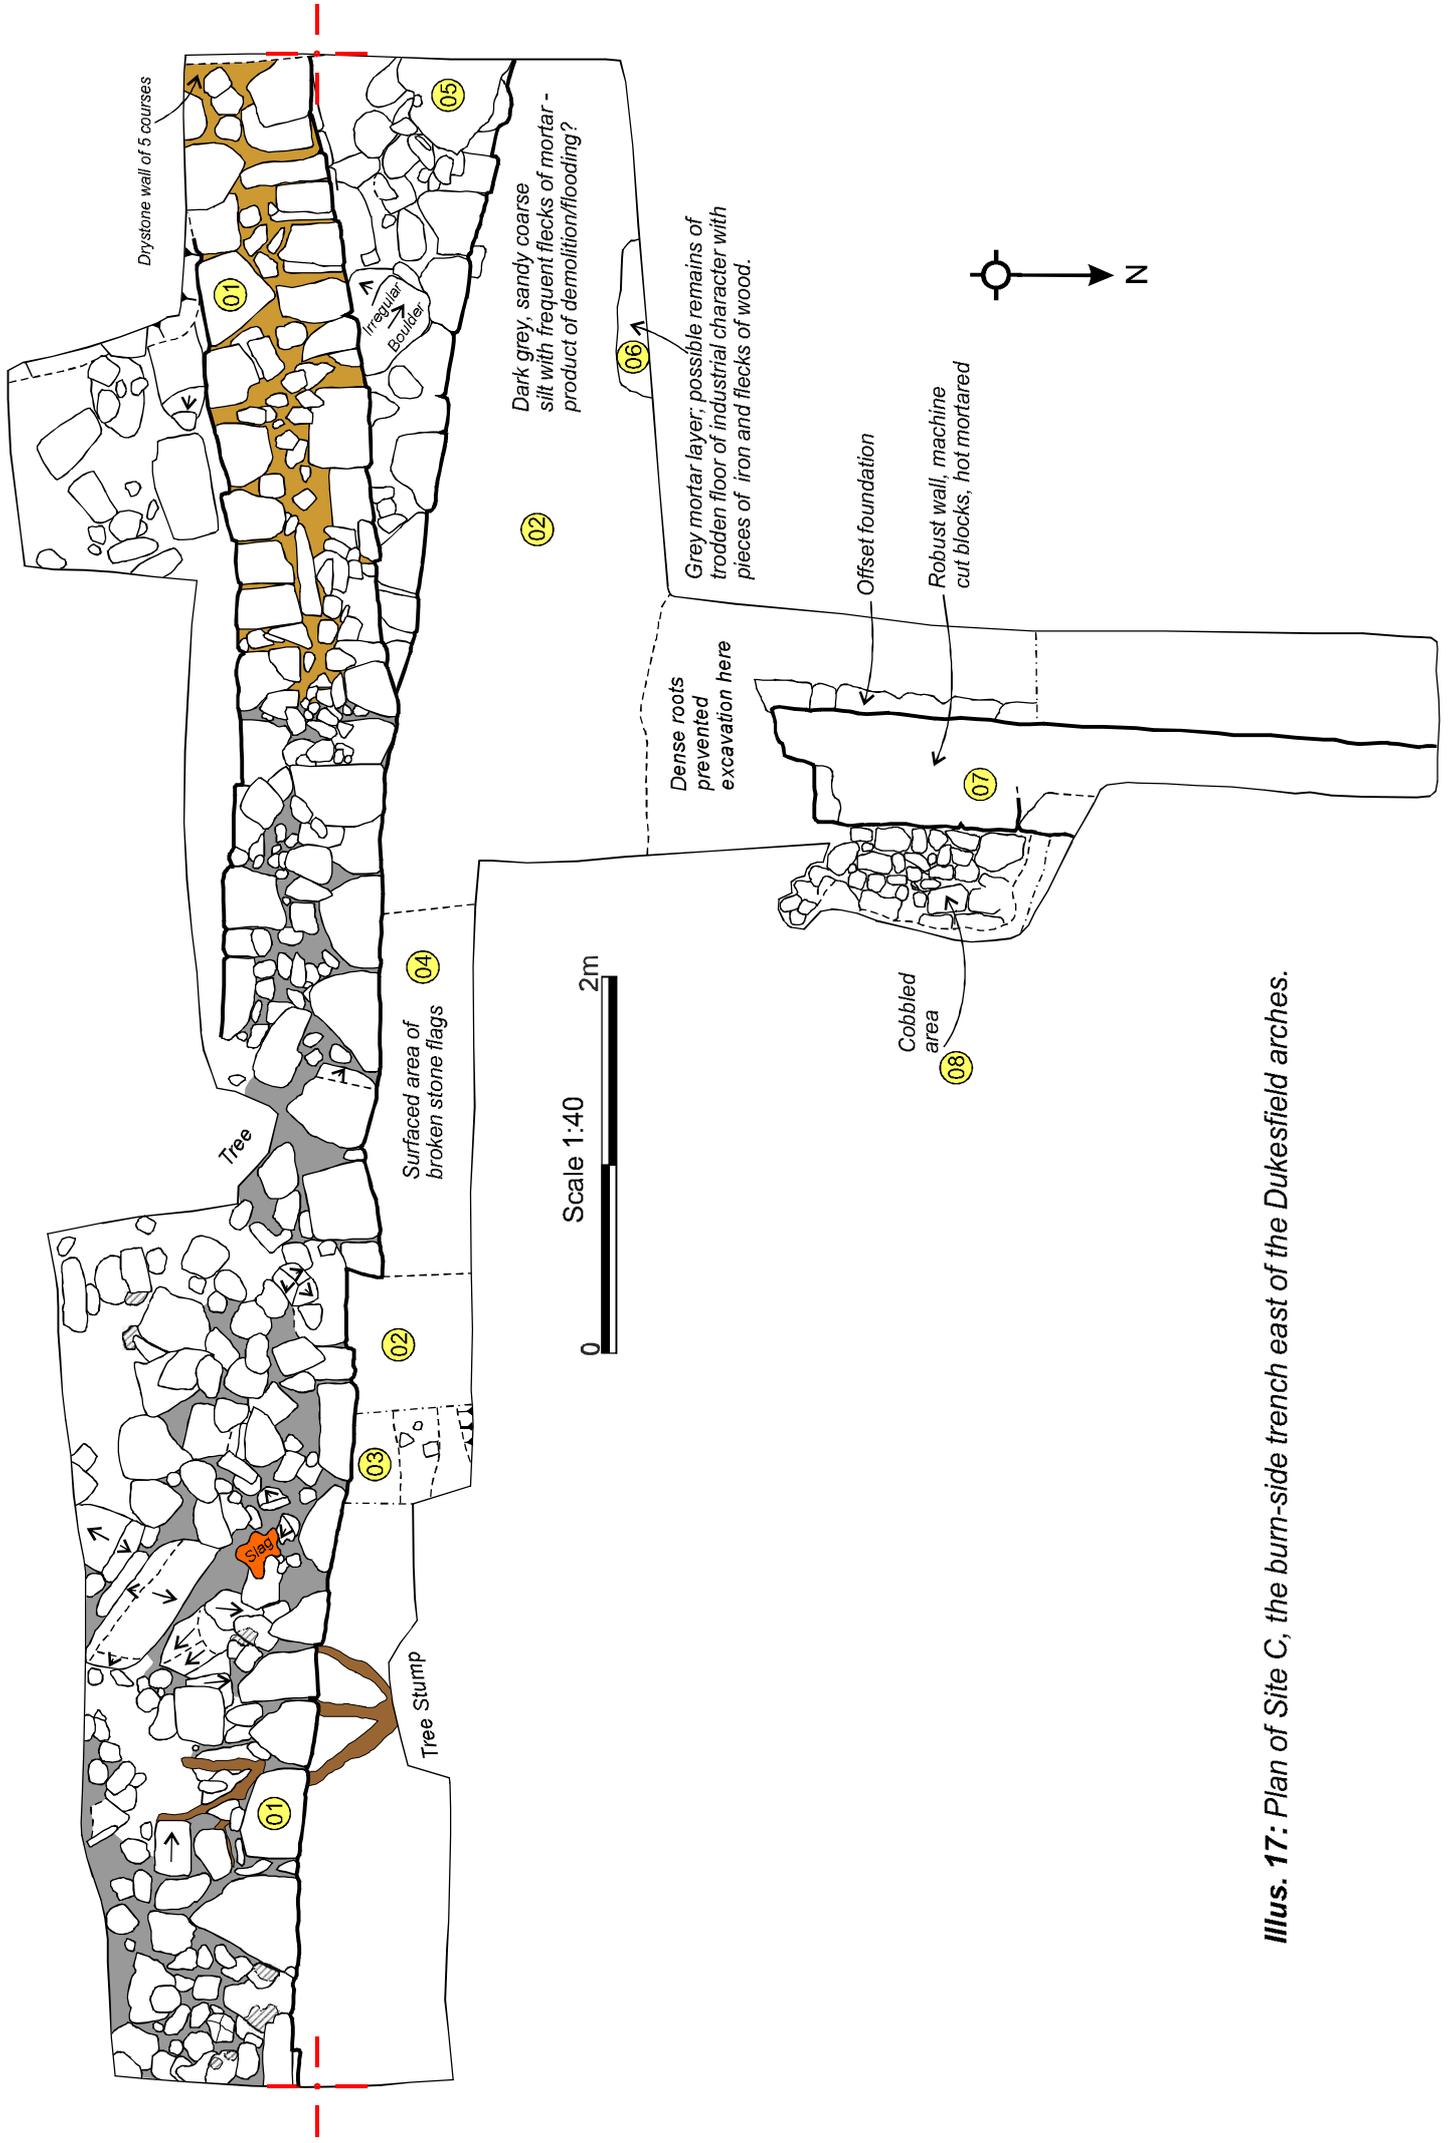
**Illus. 17:** Plan of Site C, the burn-side trench east of the Dukesfield arches.

An extension to the trench was made to the north in order to investigate potential floor deposits and/or a return to the putative enclosed building suggested by the underlying wall described above. This revealed, some 1.9 m north of the north face of the burnside wall, a wall [07] on a north-south alignment, 0.62 m wide and surviving up to two course high with an underlying off-set rubble foundation course of rough cobbles. This wall was well-built and bonded with strong mortar or cement, suggesting a fairly modern origin, almost certainly as part of a load-bearing structure. The wall, including its foundation course, appeared to end, or to have been deliberately truncated, at its south end, while on its east side at its south end were the remains of a cobbled floor [08].

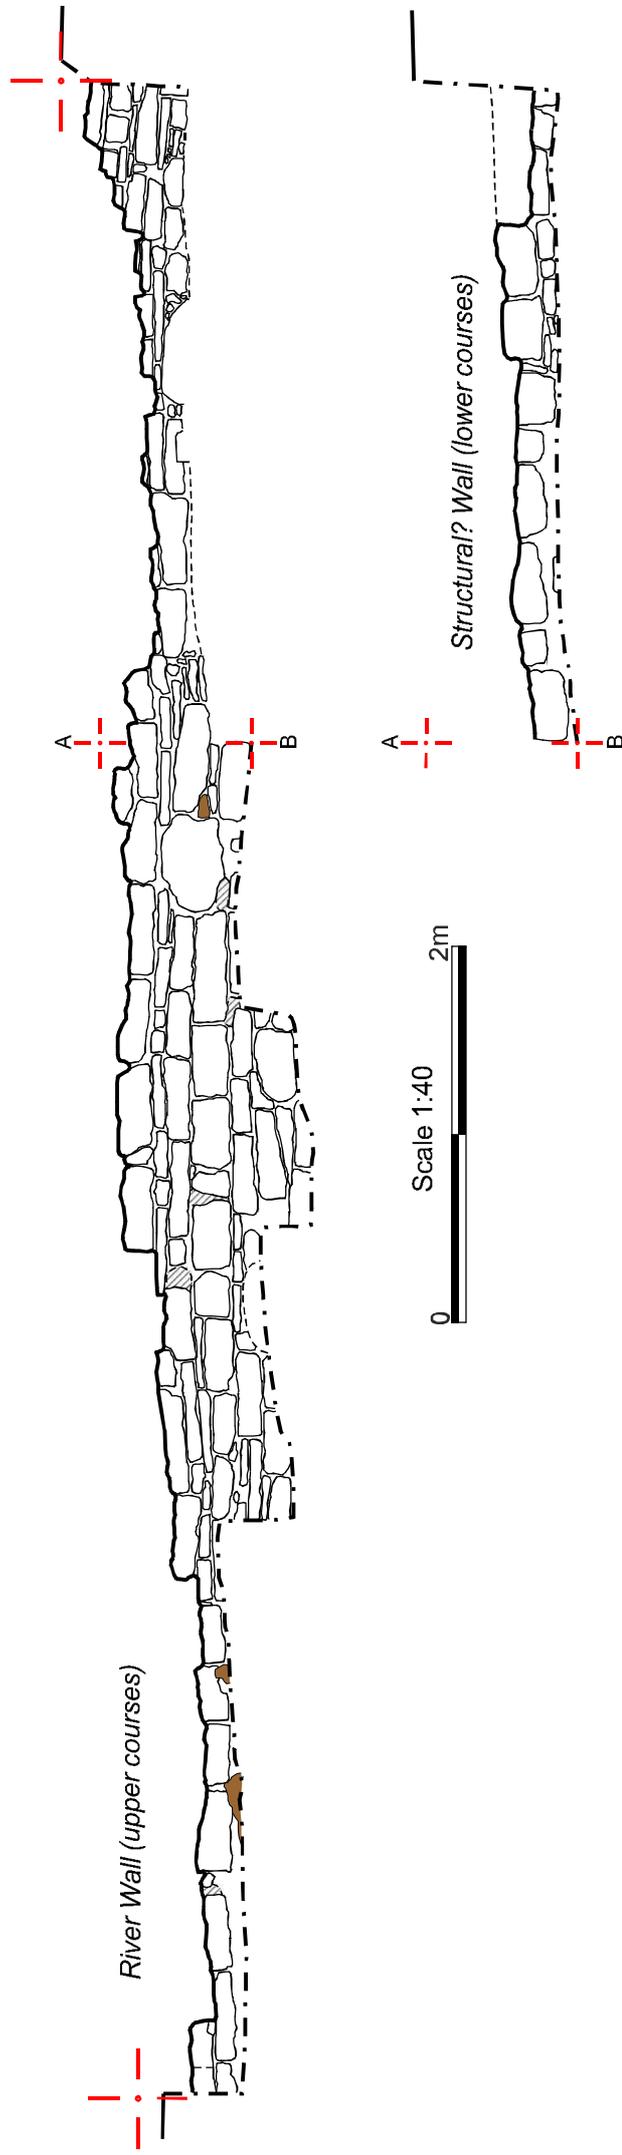
**Illus. 18:** North Facing Section of overlying walls east of the arches.
