Project name  
Dukesfield Arches

| Date | Drawn by | Scale |
|---|---|---|
| 905 | P01 | Repair |

For  
Friends of the North Pennines

Drawing title  
Repair  
Plans & Elevations

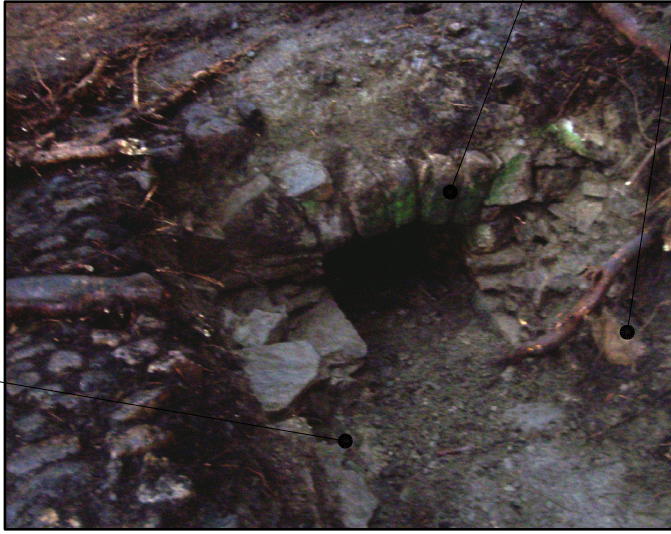
Photograph of the upstream culvert entrance during excavations, now backfilled

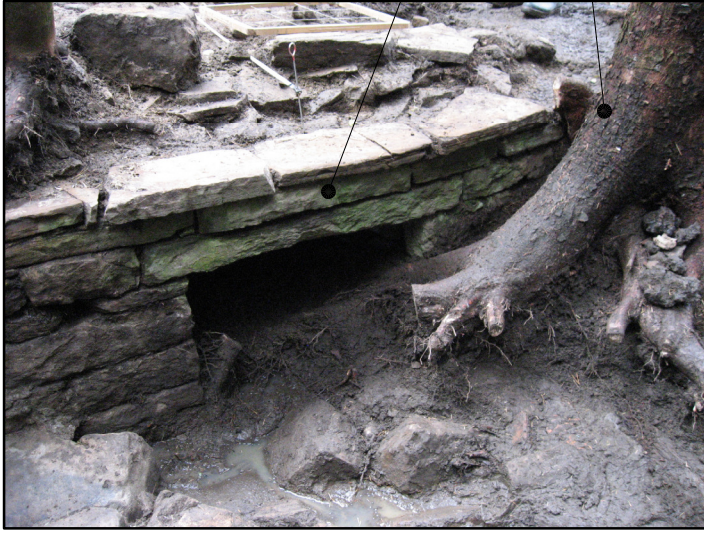
Photograph of the down stream culvert exit during excavations, now backfilled

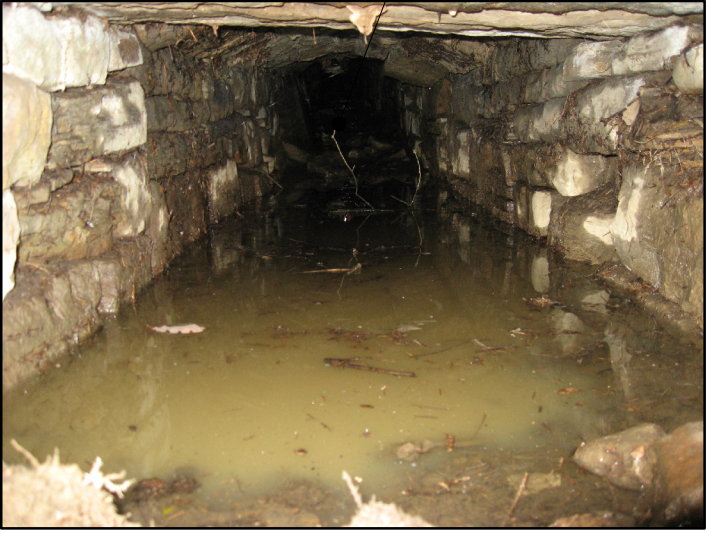
Photograph of the culvert

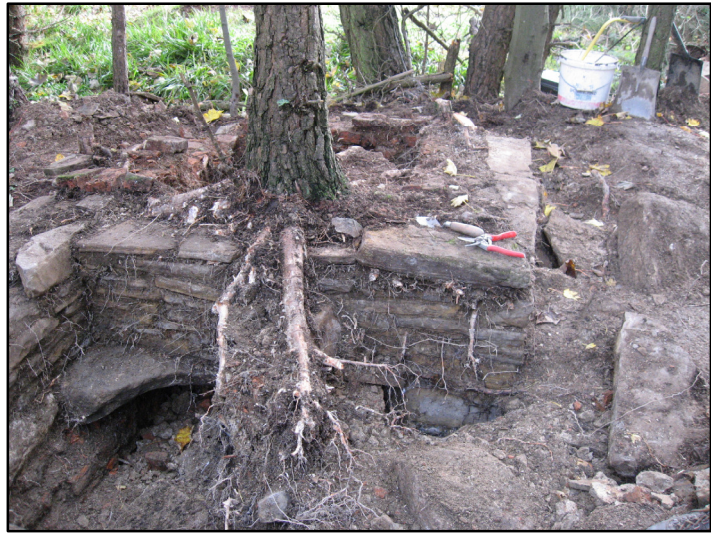
Photograph of excavated chimney bases, now backfilled
