**APPENDIX 1: Dukesfield Leat Excavation 2014, by Pete Lee**

# Dukesfield Leat Excavation 2014

*Pete Lee*

The two main sections in this document record some notes of the excavations in the leat at the Dukesfield Lead Smelting Mill: firstly during May 2014; and secondly in July 2014. Before May, the hearthstone-lined leat had been cleared out by earlier digs.

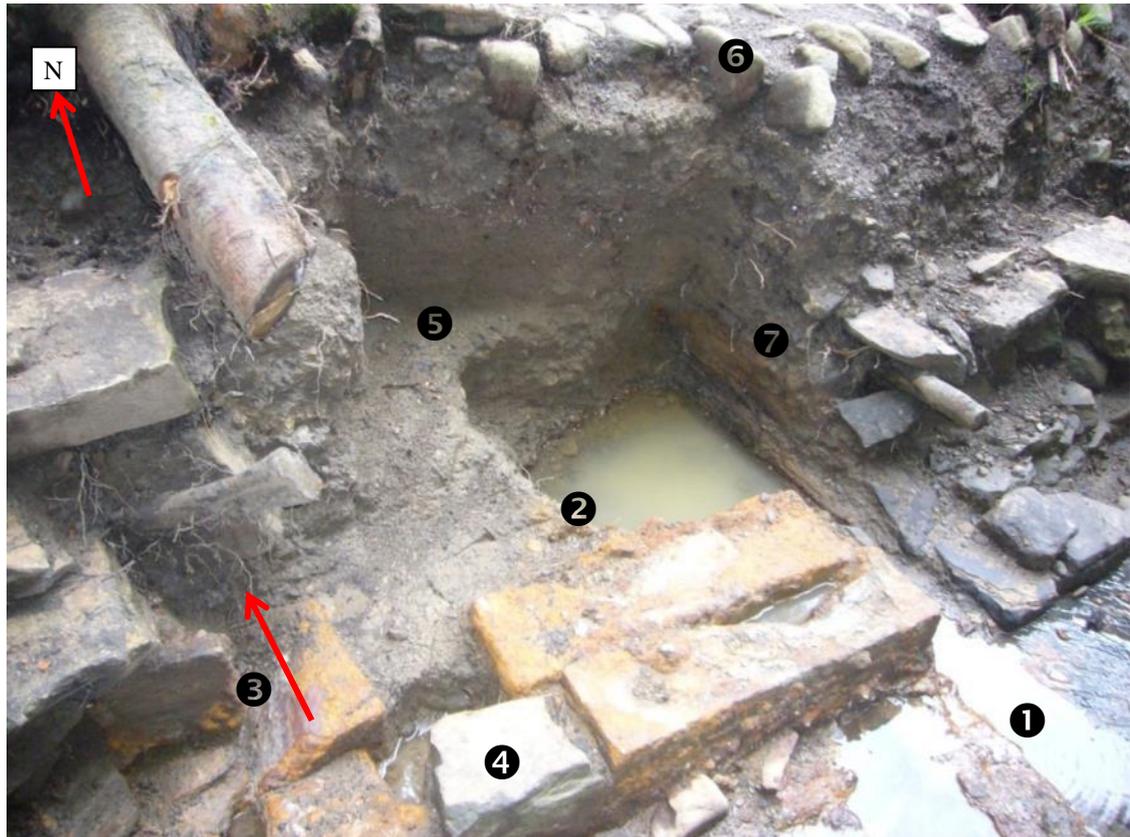
**Figure 2. East End of Leat**

- 1.10 The slot (1 in Figure 2) had been uncovered previously, together with timber remnants in the slot.
- 1.11 A half of an old hearthstone was in-situ approximately in the position identified by 2 in Figure 2. This was removed.

- 1.12 The fill materials in this area seemed to be of three distinct types:
  - A. To the left of label 2 in Figure 2 was what seemed to be compacted clay, very hard to dig out, up to the old hearthstone (3 in Figure 2, also visible in Figure 3(b)) running north into the bank and up to stone 4 in Figure 2 in between the hearth stones on the north edge of the leat. This stone looked like it was blocking a possible exitway from the leat. Were the clay and stone 4 there to provide a permanent sealing off of this exitway?

- B. Material in the area of label 5 in Figure 2, and to the right of label 2 (and in the water-filled hole) was of a much more sandy consistency, with few stones, and was easy to dig. This material headed north under the surface cobbles (6 in Figure 2), but was not explored further than shown in Figure 2 due to the possibility of collapse. It should be noted that the flat vertical face to the left of label 5 in Figure 2 seemed to appear as a feature.

- C. There was wooden shuttering on the east side (7 in Figure 2) which extended horizontally into the bank, but was not excavated further into that bank.

1.13 Later in the dig, a trial hole was dug in the sand underneath label 2 in Figure 2. This hole is shown in Figure 3.

- 1.14 The material dug through was primarily sand, with very few stones.
- 1.15 The wooden shuttering extended down, and no obvious "floor" was uncovered, although there may be one further down. The sandy nature of the fill together with the amount of moisture present prevented further vertical excavation. At a depth of approximately 30cm from the floor level of the leat (from memory), a horizontal edge to the wooden boards was uncovered – roughly at the bottom of the hole shown in Figure 2.

- 2.1. To try to determine where the exit from the leat to the launder feeding the smelt mill was situated, a 2m x 1m trench was opened on the north bank of the leat, to the north of the cobbled surface (6 in Figure 2).
- 2.2. The trench is shown in Figure 4. Here the left-hand side of the trench had been taken back to chase what looked like a wall feature extending in line with a tree root (1 in Figure 2).

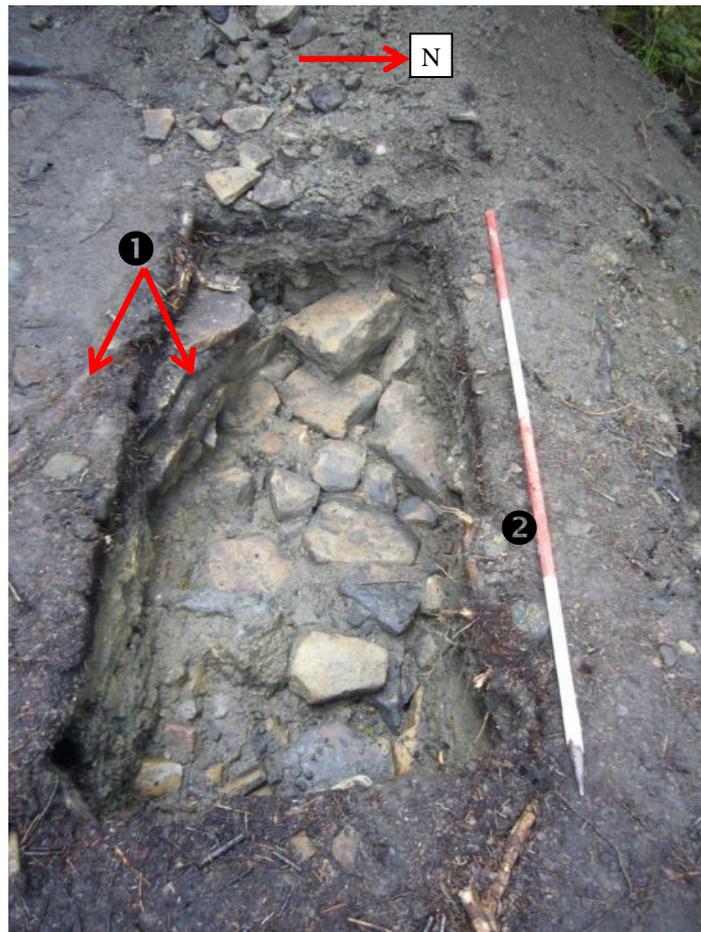
**Figure 4. Trench on Top Of Leat Bank**

- 2.4. The stone-based surface shown in Figure 4 was soon reached. As can be seen in the figure, there were layers of large stones, often with a quite flat upward-facing surface. They gave an appearance of having been placed in situ (rather than being random demolition/fill rubble). There appeared to be many small voids under each layer, also shown in Figure 6 (after further excavations from Figure 4).

- 2.7. The north-facing vertical section of the trench under label 2 in Figure 4 showed the continuation of the layers of large flat stones, with the characteristics discussed in 2.4 and 2.5 above. It was felt that more might be learned by digging away the bank to the north of the trench, again to try to uncover exits for the launder.

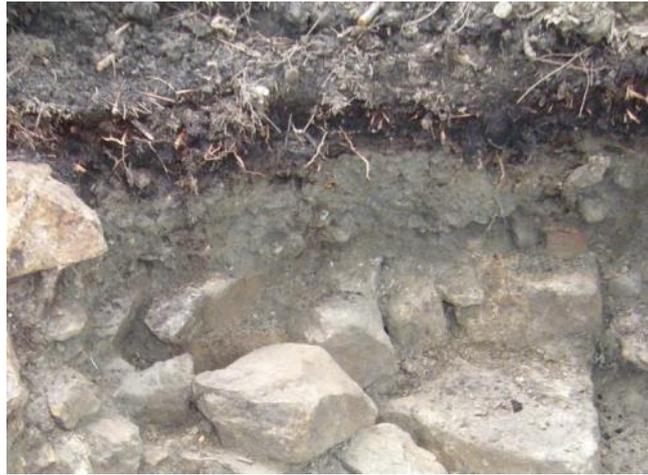
**Figure 5. Top Layers**

- 2.3. Once the top peat/soil surface had been removed, I think the next layer was of a mortar/sand consistency, although this is from memory. (Note to trainee archaeologist Pete: take more notes and pictures!) Figure 5 shows the top layers in the early excavation of the leat bank (see below) which is thought to be similar to that found in the trench.

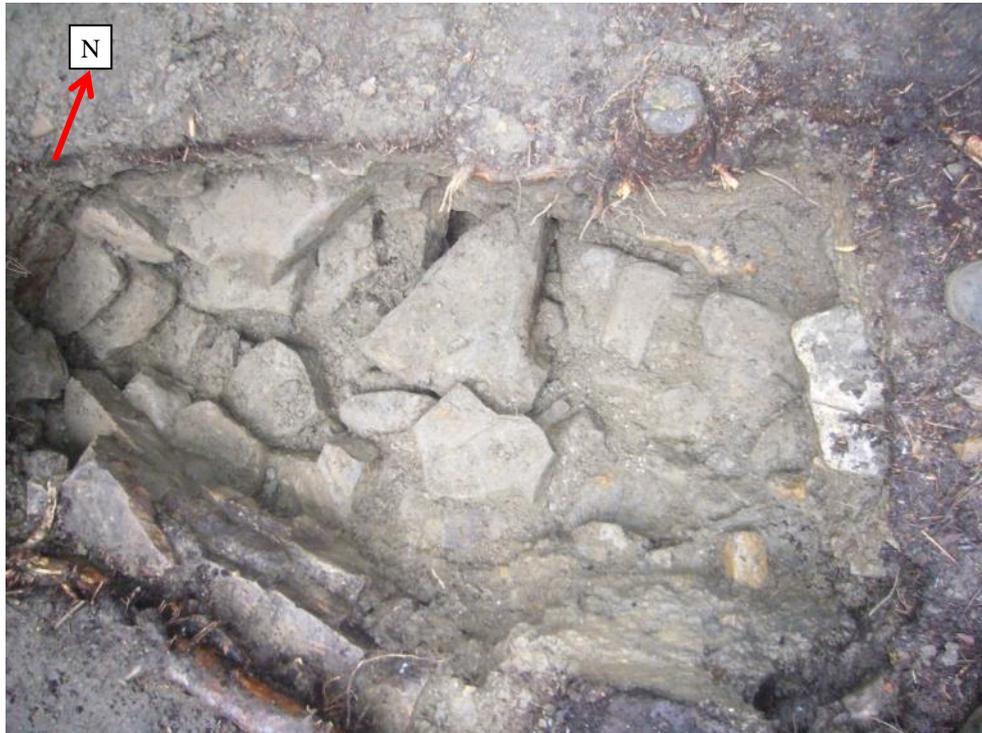
**Figure 6. Trench on Leat Bank After Further Excavation**

- 2.5. The bottom face of many of the flat stones was black; it was noticed that the stones immersed in the Hall Burn were also showed a similar colouring. Were the stones showing in this trench in a flow of water at some time (although no obvious channel was emerging)? Figure 7 shows a typical underside of a lifted stone, with the sandy colour where this stone was resting on one below. Often, as also shown in Figure 7, there were pebbles stained black under the stone, often "cleaner" than shown in that picture. Some of the rain showers (and un-expert excavation!) had led to sand (and mortar?) being washed in over the surfaces being exposed, particularly in Figure 6 and Figure 7.

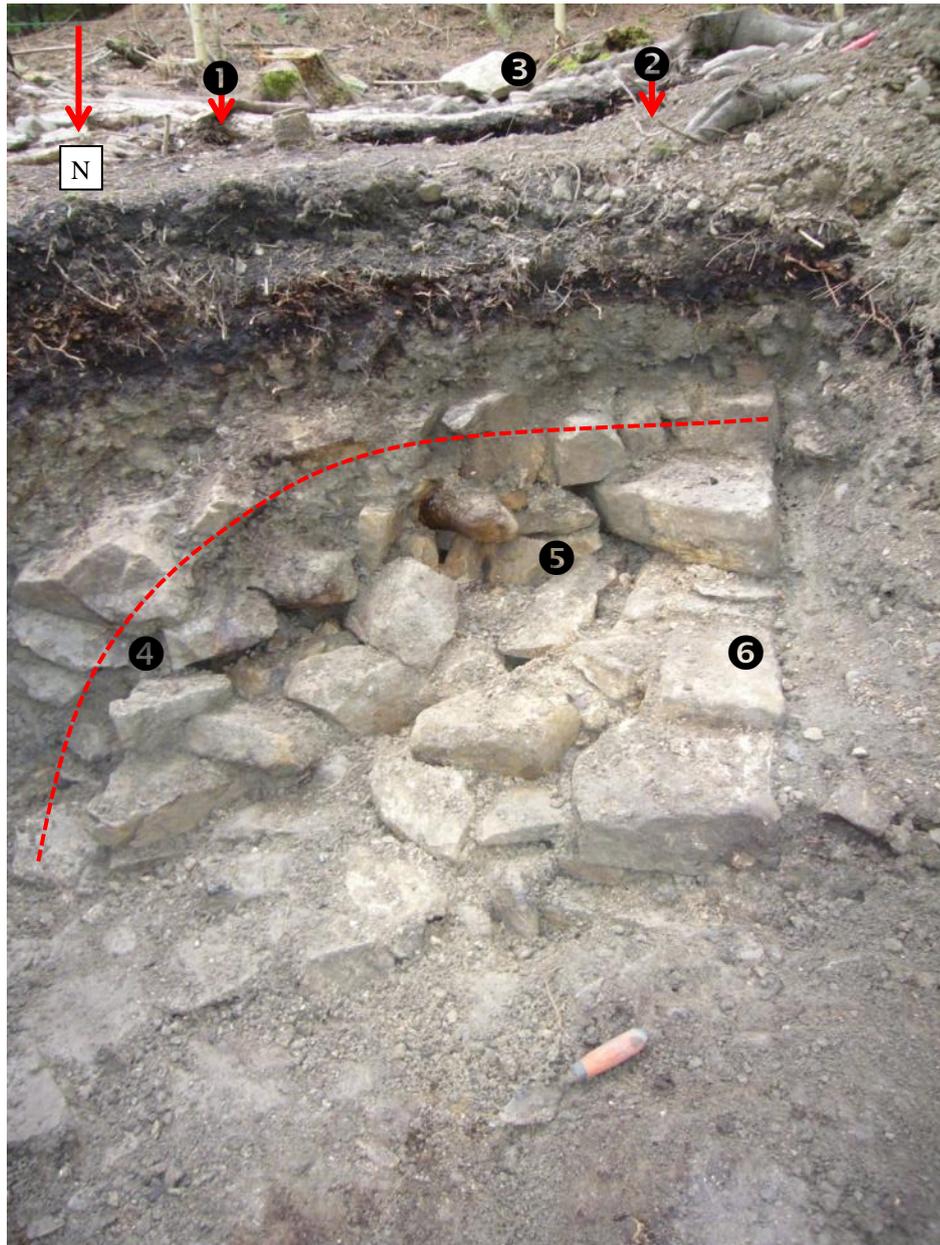
**Figure 8. Leat Bank Top and Initial Bank Excavation**

- 2.8. Figure 8 shows a first stage of the bank excavation, looking south up from the bank, and the edge of the trench discussed above can be seen, marked with labels 1 and 2. Label 3 marks the approximate position (on the top of the leat) of the edge of the wooden shuttering in the leat.

- 2.9. At this early stage, three areas of stonework, which were thought to be distinct, were apparent, as shown in Figure 8:
  - A. In the area labelled 4, the stones were more irregular and possibly mortared into place. They gave an impression of forming a rough arch shape (the arch approximately indicated by the dotted red line in Figure 8), although not a normal self-supporting arch which you would get with a tunnel below.

- B. In the area labelled 5, the stones seemed more rectangular in shape with flat upper and lower surfaces, and tightly packed, with small voids, but without any mortar, and with the black colouring characteristics described in 2.5 above. These characteristics are particularly visible in the vertical section; the horizontal section at the bottom of the photograph is obscured with excavation debris.

- C. In the area labelled 6, a stone structure was emerging with the obvious line on the right-hand side

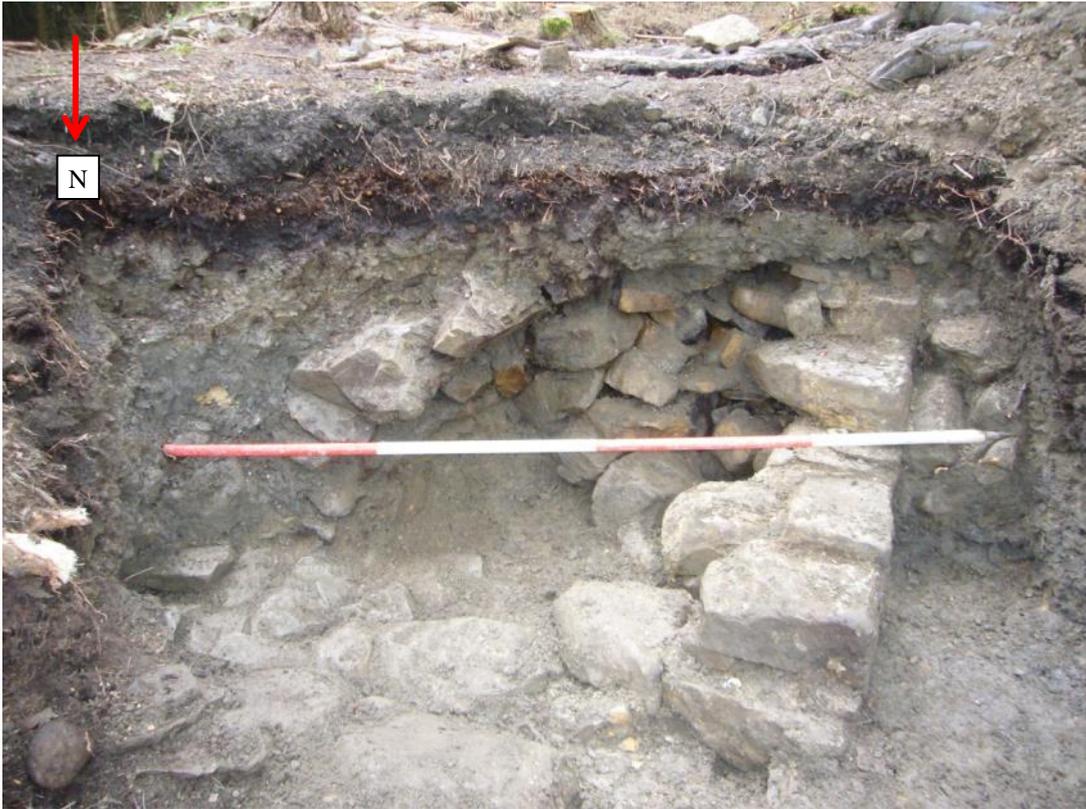
**Figure 9. Further Leat Bank Excavation**

- 2.10. The results of further excavation towards the bottom of Figure 8 and in the area labelled 5, are shown in Figure 9. This shows the emerging stone wall on the right-hand side, the possible arch, and the in-fill between these two features. Is that really an arch, or is it the result of a collapsed vertical wall? The author has little archaeological experience, but it did look like an arch structure more than a collapse (but not a self-supporting arch, as mentioned previously); the stones in-filling between the arch and the wall didn't appear to be collapsed rubble material. In particular, the stones in this in-fill (in the middle metre of the measuring pole) had the characteristics mentioned earlier in sections 2.4 - 2.6, namely of being packed in very tightly, but very cleanly, with no mortar and with lots of little voids. Figure 10 is after further excavation of this in-fill, showing these characteristics more clearly. Figure 11 is a close-up of some of the stones in this in-fill, showing their clean but blackened appearance, with the pointed stone in the foreground being one of the stones on the wall at the right-hand side of the excavation (just above the measuring pole in Figure 9).

- 2.13. Figure 12 and Figure 13 can be related to the earlier bank excavation photographs by the stone labelled 1 (for example, this stone is just above the measuring pole on the wall in Figure 9). The feature labelled 2 is the south edge of the leat trench (labelled 1 in Figure 4). The feature labelled 3 possibly shows how stones at the top of the "arch" were mortared into place.
- 2.14. Note the feature labelled 4 in Figure 12 and Figure 13. This feature will be discussed below as a possible revetment, and shown in close-up in Figure 14, but here it may be noted that the "arch" and material are on top of this revetment, so were possibly a later feature in the leat/lauder development.

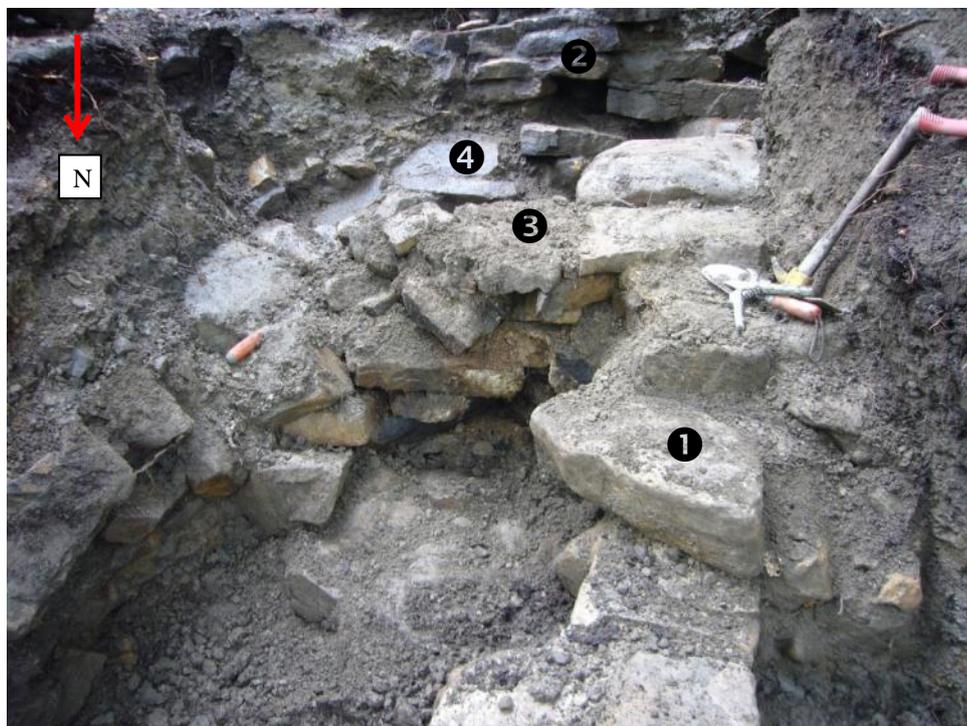
**Figure 12. Bank Excavation Joined to Leat Trench, From Below**

- 2.11. Did this "arch" and the stone wall mark the boundaries of a water channel that was in-filled with carefully positioned (and non-mortared) stones, to support the arch and a top surface, yet to give a channel, albeit with the peculiar characteristics noted in 2.6 above? It should be noted that the in-fill stones did build upwards to support the "arch" (so the arch wasn't a structural arch). Note also that the stones in the wall did jut into this possible channel, and formed part of the structure, and had mortar in places. When the in-fill stones were removed, some of these stones in the wall were unstable and had to be removed.
- 2.12. At this point it was agreed that the material in between the leat trench and bank excavations should be removed. Figure 12 and Figure 13 show a first view after this material was removed.

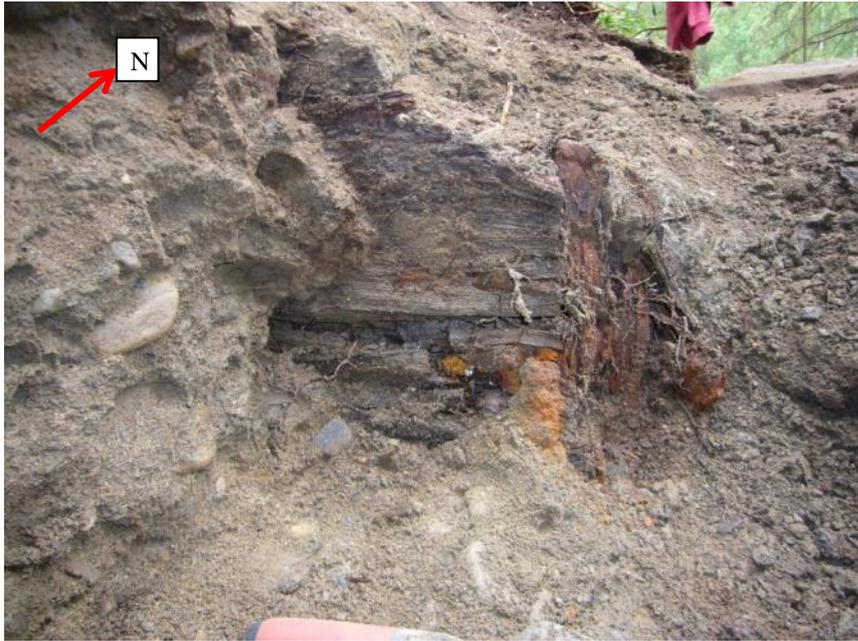
**Figure 2. Shuttering and Vertical Post**

- 1.2. Further excavation in the area labelled 2 in Figure 1 revealed more of this wooden shuttering, shown in Figure 2. A vertical wooden post together with evidence of vertical ironwork is also shown in Figure 2. The ironwork may be in the bag of finds, although it had no distinctive shape or features.

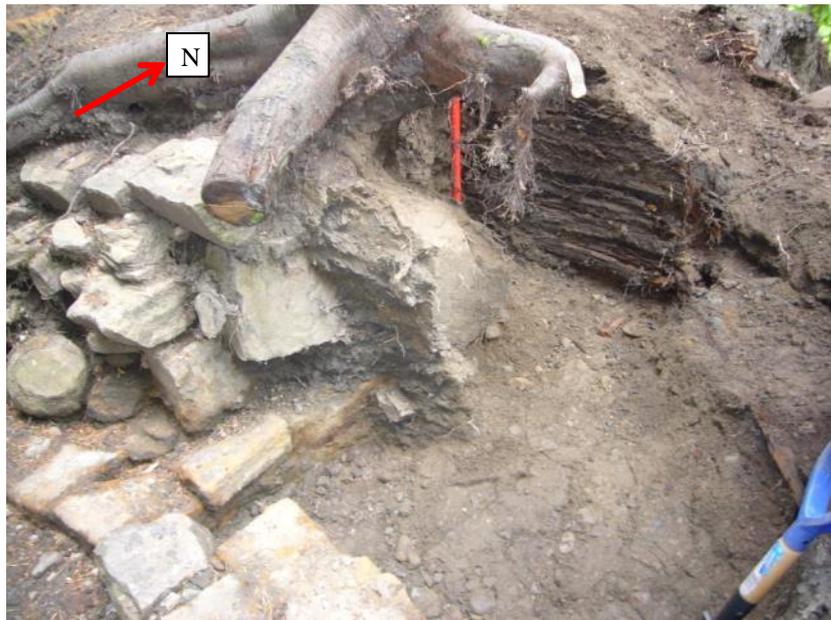
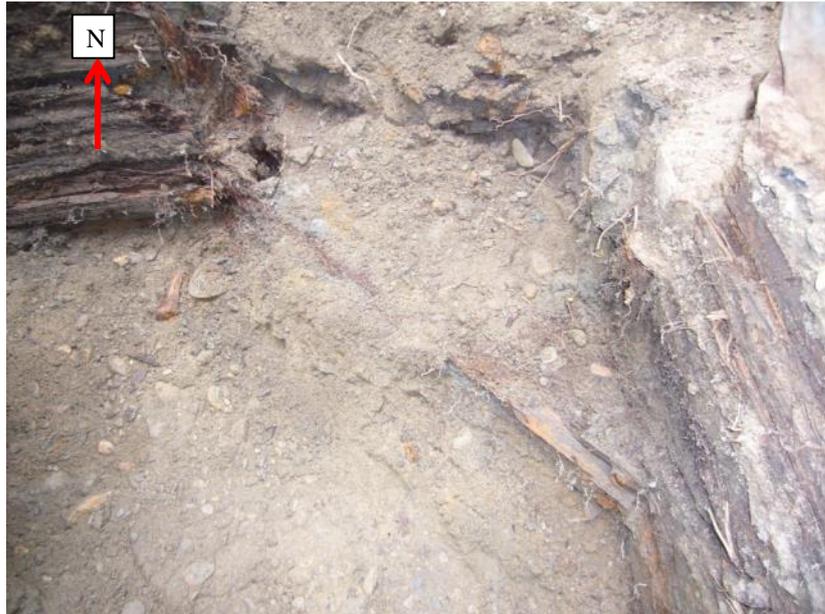
**Figure 3. Diagonal Timber (behind blue spade handle)**

- 1.3. The vertical wooden shuttering continued westward under the tree stump. The top of a diagonal piece of timber was uncovered in the area where a launder exit is predicted, heading from this new shuttering to that uncovered earlier (see 1.12 (C) and feature 7 in Figure 2, in the May 2014 document). This is shown in Figure 3 and Figure 4.

- 1.4. Removal of the tree stump shown at the top of Figure 3 allowed the vertical east/west wooden shuttering to be chased along and excavated. This work in progress is shown in Figure 5. The feature being uncovered will be referred to as "the mill pond" (rather than "mill race", since this feature may have acted partly as a reservoir for feeding the mill's water wheel).

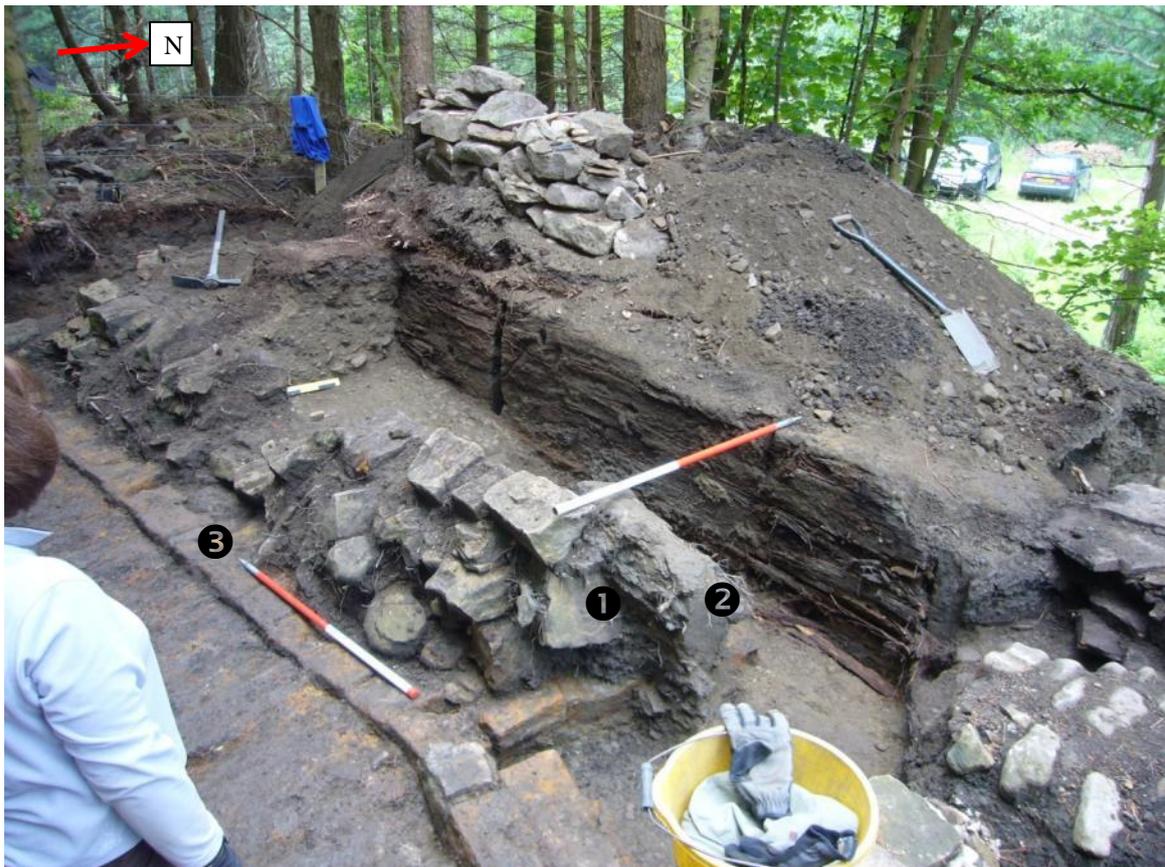
**Figure 5. Uncovering the Mill Pond North of the Leat**

- 1.5. The random nature of the the stones facing into the leat (1 in Figure 5), which had been uncovered as part of the earlier leat excavation, was originally puzzling. However, it became clear that the stones facing the leat were the rear of a stone wall, the faced side of which formed the inside face of the mill

- 1.7. The flimsy single-course brickwork uncovered in earlier digs at the west end, and labelled 1 in Figure 8, was removed, as was the block of clay (labelled 2 in the earlier Figure 5) at the east end, to enable the sandy layer in the mill pond to be completely removed. Even then, the bottom of the wooden shuttering hadn't been uncovered, so three trial holes were excavated. These had to be dug through hard, gray, compacted clay. The final state of the clearing of the mill pond is shown in Figure 9, with the trial holes labelled 1 – 3. Also in this figure, the position of a number of vertical slots in the wooden shuttering can be seen, labelled 4 – 6.

- 1.11. A previous examination of the random stones facing the leat had revealed a possible mini-arch, in the position labelled 3 in Figure 5, where the stones appeared to have been more carefully positioned than in other places. This is shown in detail in Figure 13, before the excavations on the left, and during the excavation on the right. The rear of this area, from the mill pond side, is shown in Figure 14. A possible function for this feature will be discussed in Section 3.

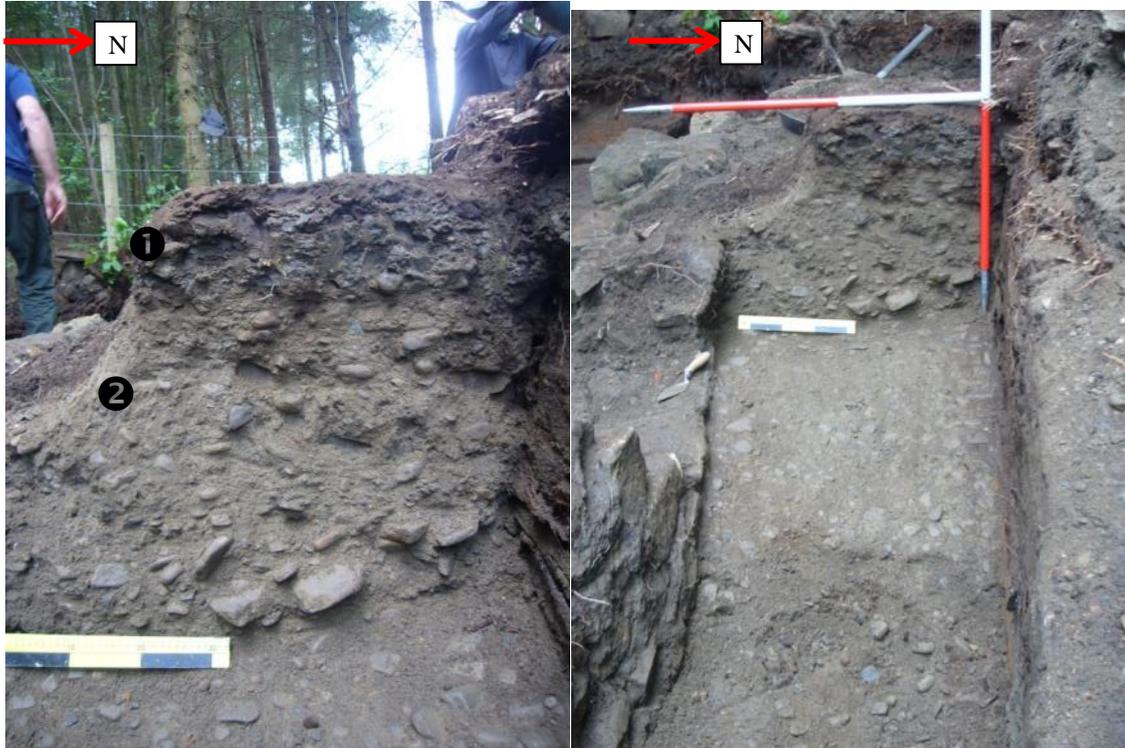
**Figure 6. Section across Mill Pond**

pond, with the timber shuttering forming the other side. A section of the typical material filling the mill pond is shown in Figure 6. This comprised a top layer of natural material (0.2M deep, already removed), followed by a light gray clay layer (labelled 1 in Figure 6), and then very sandy material containing small pebbles (labelled 2 in the figure). Although the right-hand photograph in Figure 6 appears to show a cobbled floor, this is believed to be a consequence of the excavation rather than a feature, since the sandy material and wooden shuttering continued below that level for approximately 0.5M where a compacted clay layer was uncovered. This is discussed further subsequently.

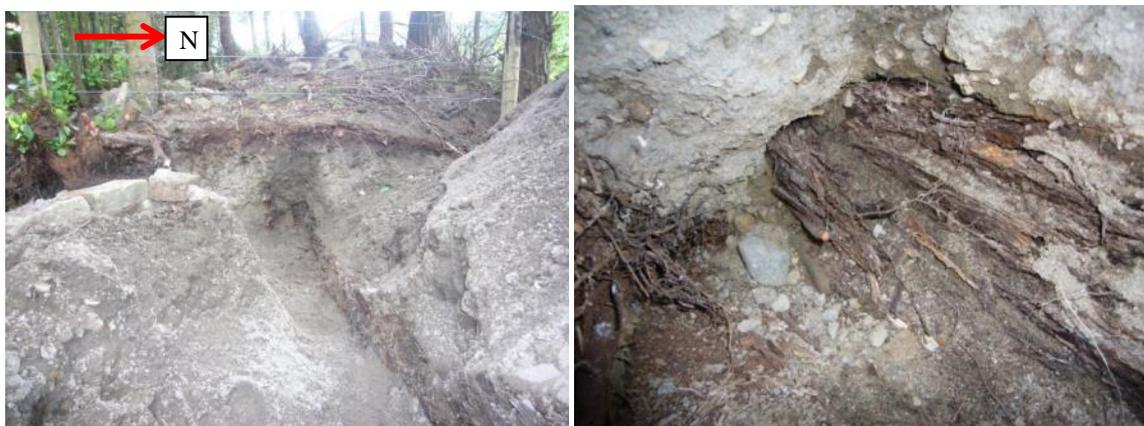
**Figure 7. West End of Mill Pond Excavation (close-up on rhs)**

- 1.6. Excavating the mill pond westward revealed that the wooden shuttering continued right up to, and under, the wire fence marking the current boundary of the site, shown in Figure 7, with a close-up picture of the disappearing shuttering on the right. The top of the shuttering that would have been level with that discovered to the east had disappeared with only the lower level remaining, as shown in Figure 8. All the timber shuttering was in poor condition, with only a thin layer remaining that was infiltrated with small tree roots. Behind the timber framing appeared to be a layer of clay, presumably helping to form a watertight barrier (but also impervious to tree roots).

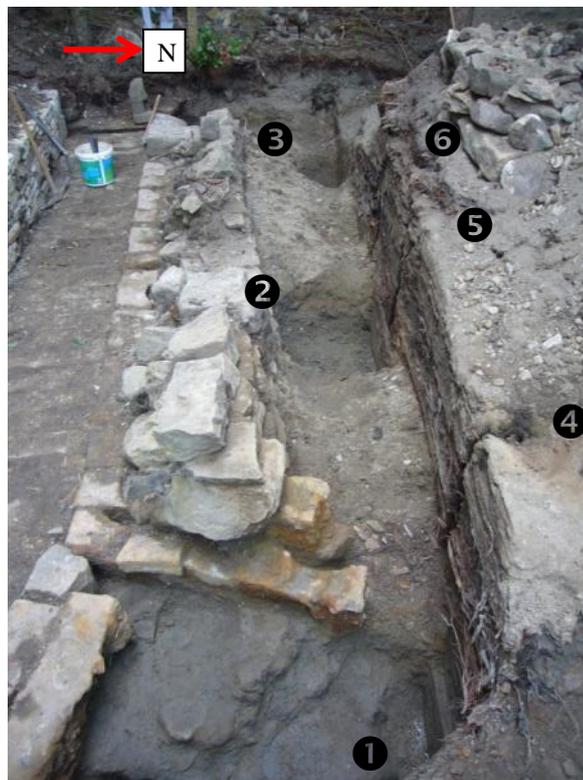
**Figure 9. Cleared Millpond In July 2014**

- 1.8. The trial hole labelled 1 in Figure 9 is at the culvert end of the leat, directly opposite the cobbled chute exposed on the hill on the south bank. Excavating part of the very hard clay floor revealed the bottom of the wooden shuttering, possibly coming down onto a cobbled surface; see Figure 10.

1.9. Holes labelled 2 and 3 in Figure 9 are shown in detail in Figure 11 on the left- and right-hand respectively. The thicker horizontal timber board that is seen in Figure 10 also appears in the detail of hole 2.

1.10. Detail of the three horizontal slots seen in Figure 9, labelled 4 – 6, are shown in Figure 12. Were these just part of the construction of the shuttering, or did they have another purpose? A possible answer will be discussed in Section 3.

At the culvert end, old hearth stones were laid across the Mill Pond as foundations (see features labelled 1 in Figure 33), and a clay wall (2 in Figure 33) built on top of this, with its inner face (3) angled towards the exit at the top of the bank (4). There was possibly some wooden shuttering across between 3 and 4 to form the west side of the water exit. See Figure 9 also.

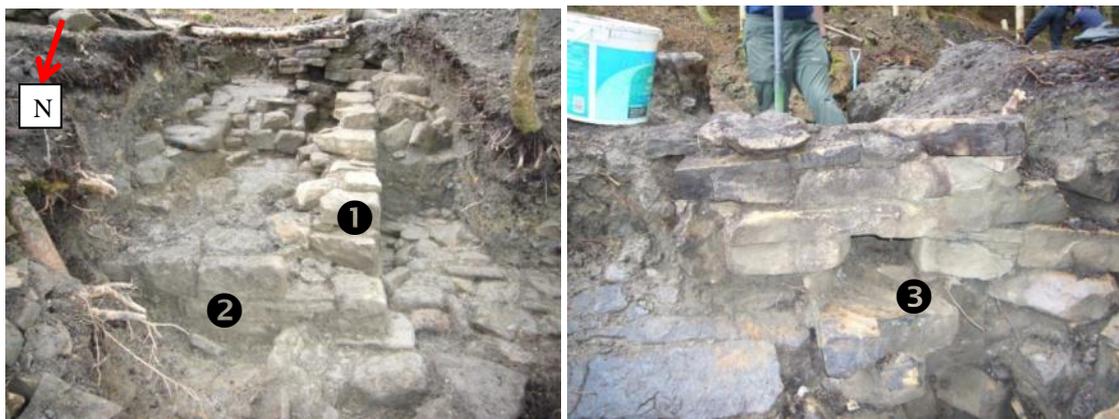
**Figure 15. Top of Bank With Possible Water Exit Hole**

- 2.1. The starting point for the July excavations is shown in Figure 15, on the left-hand side. A more detailed picture of the top area after some excavations is shown on the right-hand side. A possible water exit is clearly visible, with a horizontal stone labelled 3 forming a protruding floor. The stones surrounding this hole were of the same material as those in the slotting revetment to the left, and it is suggested that these stones were originally part of the sloping revetment and removed and reused in a subsequent development of the area. This idea will be explored further in Section 3.

- 2.5. At the base of the excavated bank, further clearing of the substantial stone wall (labelled 2 in Figure 15 and in Figure 18) running west/east under the large tree exposed more of the structure of that wall. The tree and its roots prevented finding an answer to whether the end of the wall had been uncovered (see Figure 19).

- 2.6. Excavation down the side of the stone wall labelled 1 in Figure 15 revealed an interesting set of substantial stone steps meeting the previously uncovered cobbled surface, and looking contemporary with that surface (Figure 20). The dressed stone face of this wall was originally puzzling, and it was thought that it perhaps was the inside of a water channel. However, the uncovering of the steps now

- 2.7. Figure 21 shows the top of the bank after further excavations down to the protruding stone labelled 3 in Figure 15. Clay is again prominent in the bank (labelled 1) and above the stones labelled 2, as if sealing those areas and making them watertight. The area around and under 2 appears to consist of large stones with many voids around them, rather than random in-fill, a characteristic of the area under the bank when first excavated (described in the May 2014 report) , although there was not time to investigate this further. At the time of this photograph, the steps described above had not been uncovered.

It is presumed that the substantial stone walls labelled 1 and 2 in Figure 15 were built as part of this re-development, as they are, in parts, on top of earlier stonework/cobbles. What was the purpose of these walls? Given their engineering, it could be assumed that they were built to carry something substantial, such as a wooden launder attached to the exit from the leat shown in Figure 15 and Figure 34. A launder there would provide additional height to the water carried to the Mill compared to a launder taken from the bottom of the stone walls.

A launder at the bottom would have required water to flow in some form of channel to the left of stone wall 1 in Figure 15. The possibility of a water channel there was investigated in the May document, with some features suggesting the flow of water (blackened stones, stones laid without mortar to form voids). However, experts who visited the site didn't think that was a possibility, as water flows to feed machinery usually needed a smooth pathway. Perhaps the stones found between the stone wall and the bank on the east side were in-fill used when the leat was decommissioned. However, some of the features uncovered in May suggested that stones were more carefully positioned than might have been the case for a "demolition job". (Please see the May section above for more details.)

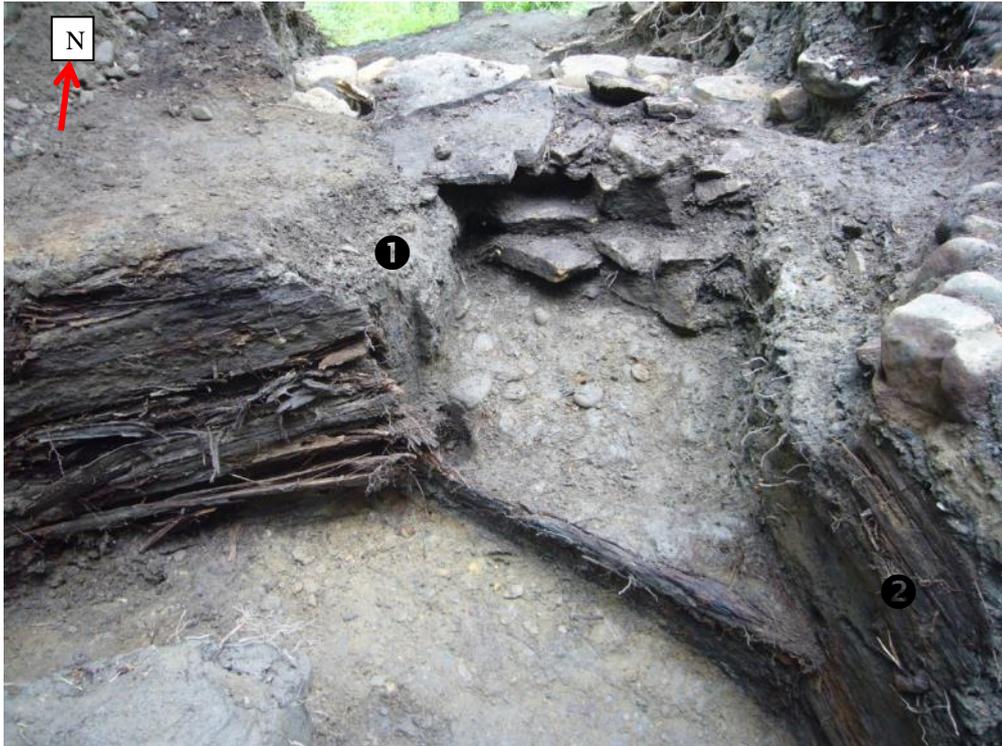
**Figure 16. Possible Launder Exit From Leat Area Side**

- 2.2. The rear of the area in Figure 15 is shown in Figure 16. It can be seen that the level of the hole is approximately the same as the top of the diagonal timber that was discussed earlier in Section 1.3. The small amount of timber that was the vertical post had fallen out after the further excavation, but its position can clearly be seen (labelled 1 in Figure 16).

The old Mill Pond water exit on the Mill Pond side was blocked with the board and clay (see Figure 10), as mentioned at the end of Section 3.1. The floor level around this exit was then increased up to the level of the leat bottom (see left-hand photograph in Figure 29), with the diagonal piece of wood helping to raise the floor level between the leat side and the exit through the bank towards Devil's Water. See Section 2.2 and Figure 16.

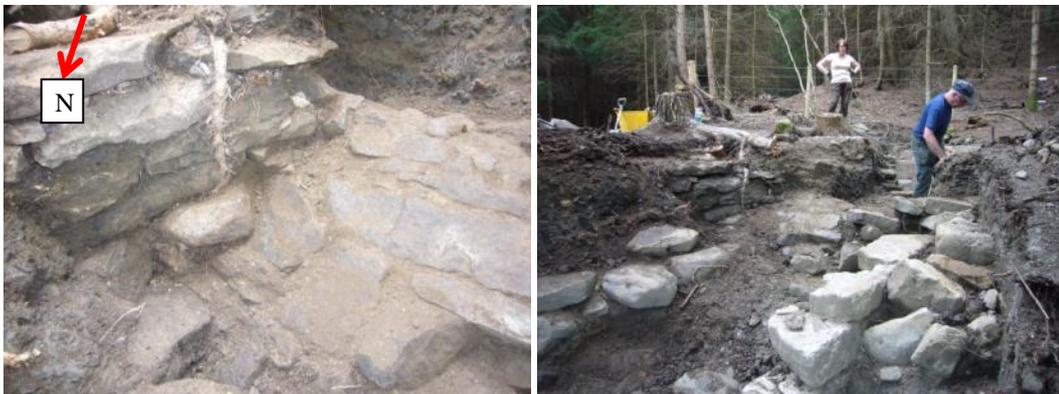
**Figure 17. Stone Feature At Top of Bank**

- 2.3. The bank on the right-hand side when looking towards Devil's Water was cleared further to uncover the stone feature, running approximately north-east that the May excavations had found. To the unexperienced eye, this stone feature appears to integrate with the sloping revetment wall (see Figure 17), and did not appear to extend any further down the bank. The large tree stump hindered further investigation.

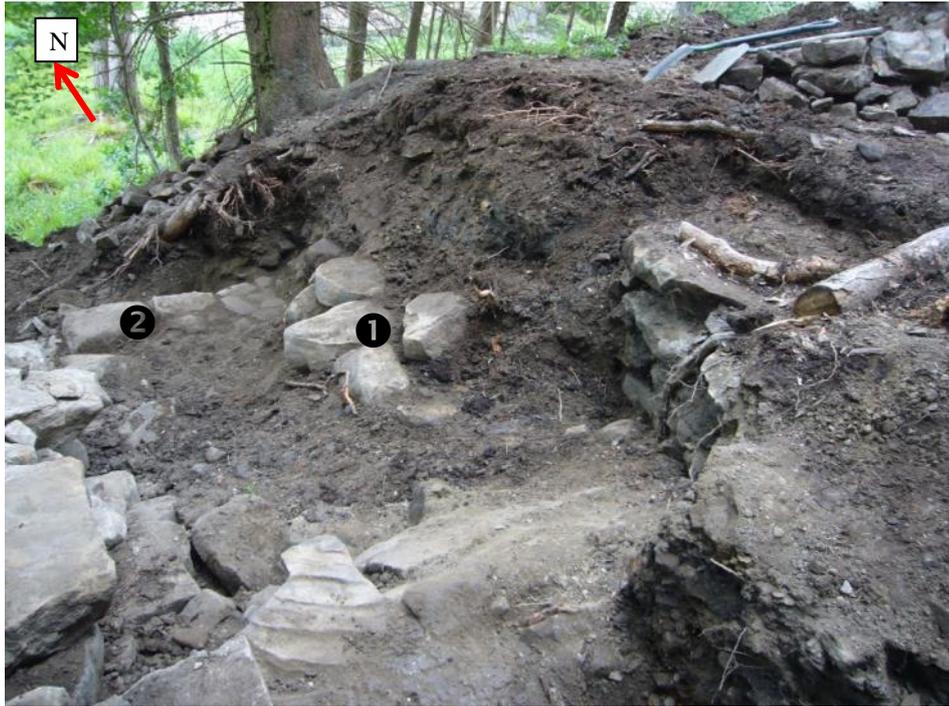
**Figure 18. Excavation on Right-hand Side of Bank**

- 2.4. Further clearing of the right-hand bank side (looking towards Devil's Water) revealed more of the large stones (labelled 1 in Figure 18), with a layer of gray clay-like material on top, but no obvious additional features.

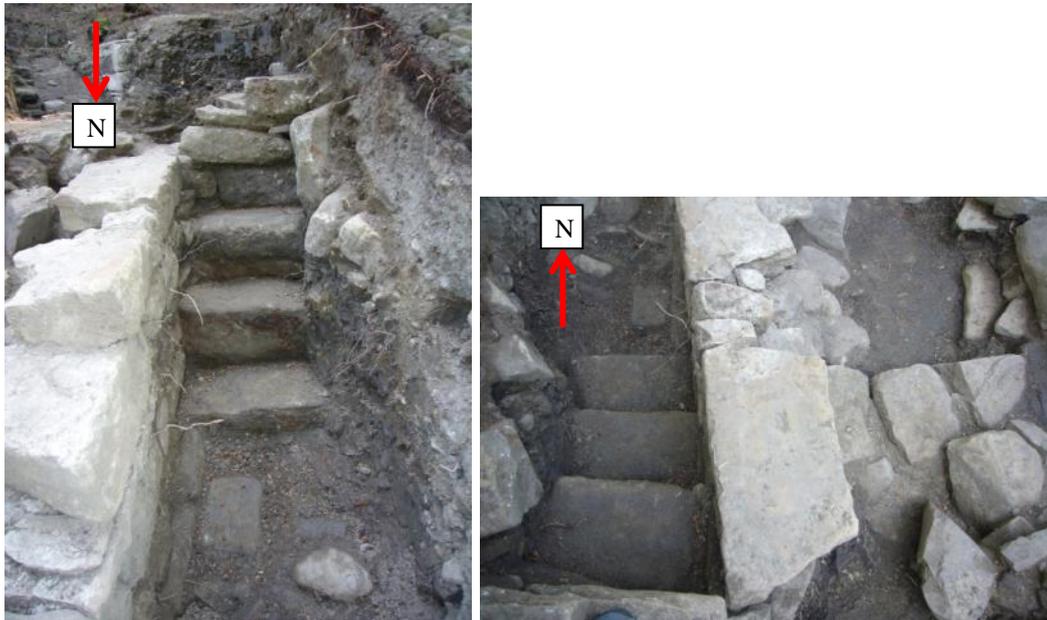
**Figure 20. Stone Steps in Bank**

suggests that wall's face was dressed because of the steps. The May excavations had suggested the stone walls were a later development than the cobbled surface, so that development presumably kept the steps as a feature. Looking at the left-hand picture of the steps in Figure 20, do they appear to be curving to the right-hand side towards the top?

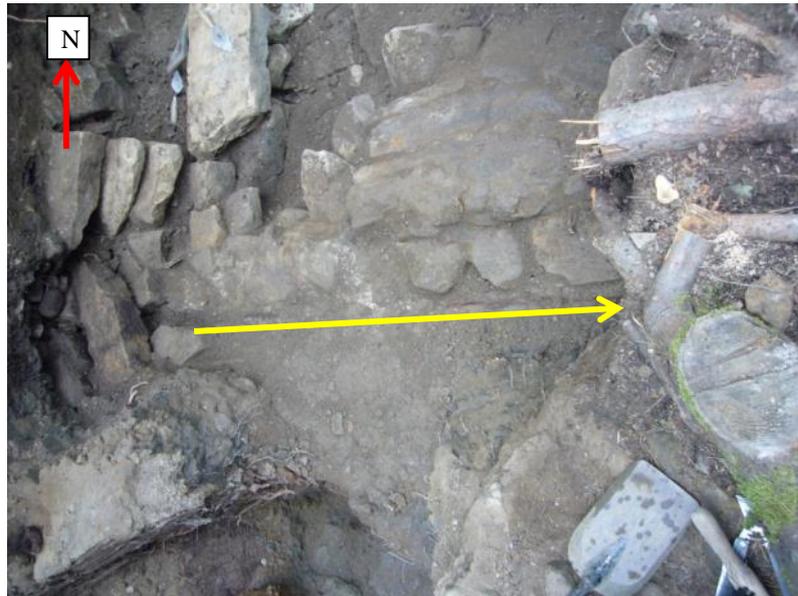
**Figure 22. Timber Across Top of Sloping Revetment**

- 2.8. Excavations at the top of the bank continued down to the level which was the top of the sloping revetment, including removal of the protruding stone mentioned in Section 2.9 above. This work uncovered the top of yet another piece of timber, running west/east across the top of the revetment,

and indicated by the yellow arrow in the view from above in Figure 22. A more detailed picture of the ends of this timber are shown in Figure 23, the left-hand one in particular does look like a slot structure.

The timber discovered running across the top of the revetment (see section 2.8 and Figure 22 - Figure 24) could be the remains of a sluice gate controlling this Mill Pond exit, left in place in the later re-development to seal the exit. Further excavations of this timber seem highly desirable.

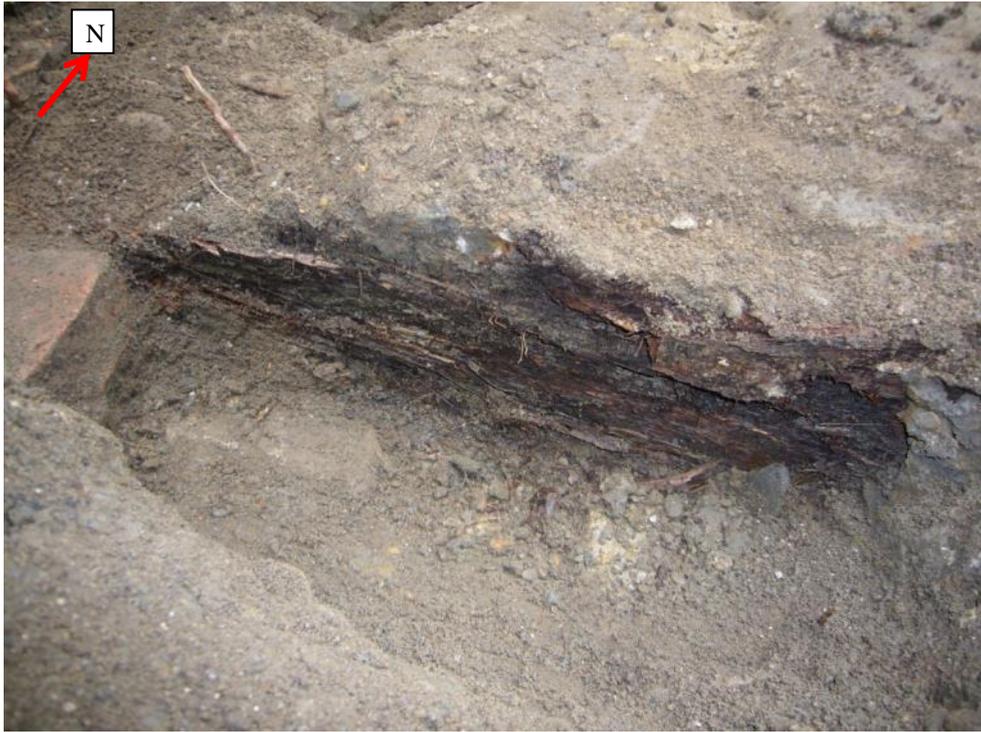
**Figure 24. Detail of Timber Across Revetment Top**

- 2.9. A trial hole was dug to expose more of the timber, as seen in Figure 24. A brick can clearly be seen, possibly part of in-fill when some feature here was decommissioned, but time prevented further excavation, and the hole was filled in to preserve the feature.

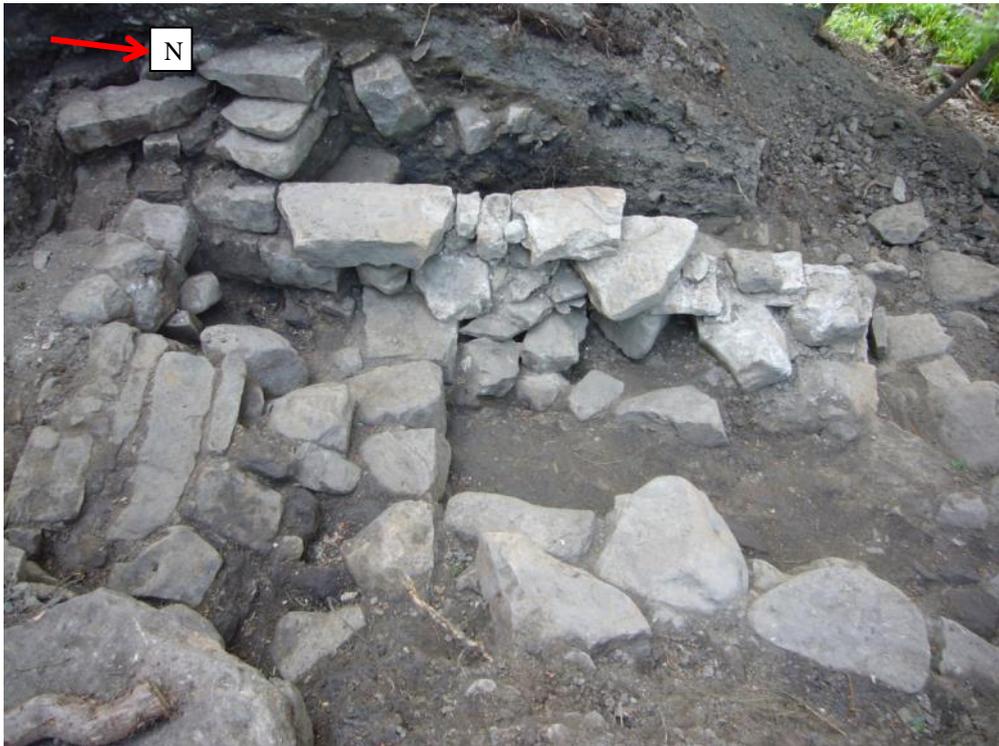
**Figure 25. Bank after July Dig**

2.10. A view of the bank excavation at the end of the July dig is given in Figure 25, from the top standing on the east side and looking down.

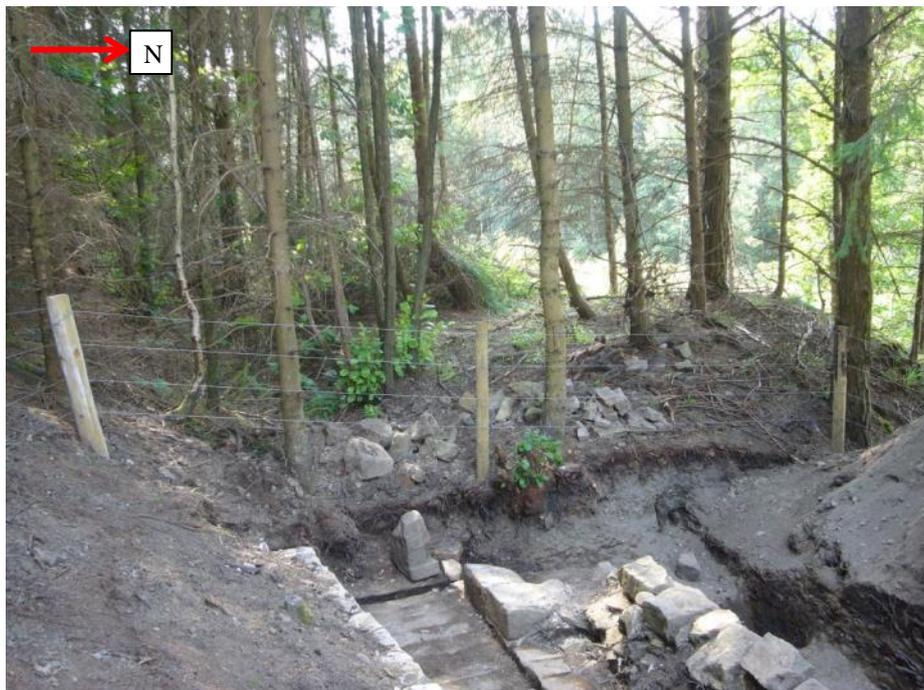
Figure 26. Undisturbed Bank to West From The Top

The Mill Pond was dug into the bank, with a faced stone retaining wall on the upper (south) bank side, and the timber shuttering on the north (Devil's Water) side. The spoil from this digging was thrown down the bank, resulting in the "widening" of the bank as it descends down towards the track. This widening has been somewhat obscured by the spoil from the May and July digs, but an indication of the widening from the original hillside slope is provided by the area immediately to the west of the currently fenced area which has not been disturbed. That area is shown in Figure 26 and Figure 27. Given that the wooden shuttering of the Mill Pond was found to be extending westward into this uninvestigated area, and given the size of the flat area of the banking in this area (see Figure 26), there is a strong possibility that further extensions of the already uncovered Mill Pond could be found in that area.

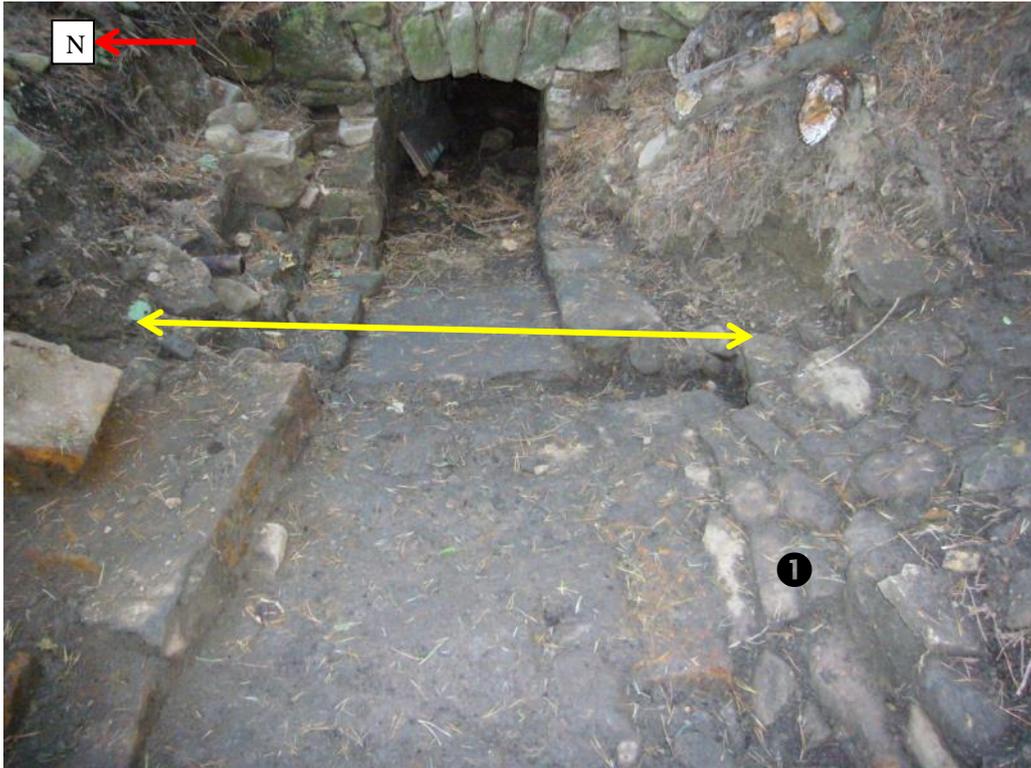
**Figure 28. Line of Mill Pond Shuttering**

The water supply to the Mill Pond was primarily from the Hall Burn, which was probably diverted completely to feed the Mill Pond via the cobbled chute near the later-developed culvert. There are a number of stone structures on the Hall Burn up the hill towards Dukesfield Hall that support this possibility, and further investigations there could reveal the feed into the Mill Pond below. The stone chute entered the East end of the Mill Pond, with vertical timber shuttering along that east side built into the bank. Remains of this shuttering have been uncovered. The feature labelled 2 in Figure 16 shows this vertical shuttering close to where the launder exit is assumed to be. Figure 28 below shows the line of the shuttering in front of the culvert (built later) and the end of the cobbled chute (labelled 1), perhaps also indicating that the slot was retained as a sluice gate in the re-development. Figure 29 shows a close up of the shuttering (after the culvert walls had been rebuilt), but comparing that picture with Figure 28 suggests the timber pre-dates the culvert and leat development. The excavation in the floor of the east end of the Mill Pond, as shown in Figure 10, has exposed what looks like cobbles and hence the possible end of the cobbled chute, which the leat development has cut across.
