**APPENDIX 1: Dukesfield Leat Excavation 2014, by Pete Lee**

# Dukesfield Leat Excavation 2014

*Pete Lee*

The two main sections in this document record some notes of the excavations in the leat at the Dukesfield Lead Smelting Mill: firstly during May 2014; and secondly in July 2014. Before May, the hearthstone-lined leat had been cleared out by earlier digs.

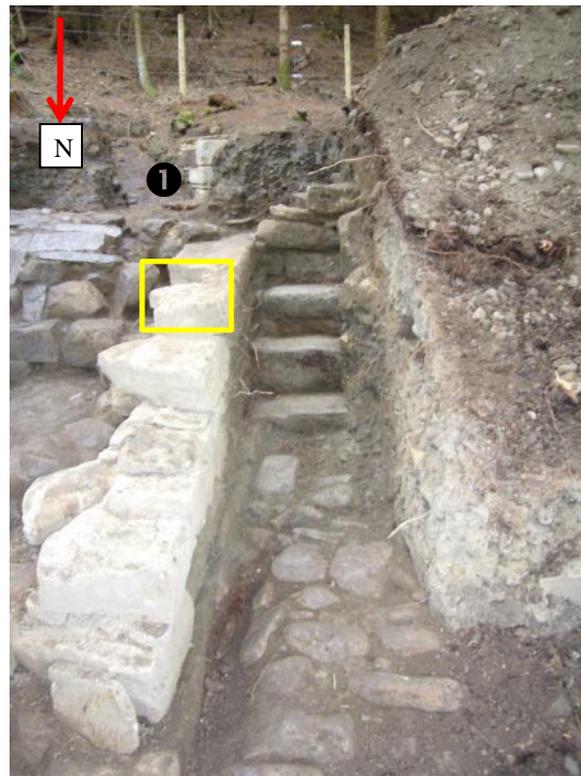
**Figure 32. Cobbled Water Chute and Possible Water Exit Point**

Figure 32 shows the alignment of the stone chute (1) and the possible water exit point (outlined in yellow).

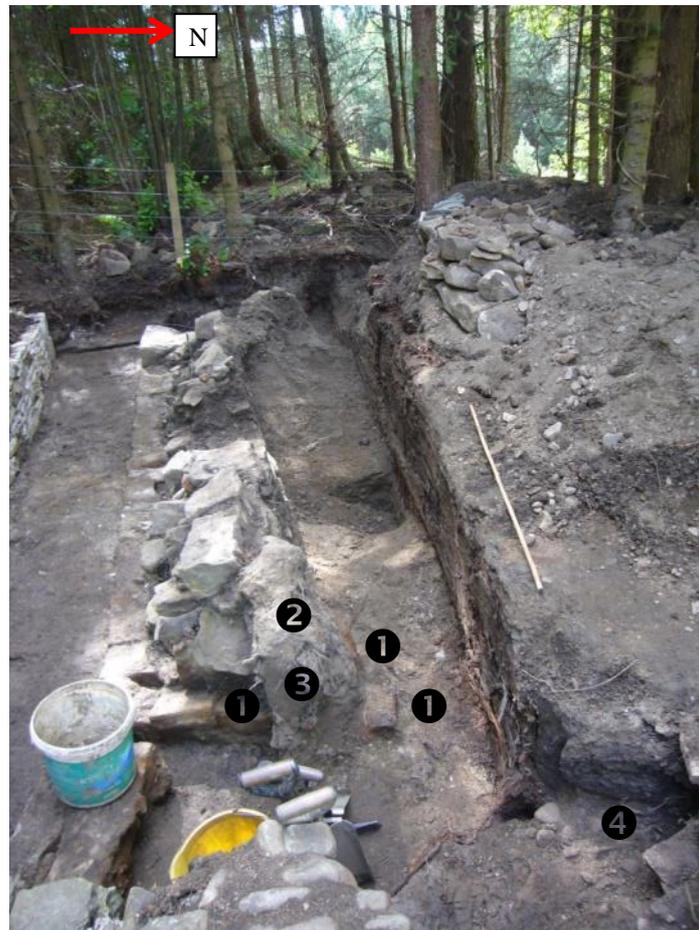
**Figure 33. Features of Leat Development**

At the culvert end, old hearth stones were laid across the Mill Pond as foundations (see features labelled 1 in Figure 33), and a clay wall (2 in Figure 33) built on top of this, with its inner face (3) angled towards the exit at the top of the bank (4). There was possibly some wooden shuttering across between 3 and 4 to form the west side of the water exit. See Figure 9 also.

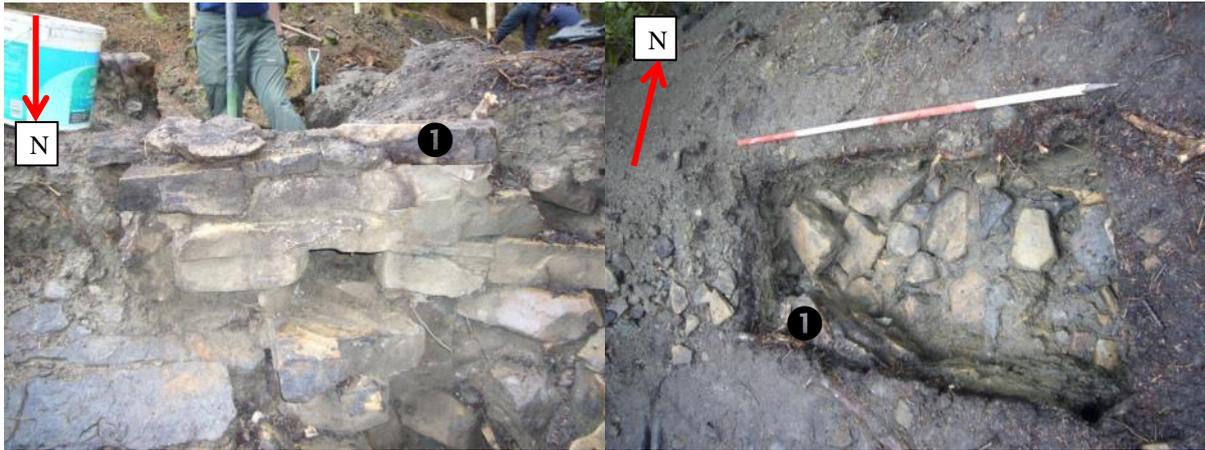
**Figure 34. Leat Exit**

The Mill Pond exit on the bank side was filled in with clay and stones, and the sloping revetment partly dismantled to provide some flat stones that were used to build up the height of the wall above this revetment, and to form a water exit from the leat. This exit hole is shown on the left in Figure 34 (repeated from Figure 15), together with an earlier picture on the right from the top taken in May (from approximately where the person in the left is standing) of a trench excavated down to the top of this feature. The stone labelled 1 in each picture is believed to be the same stone. Also, see Sections 2.1 and 2.2, and Figure 15 and Figure 16. The increased height of the water exit would provide additional power to the Mill's machines, and possibly powered a waterwheel to the west of that below the Arches. This will be discussed further below.

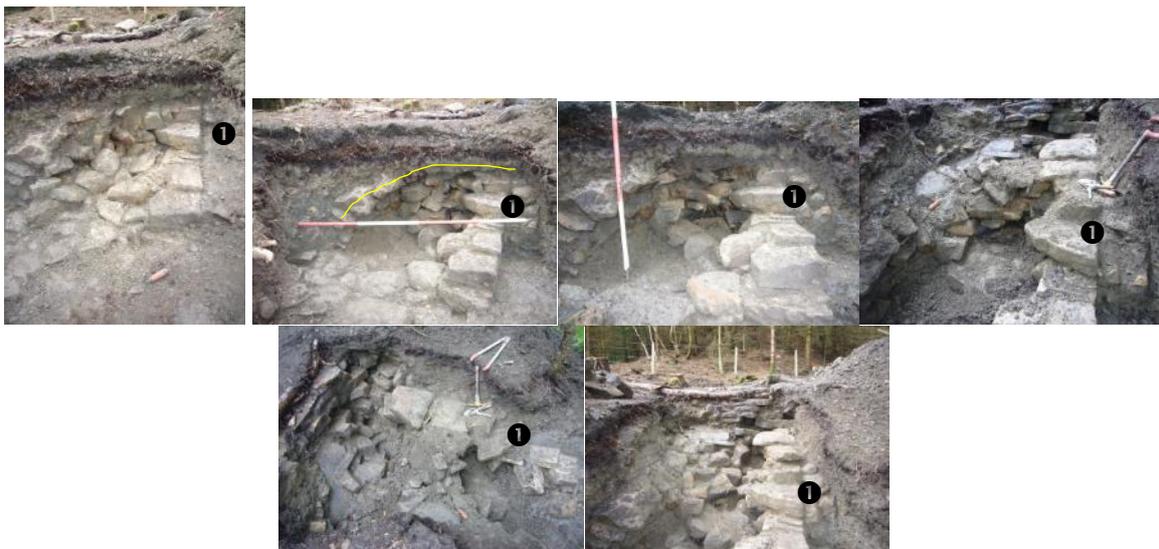
**Figure 35. Excavation Sequence in Bank**

The May excavation suggested that this area of the bank was constructed as a sort of internally-supported archway, from the east bank onto the stone wall. A chronological sequence of photographs (Figure 35) from May illustrate what was uncovered. The stone labelled 1 is believed to be common across all of the shots (and is also visible in Figure 15, just above the 1 label in the left-hand photograph).

Photographs in Figure 35 shows the stone wall and "internally-supported arch" (illustrated by the yellow line, just above the horizontal measuring pole). A capping layer of light gray clay is also visible just below the brown

layer of natural material. Was this all part of the construction, or part of the decommissioning? As mentioned in the May section, the in-fill stones seemed to have been carefully positioned, without mortar, and integrated into the construction of the wall (e.g. stones jutting from the wall were supported by stones inside), so the possibility of this being part of a decommissioning seems unlikely. If it was part of the construction that clay layer would presumably form a reasonably watertight seal, so if a wooden launder was above it, leaks from the launder wouldn't soak away into that area. However, it would provide a surface upon which the workers could walk to access the area (e.g. to any sluice gates). Moreover, the area would act as a drain for any leakage from the old Mill Pond exit, and perhaps that was its only function.

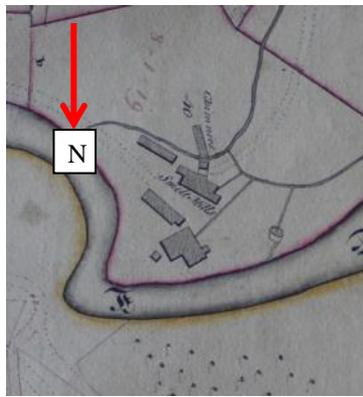
**Figure 36. Buildings From 1802 Map**

Visual sightings of the direction of the pier and its launder suggests it was oriented in a slightly different direction from the earlier launder discussed in Section 3.1. As was noted, the earlier launder headed towards the wheelpit at the bottom of the Arches. The later launder is oriented to the west of that, and would appear to align with the end of an extended smelt mill as shown on the 1802 map (Figure 36).
